BMW 1 HATCH: 1KUK138

Limited Technical Inspection

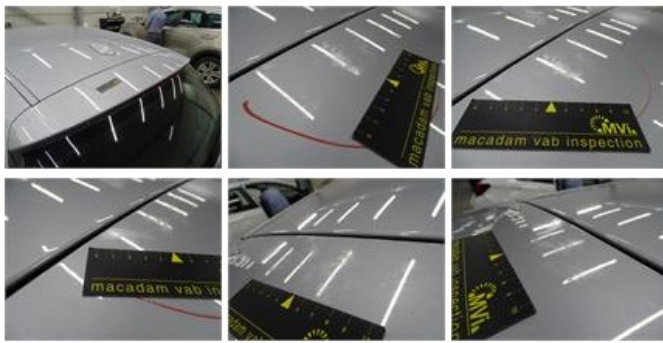
Rear spoiler, Chemical polution, LI - Repair and paint (complete)

115,56

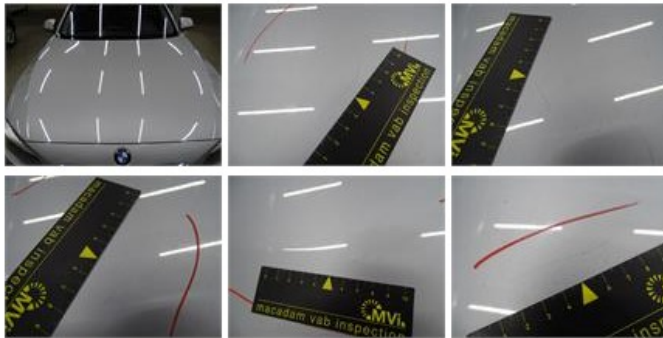
Bonnet, Scratch(es), LI - Repair and paint (complete)

290,08

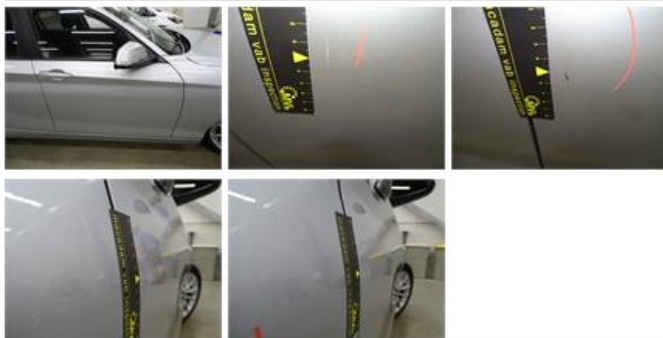
Door F R, Dent(s) and scratch(es), LI - Repair and paint (complete)

318,35

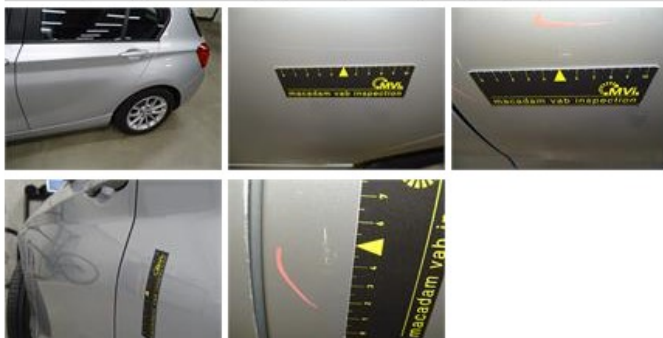
Door R L, Dent(s) and scratch(es), LI - Repair and paint (complete)

318,35

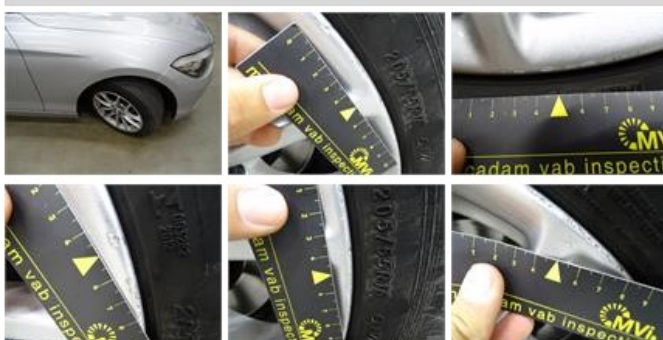
Alloy rim F R, Scratch(es), LI - Repair and paint (complete)

95,00

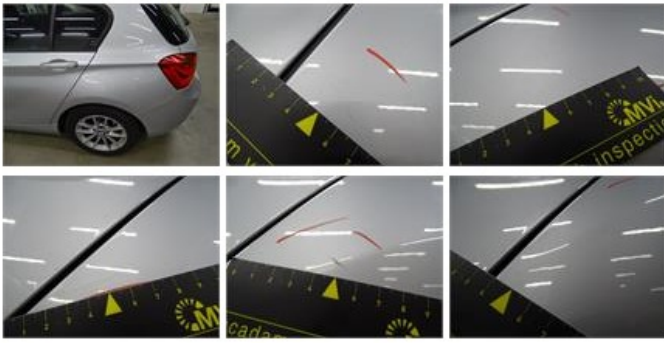
Wing R L, Scratch(es), LI - Repair and paint (complete)

308,20
