BMW 1 HATCH: 1LFH206

Limited Technical Inspection

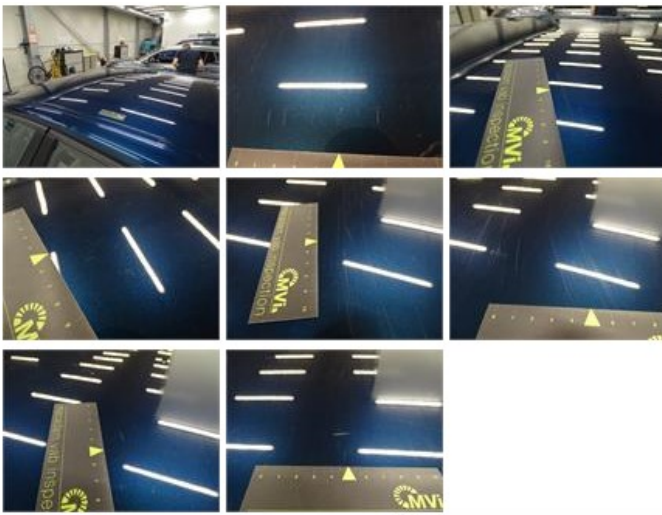
Total cost ex VAT	576,50
Bumper R, Scratch(es), Acceptable	0,00
<i>No pictures to display</i>	
Roof, Scratch(es), LI - Repair and paint (complete)	481,50

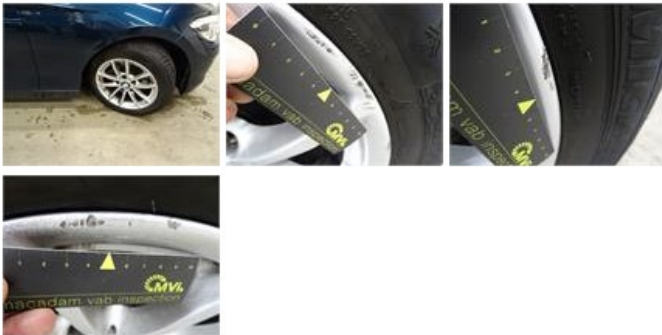
Alloy rim F R, Scratch(es), LI - Repair and paint (complete)	95,00
--	-------
