**BMW 3: 1HSR510**

**Limited Technical Inspection**

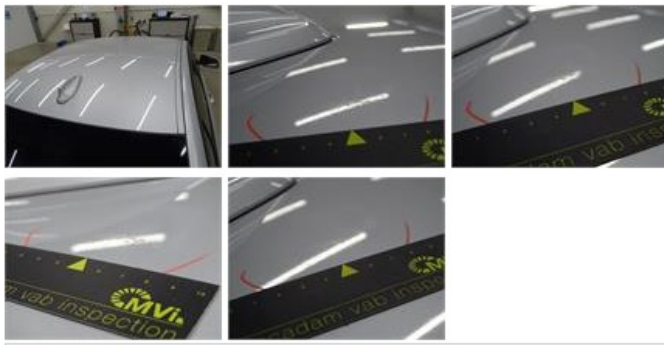
<b>Total cost ex VAT</b>	<b>1940,69</b>
<b>Roof, Chemical polution, LI - Repair and paint (complete)</b>	<b>481,50</b>

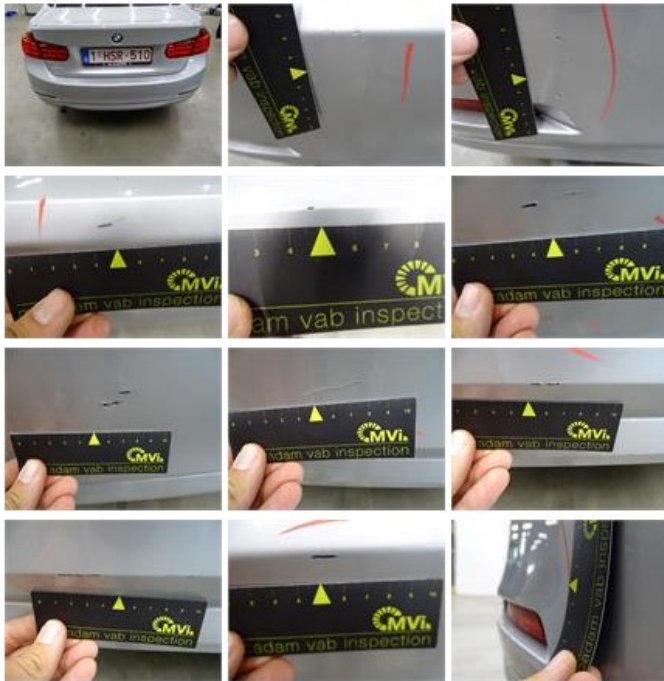
Bumper R, Scratch(es), LI - Repair and paint (complete)

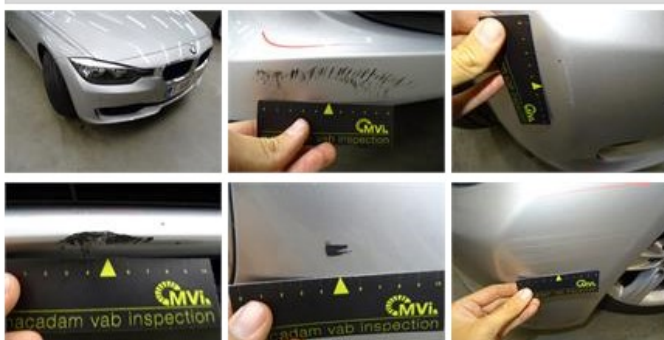
Bumper F, Scratch(es), LI - Repair and paint (complete)

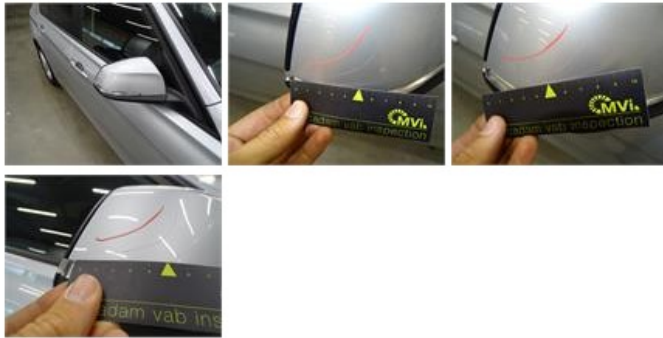
Rearview mirror housing R, Scratch(es), LI - Repair and paint (complete)

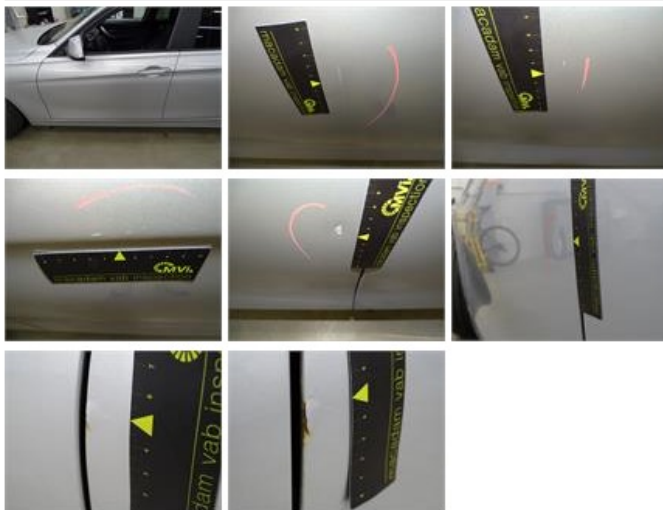
Door F L, Dent(s) and scratch(es), LI - Repair and paint (complete)
