**Ford fiesta: 1UMM365**

**Limited Technical Inspection**

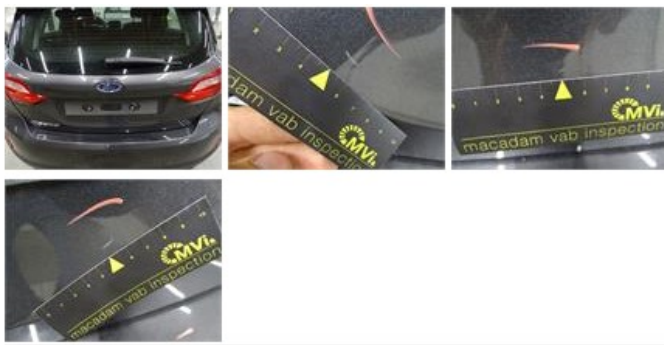
Total cost ex VAT	1729,58
Certificate Of Conformity, Missing, E - Replace	150,00
<i>No pictures to display</i>	
Tailgate, Scratch(es), LI - Repair and paint (complete)	241,34

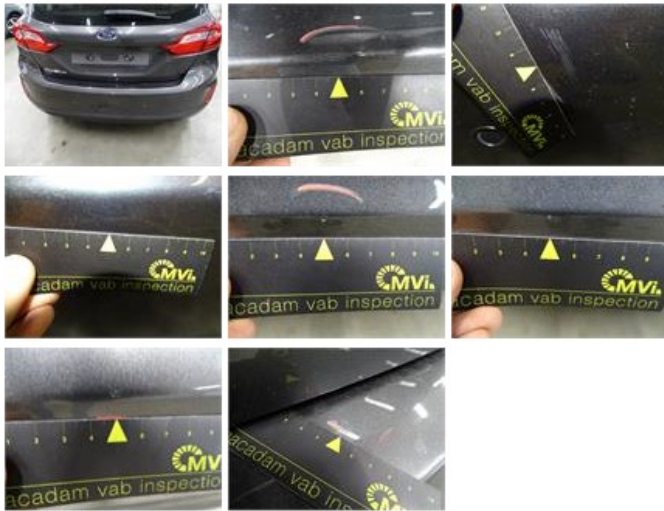
Bumper R, Scratch(es), LI - Repair and paint (complete) 169,44

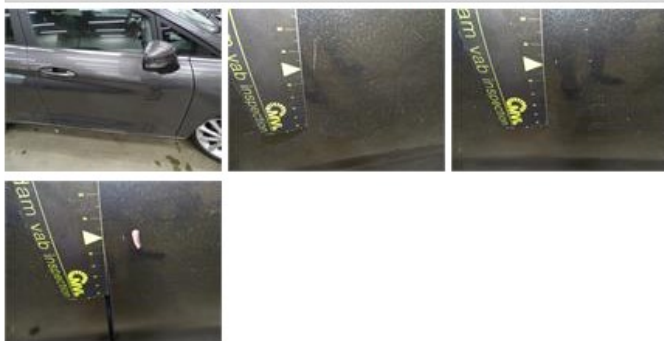
Door F R, Scratch(es), LI - Repair and paint (complete) 254,68

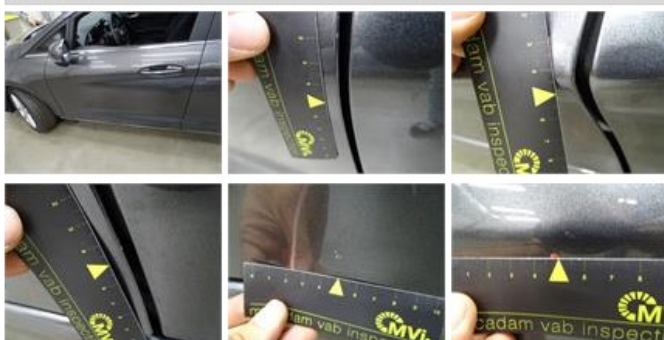
Door F L, Scratch(es), LI - Repair and paint (complete) 254,68

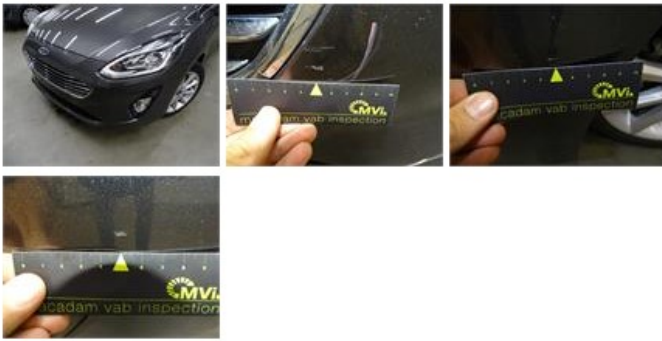
Bumper F, Scratch(es), LI - Repair and paint (complete) 169,44
