**MERCEDES A: 1KRL090**

**Limited Technical Inspection**

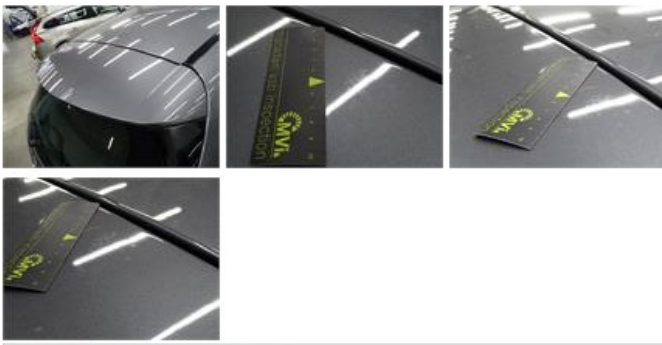
<b>Total cost ex VAT</b>	<b>998,86</b>
<b>Rear spoiler, Chemical polution, LI - Repair and paint (complete)</b>	<b>115,56</b>

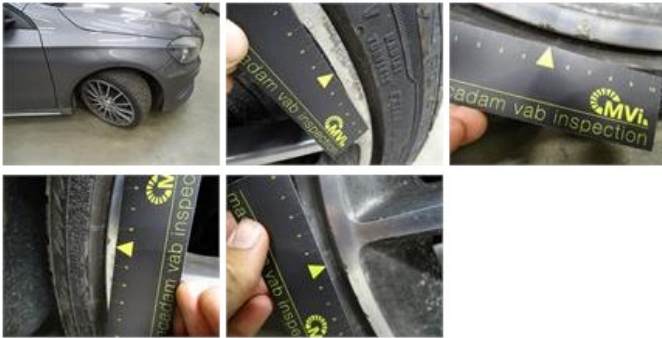
Alloy rim F R polished, Scratch(es), LI - Repair and paint (complete) 95,00

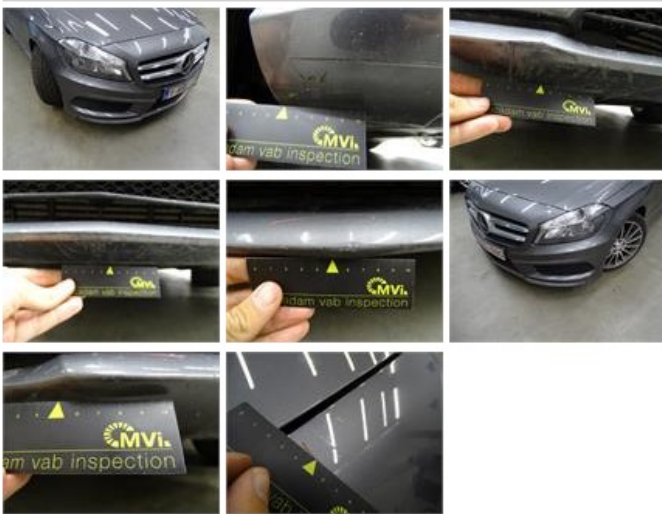
Bumper F, Scratch(es), LI - Repair and paint (complete) 211,80

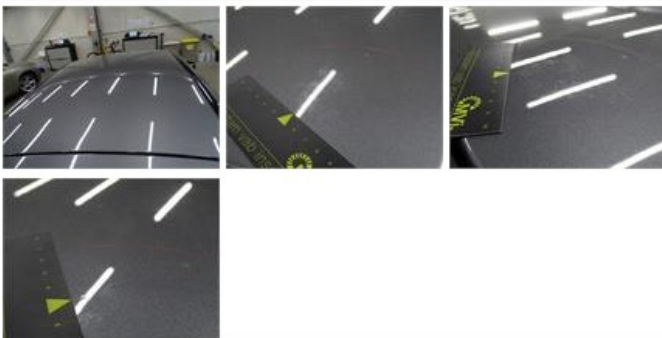
Roof, Chemical pollution, LI - Repair and paint (complete) 481,50
