**OPEL Astra: 1HHY836**

**Limited Technical Inspection**

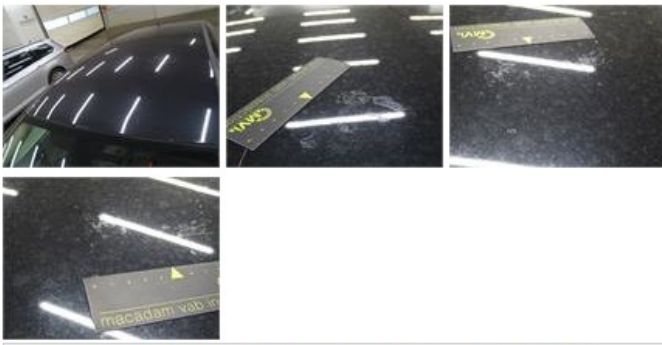
Total cost ex VAT	3468,43
Roof, Chemical polution, LI - Repair and paint (complete)	481,50

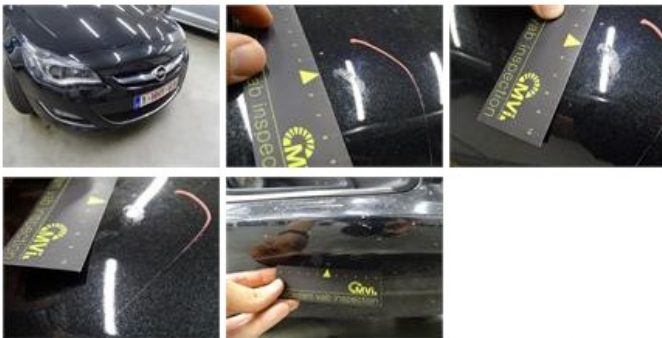
Bumper F, Chemical pollution, LI - Repair and paint (complete) 211,80

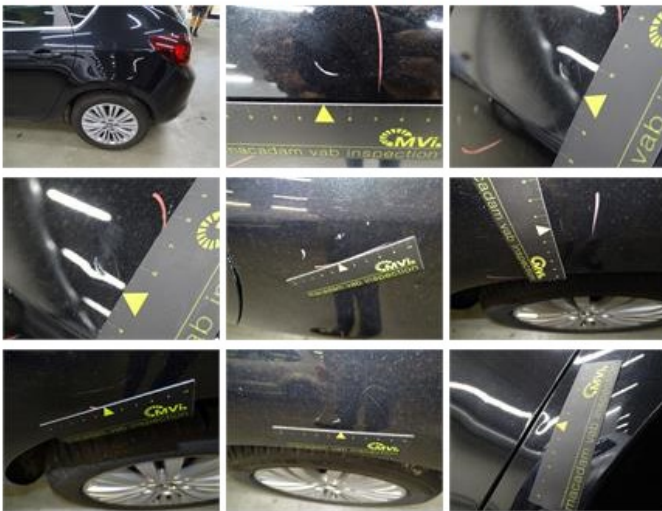
Wing R L, Dent(s) and scratch(es), LI - Repair and paint (complete) 308,20

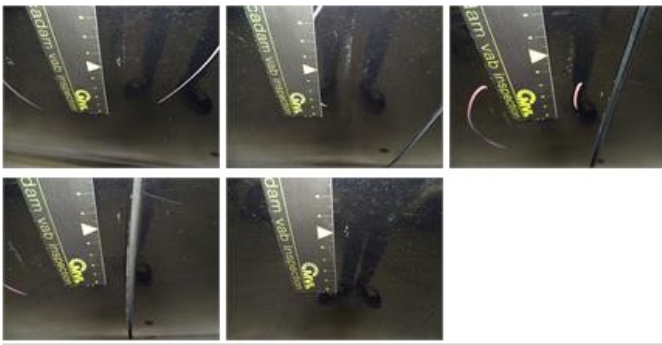
Door F L, Scratch(es), LI - Repair and paint (complete) 318,35

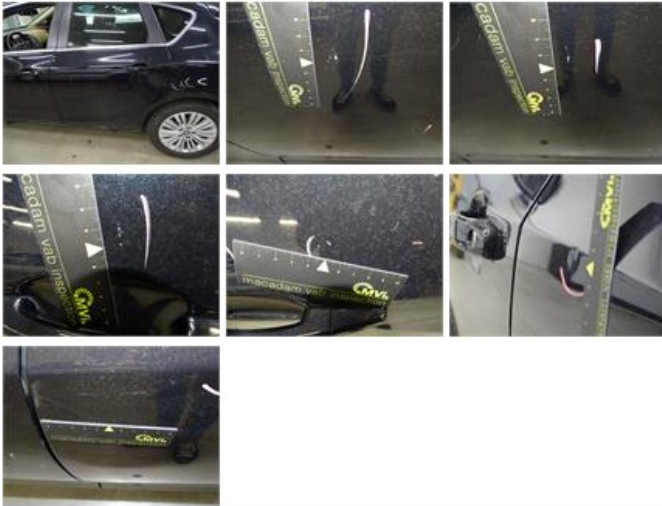
Door R L, Dent(s) and scratch(es), LI - Repair and paint (complete) 318,35

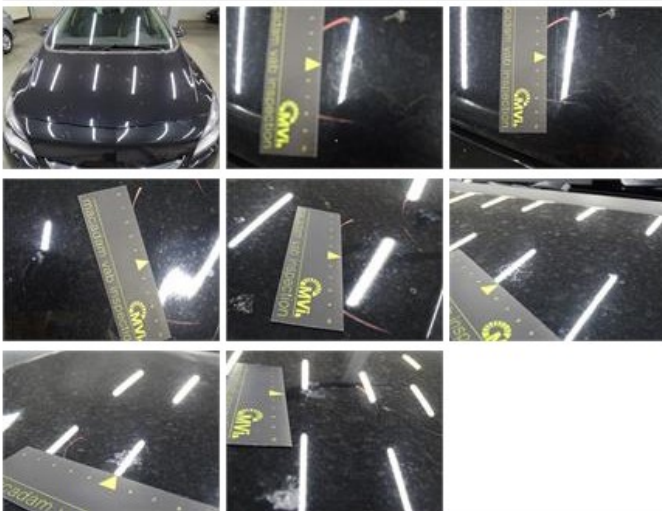
Bonnet, Chemical polution, LI - Repair and paint (complete) 290,08

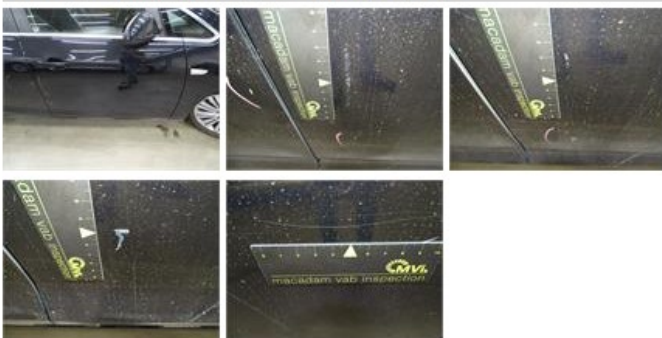
Door F R, Scratch(es), LI - Repair and paint (complete) 318,35

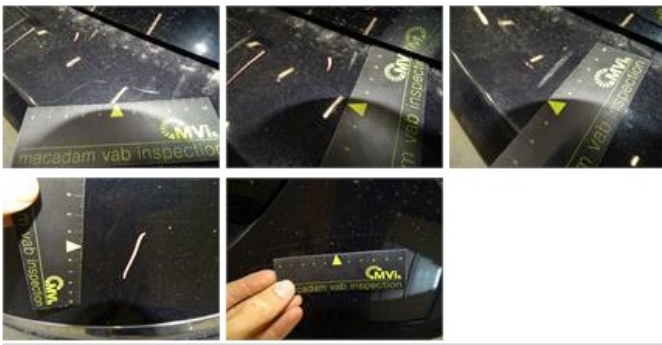
Bumper R, Scratch(es), LI - Repair and paint (complete) 211,80

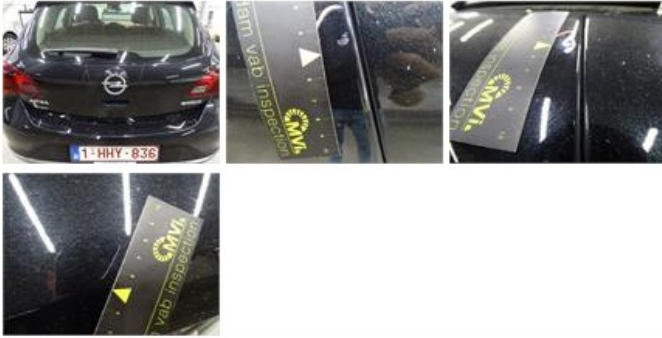
Tailgate, Dent(s) and scratch(es), LI - Repair and paint (complete) 301,68
