FORD S Max: 1FWF214

Limited Technical Inspection

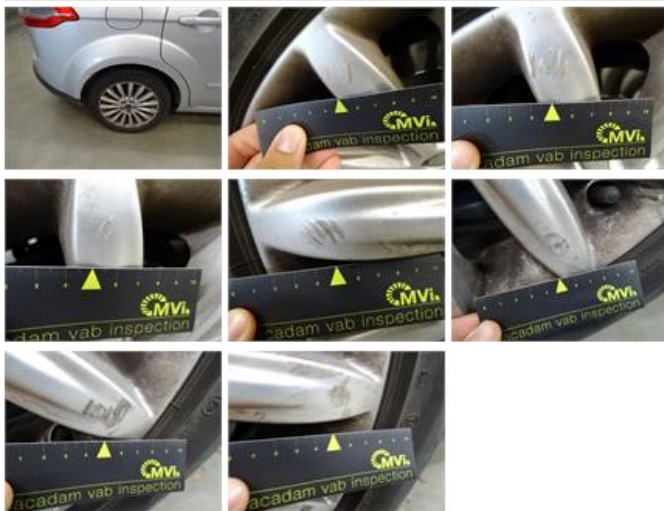
Alloy rim R R, Scratch(es), LI - Repair and paint (complete)

95,00

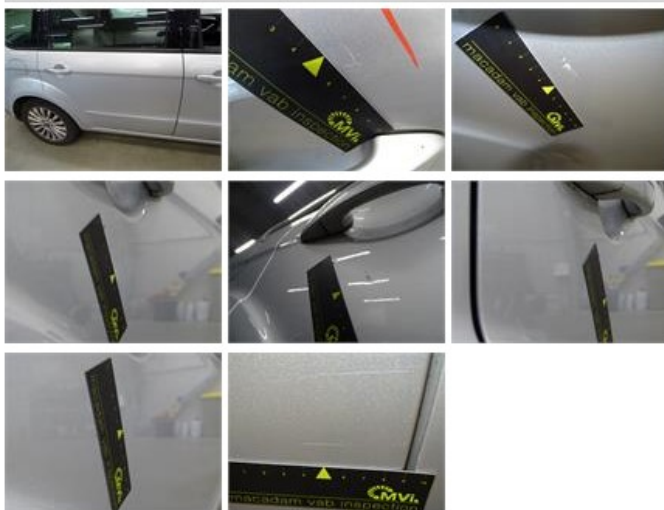
Door R R, Dent(s) and scratch(es), LI - Repair and paint (complete)

382,02

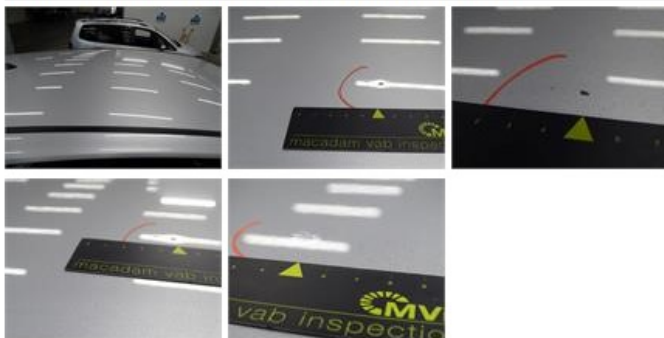
Roof, Dent(s) and scratch(es), LI - Repair and paint (complete)

577,80
