MERCEDES C: 1GHP953

Limited Technical Inspection

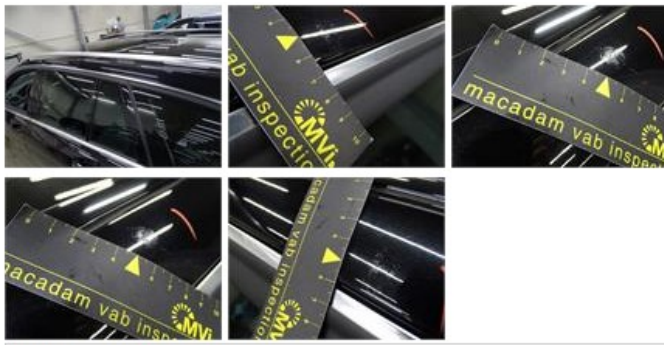
Total cost ex VAT	3523,49
Roof pillar L, Chemical polution, LI - Repair and paint (complete)	220,18

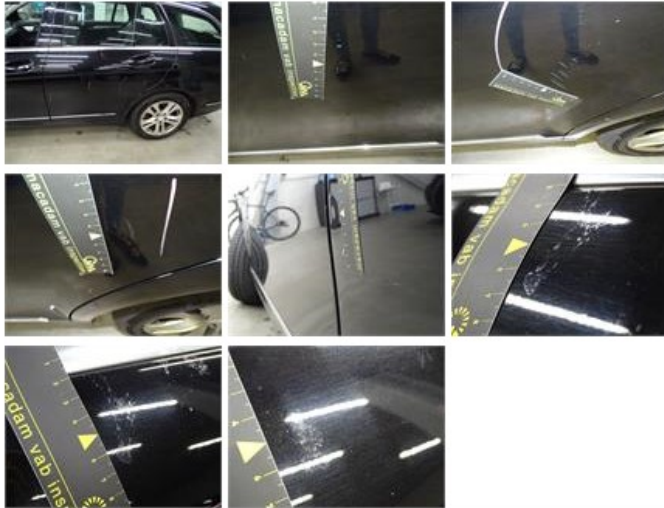
Door R L, Dent(s) and scratch(es), LI - Repair and paint (complete) 318,35

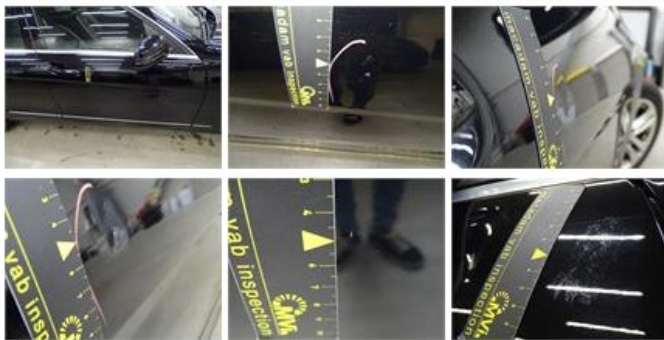
Door F R, Dent(s) and scratch(es), LI - Repair and paint (complete) 318,35

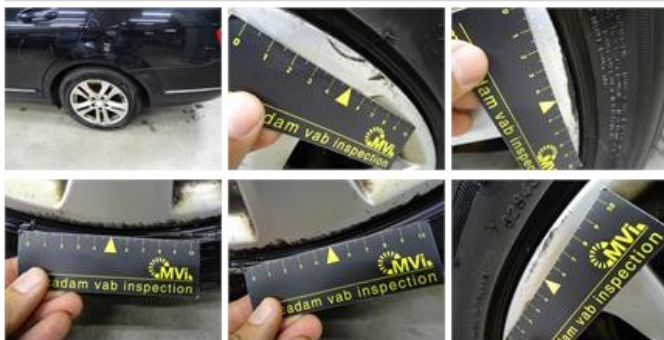
Alloy rim R L, Scratch(es), LI - Repair and paint (complete) 95,00

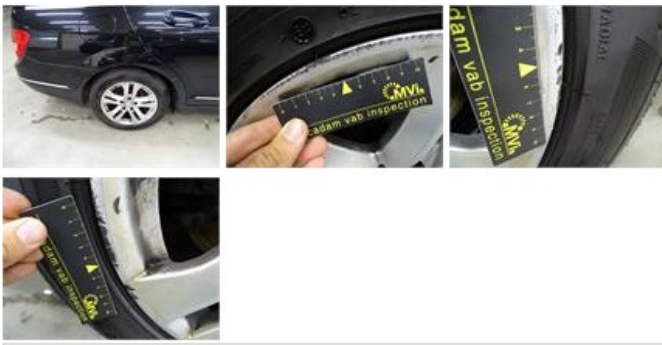
Alloy rim R R, Scratch(es), LI - Repair and paint (complete) 95,00

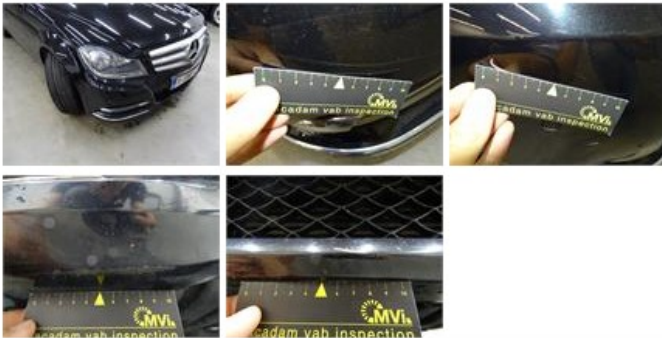
Bumper F, Scratch(es), LI - Repair and paint (complete) 211,80

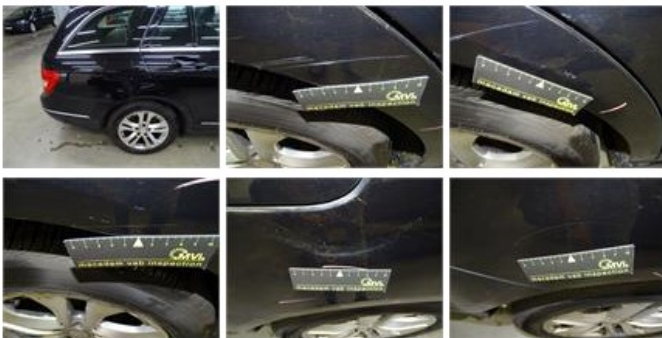
Wing R R, Scratch(es), LI - Repair and paint (complete) 308,20

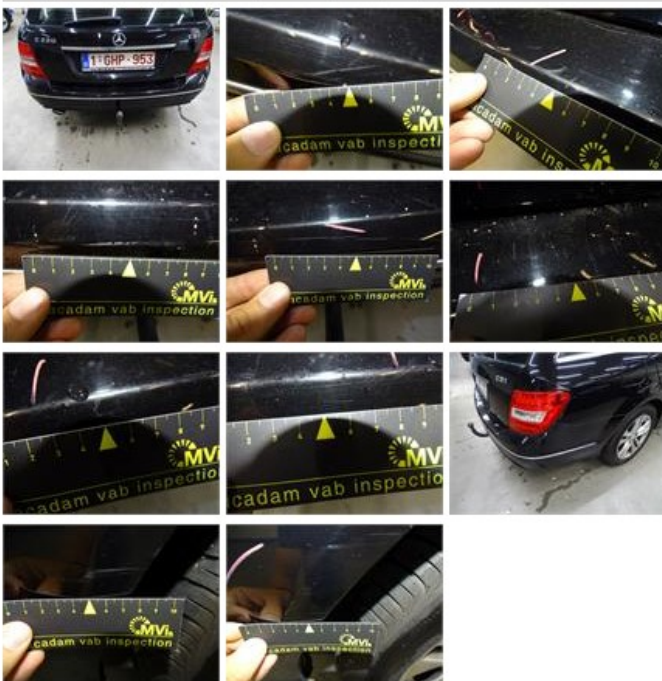
Bumper R, Scratch(es), LI - Repair and paint (complete) 211,80

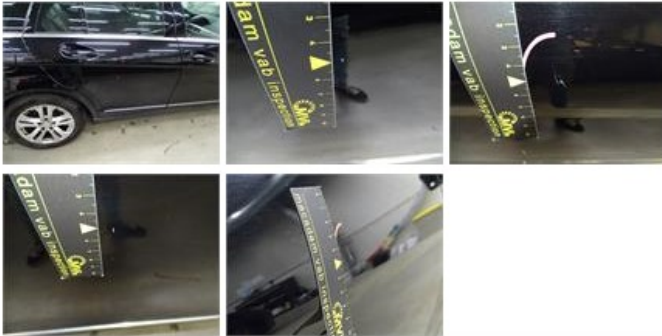
Door R R, Dent(s) and scratch(es), LI - Repair and paint (complete)

318,35

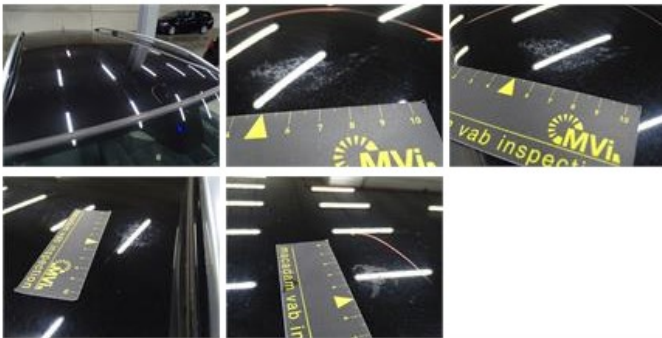
Roof, Chemical polution, LI - Repair and paint (complete)

481,50

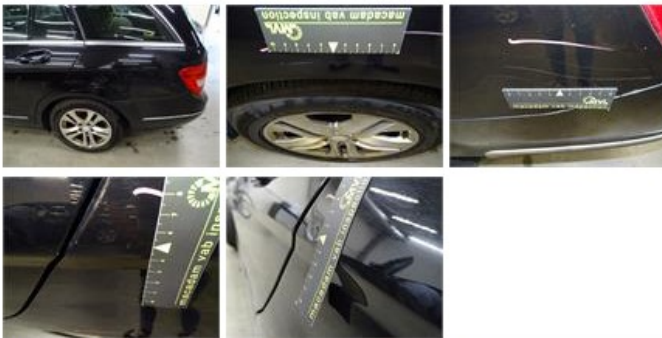
Wing R L, Dent(s) and scratch(es), LI - Repair and paint (complete)

308,20

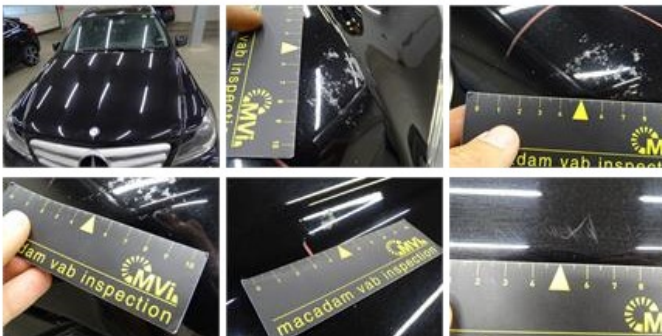
Bonnet, Chemical polution, LI - Repair and paint (complete)

290,08
