OPEL Movano 3500 MWB Med.High Roof: 1GNJ707

Limited Technical Inspection

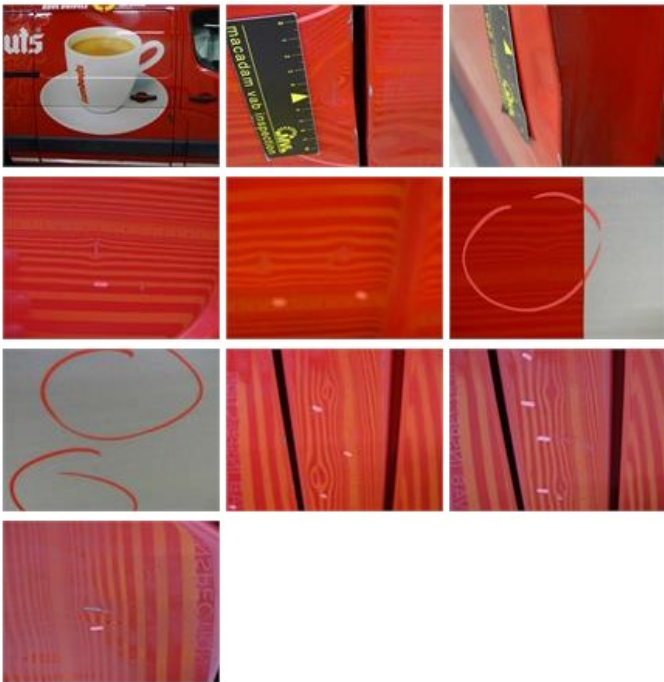
Door R R, Dent(s), LI - Repair and paint (complete)

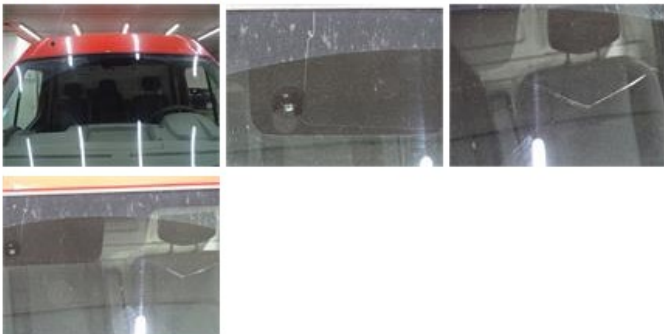
Windscreen, Crack, E - Replace
