VOLKSWAGEN Crafter 35 MWB: 1ALZ512

Limited Technical Inspection

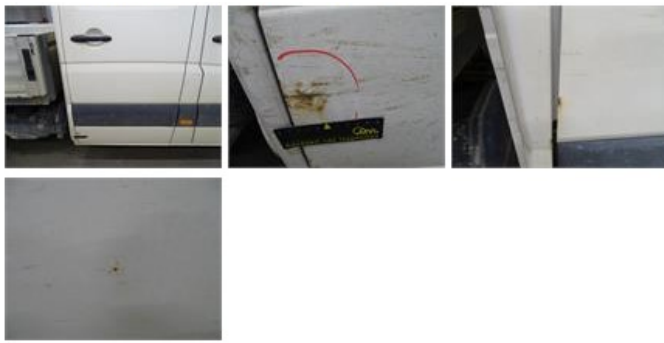
Door R R, Rust, LI - Repair and paint (complete)	238,76
--	--------
