VOLVO V40: 1GGW779

Limited Technical Inspection

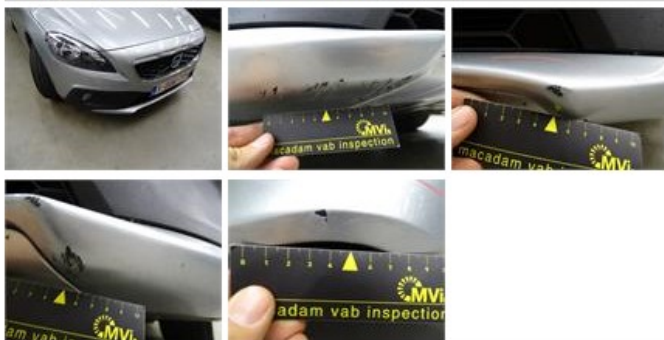
Bumper F, Scratch(es), LI - Repair and paint (complete)

211,80

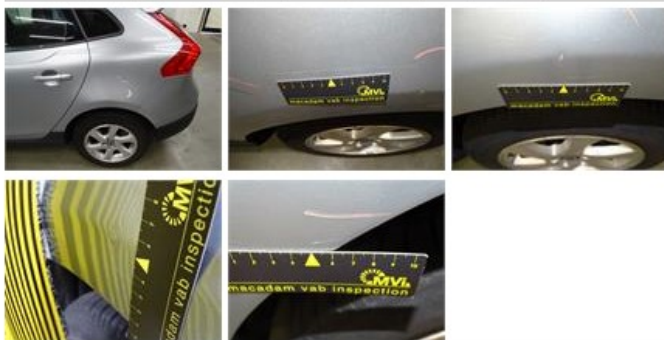
Wing R L, Dent(s) and scratch(es), LI - Repair and paint (complete)

308,20

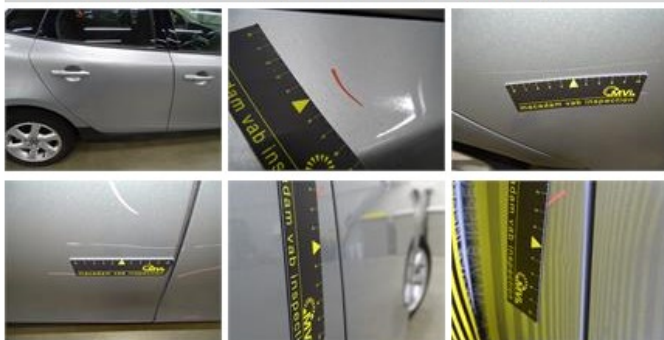
Door R R, Dent(s) and scratch(es), LI - Repair and paint (complete)

318,35

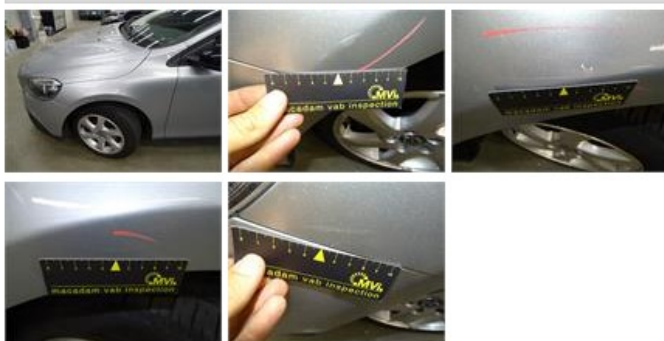
Wing F L, Scratch(es), LI - Repair and paint (complete)

220,18

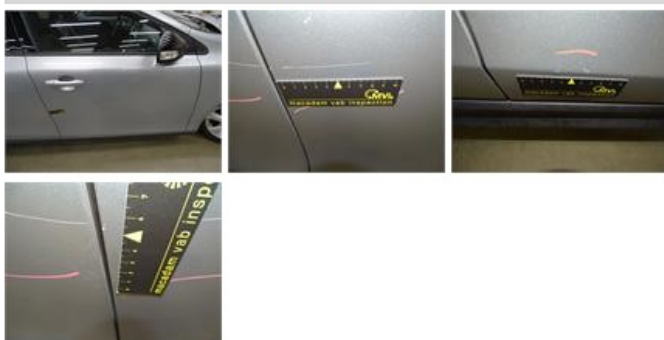
Door F R, Scratch(es), LI - Repair and paint (complete)

318,35

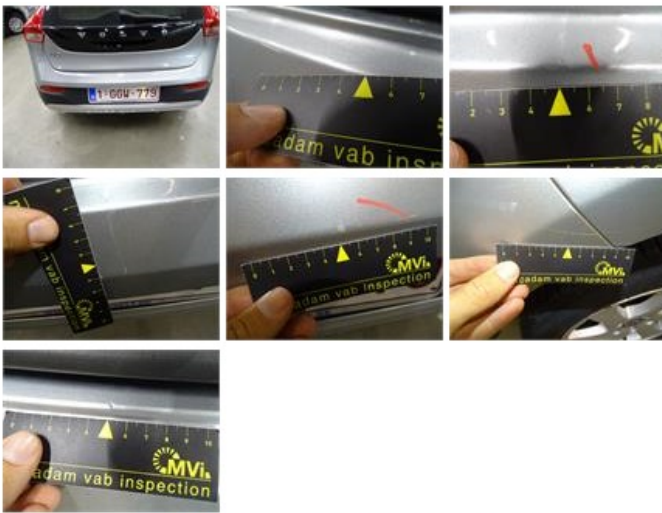
Bumper R, Scratch(es), LI - Repair and paint (complete)

211,80

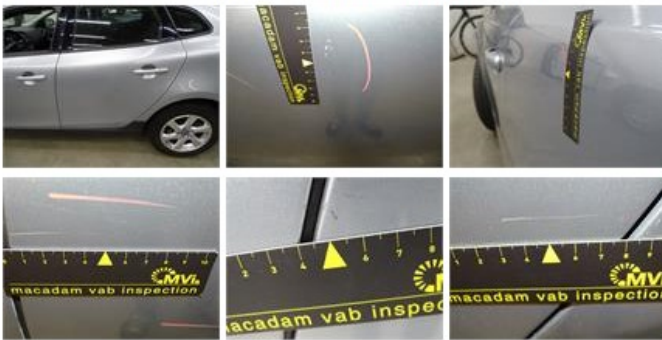
Door R L, Dent(s) and scratch(es), LI - Repair and paint (complete) 318,35

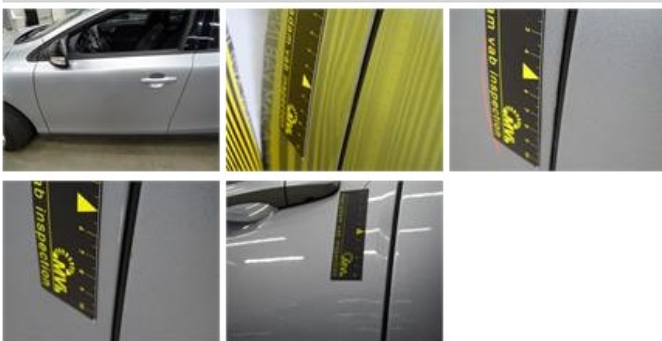
Door F L, Dent(s) and scratch(es), LI - Repair and paint (complete) 318,35
