**VOLKSWAGEN SHARAN: 1KNY582**

**Limited Technical Inspection**

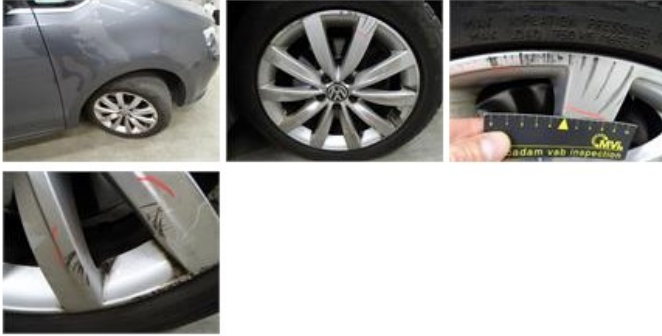
Wing R R, Scratch(es), 67 - Polish	0,00
<i>No pictures to display</i>	
Door R L, Scratch(es), Acceptable	0,00
<i>No pictures to display</i>	
Bumper F R, Scratch(es), Acceptable	0,00
<i>No pictures to display</i>	
Bumper F, Dent(s), Acceptable	0,00
<i>No pictures to display</i>	
Alloy rim F R, Scratch(es), LI - Repair and paint (complete)	95,00
