**VOLVO V60: 1HEJ591**

**Limited Technical Inspection**

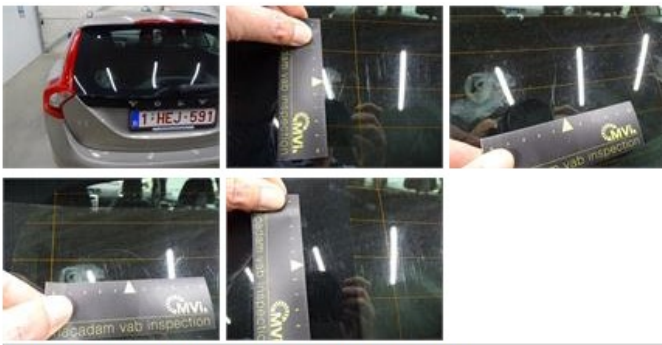
Total cost ex VAT	2034,91
Rear window, Scratch(es), E - Replace	0,00

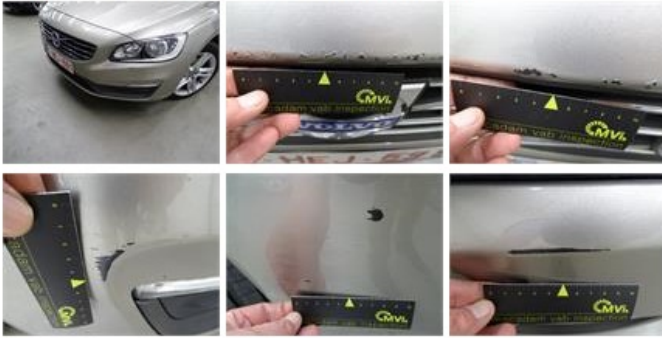
Bumper F, Scratch(es), LI - Repair and paint (complete) 211,80
