VOLKSWAGEN GOLF VII: 1WMF614

Limited Technical Inspection

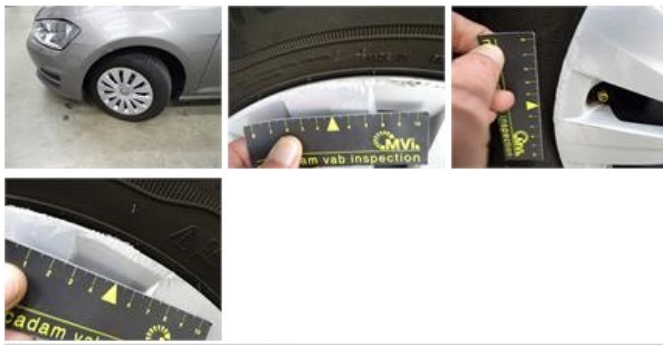
Wheel cover F L, Scratch(es), E - Replace	30,00
---	--------------

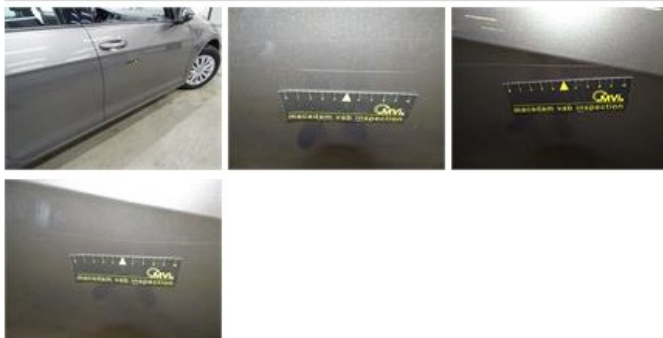
Door F R, Scratch(es), LI - Repair and paint (complete)	318,35
---	--------

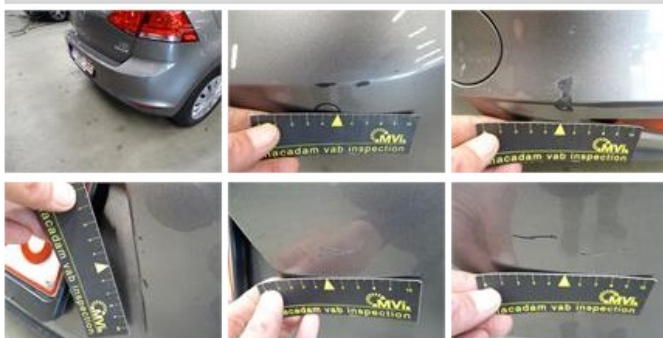
Wing R R, Scratch(es), Acceptable	0,00
<i>No pictures to display</i>	
Bumper F, Scratch(es), Acceptable	0,00
<i>No pictures to display</i>	
Bumper R, Scratch(es), LI - Repair and paint (complete)	211,80
