VOLVO V60: 1JVB730

| Vinnumber: | YV1FW8481F1260482 | Versionname: | 1.6 D2 KINETIC |

Limited Technical Inspection

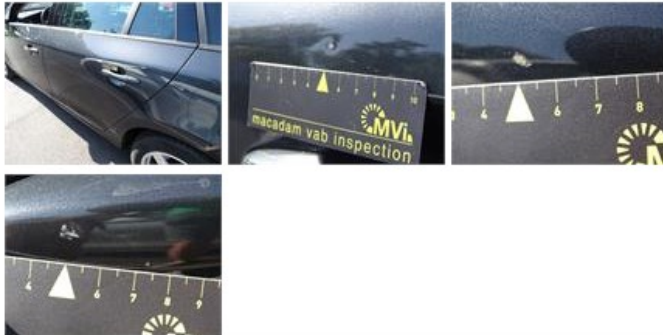
Door R L, Dent(s) and scratch(es), It - Spot repair 115,56

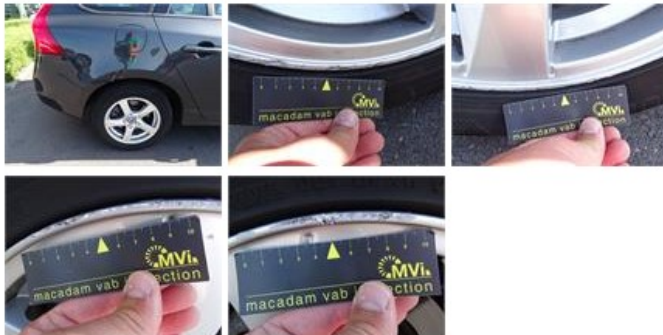
Alloy rim R R, Scratch(es), LI - Repair and paint (complete) 95,00

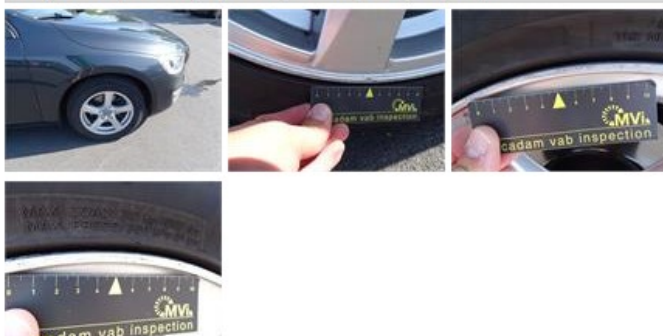
Alloy rim F R, Scratch(es), LI - Repair and paint (complete) 95,00

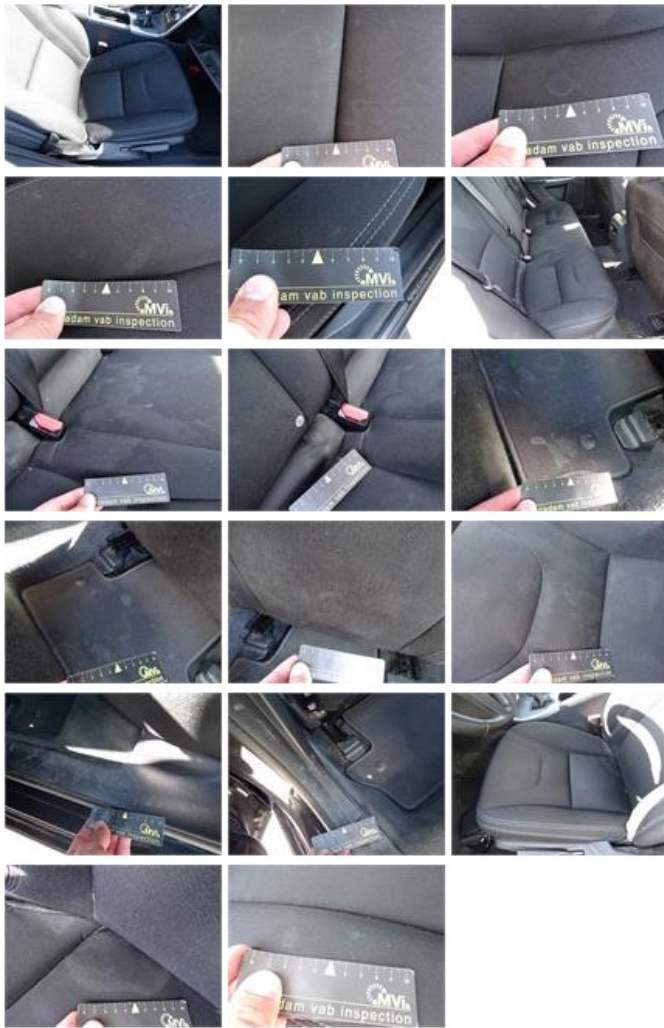
Interior, Stain, Shampooing 75,00
