VOLVO V40: 1LEP820

Limited Technical Inspection

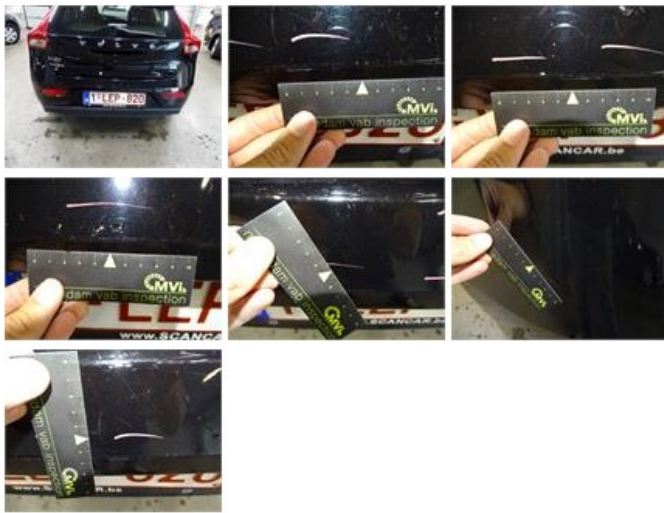
Total cost ex VAT	2060,28
Bumper R, Scratch(es), LI - Repair and paint (complete)	211,80

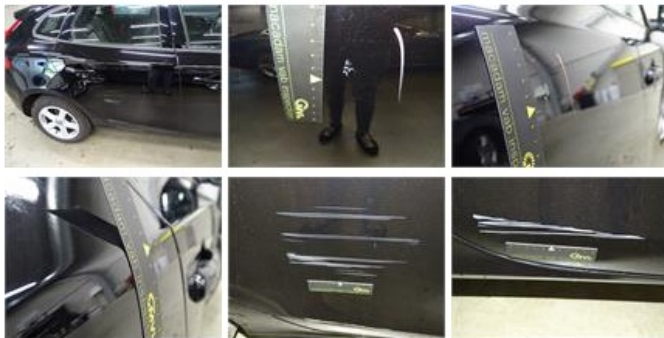
Door R R, Dent(s) and scratch(es), LI - Repair and paint (complete)

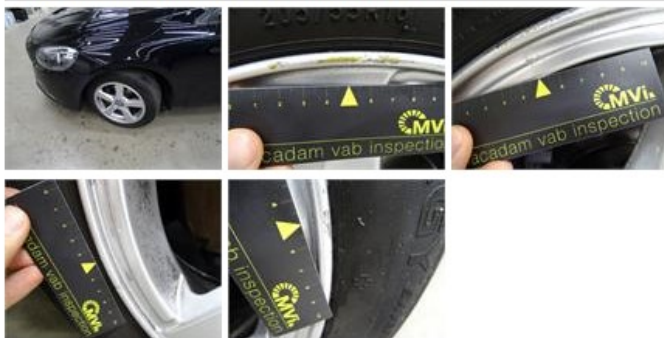
Alloy rim F L, Scratch(es), LI - Repair and paint (complete)

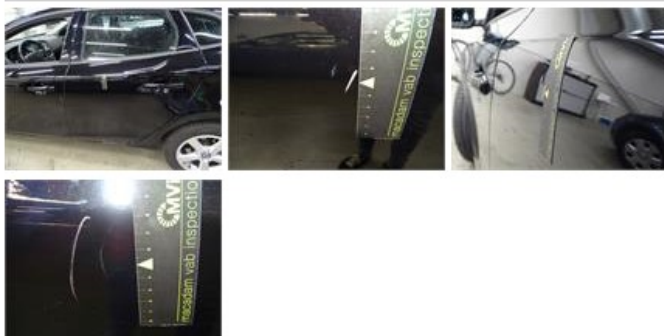
Door R L, Dent(s) and scratch(es), LI - Repair and paint (complete)

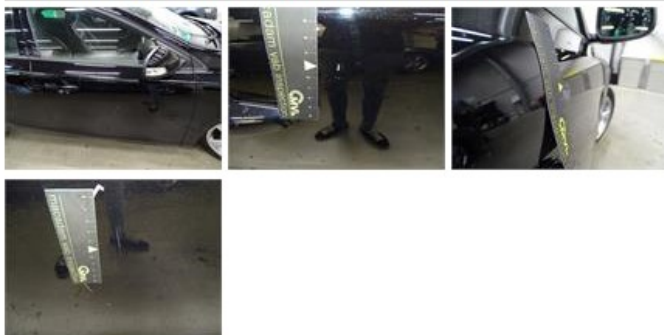
Door F R, Dent(s) and scratch(es), LI - Repair and paint (complete)

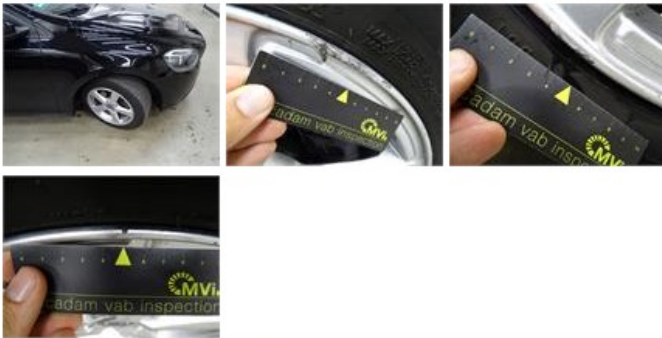
Wing F R, Scratch(es), Acceptable
