SKODA Octavia: 1HEF977

Limited Technical Inspection

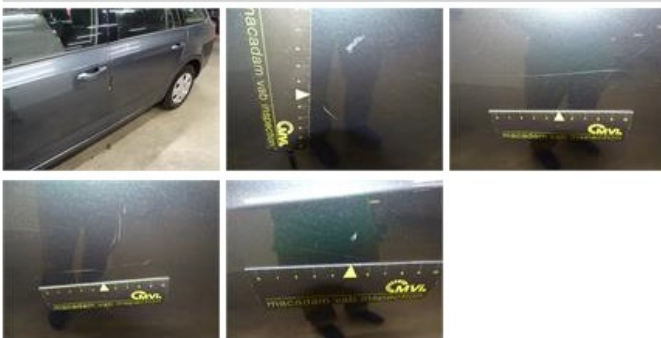
Door R L, Scratch(es), LI - Repair and paint (complete) 318,35
