**VOLKSWAGEN Crafter 35 MWB: 1BJR421**

**Limited Technical Inspection**

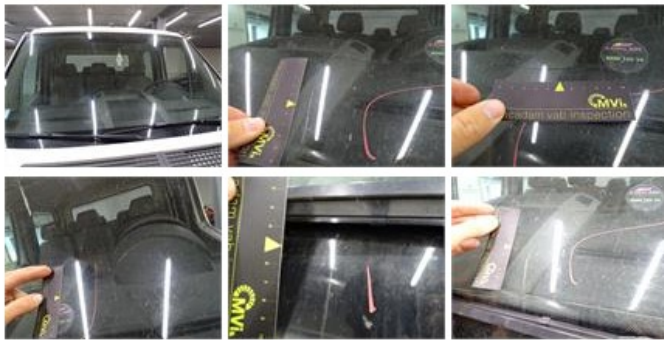
Windscreen, Crack, E - Replace

395,40

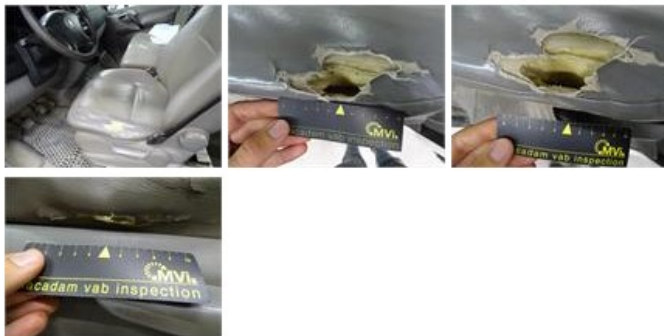
Seat cover F L, Hole, E - Replace

300,00

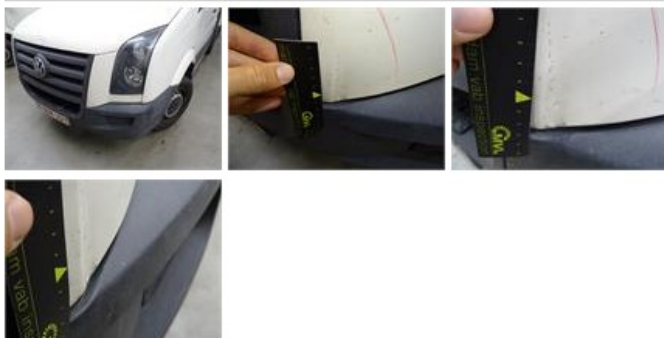
Bumper F L, Dent(s) and scratch(es), It - Spot repair

115,56

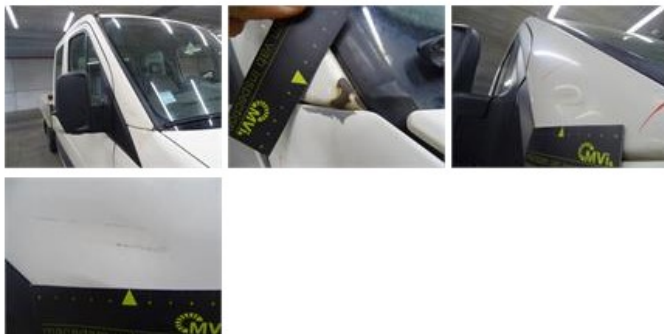
A-pillar right, Dent(s) and scratch(es), LI - Repair and paint (complete)

124,23

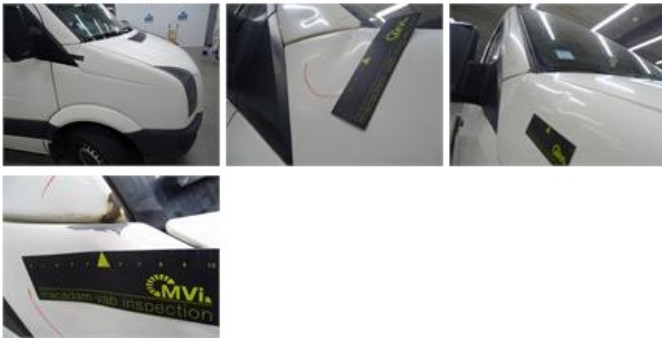
Wing F R, Dent(s) and scratch(es), LI - Repair and paint (complete) 165,13

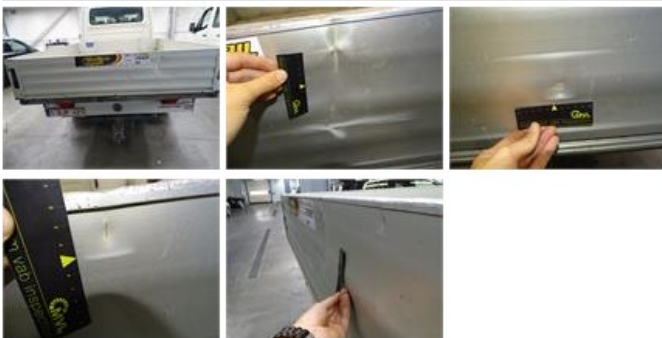
Tailgate, Dent(s) and scratch(es), Le - Replace and paint 385,50

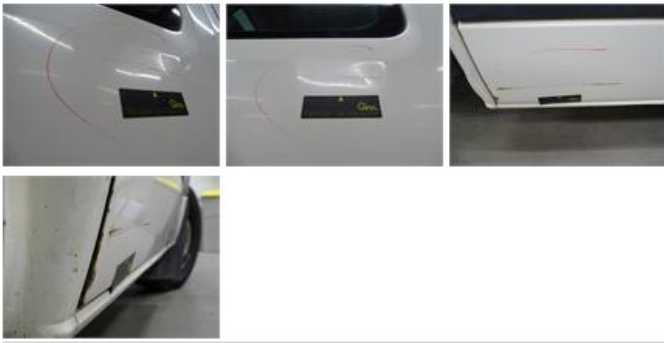
Door R R, Dent(s) and scratch(es), LI - Repair and paint (complete) 238,76
