SKODA OCTAVIA COMBI: 1LUU042

Limited Technical Inspection

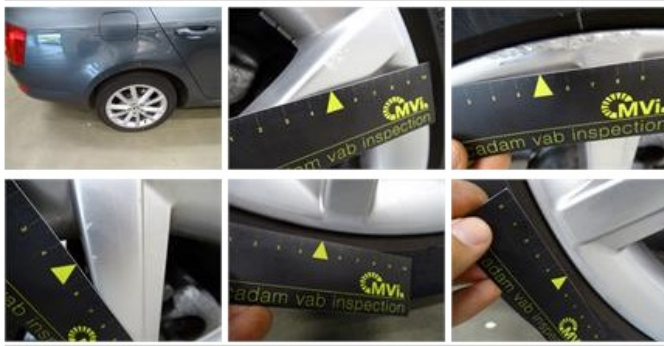
Alloy rim R R, Scratch(es), LI - Repair and paint (complete) 0,00

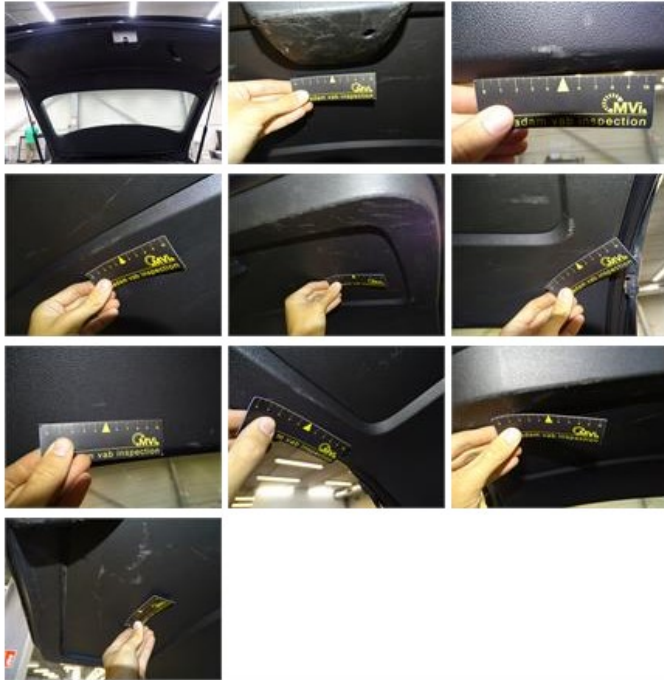
Trunk lid covering R, Scratch(es), Smart repair

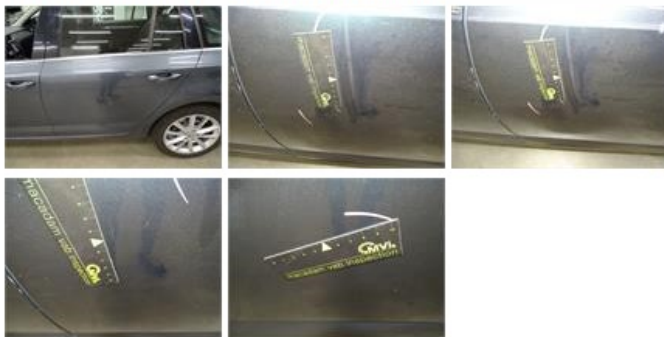
Door R L, Scratch(es), LI - Repair and paint (complete)

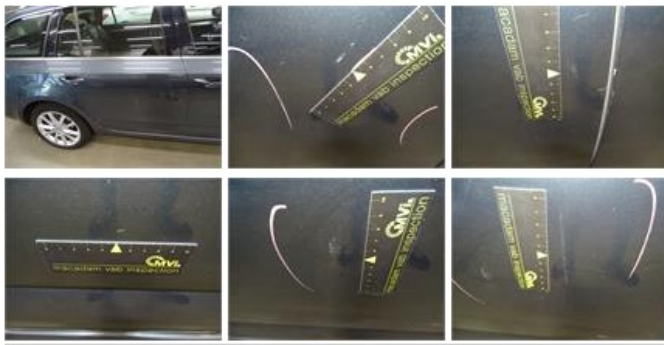
Door R R, Scratch(es), LI - Repair and paint (complete)

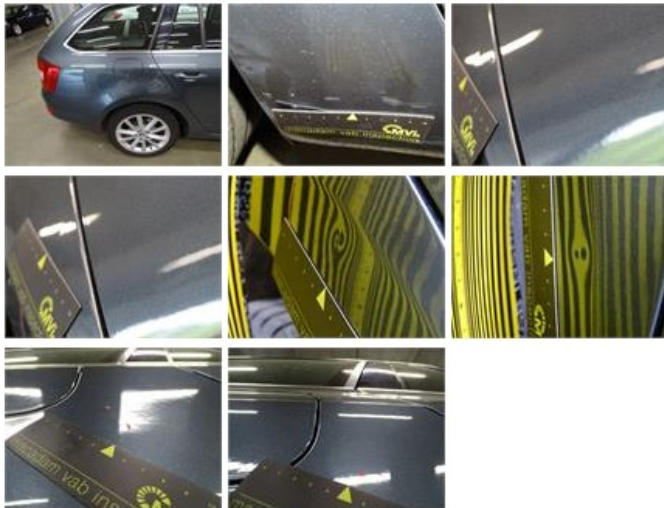
Wing R R, Dent(s) and scratch(es), LI - Repair and paint (complete) 0,00

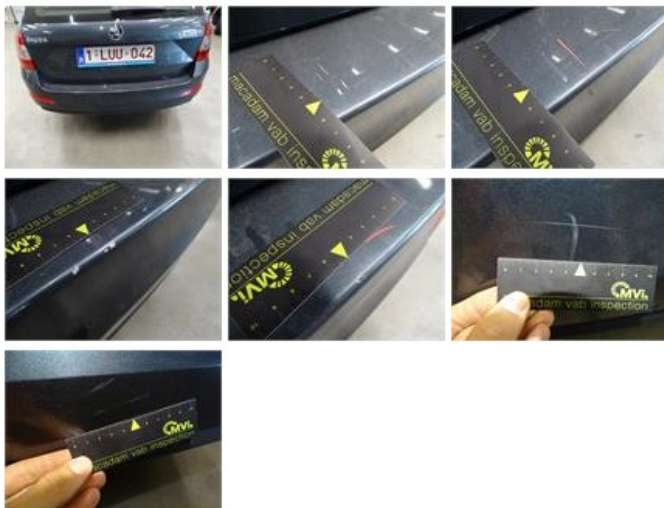
Bumper R, Scratch(es), LI - Repair and paint (complete) 0,00

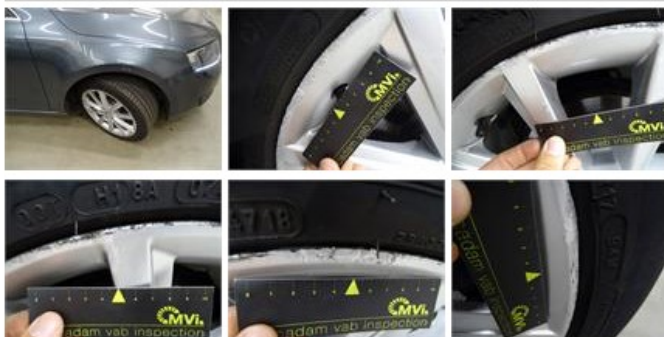
Alloy rim F R, Scratch(es), LI - Repair and paint (complete) 0,00

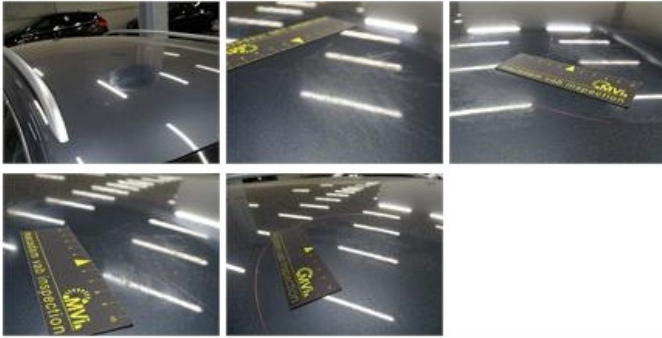
Roof, Chemical polution, LI - Repair and paint (complete)
