RENAULT CLIO: 1KNX647

Limited Technical Inspection

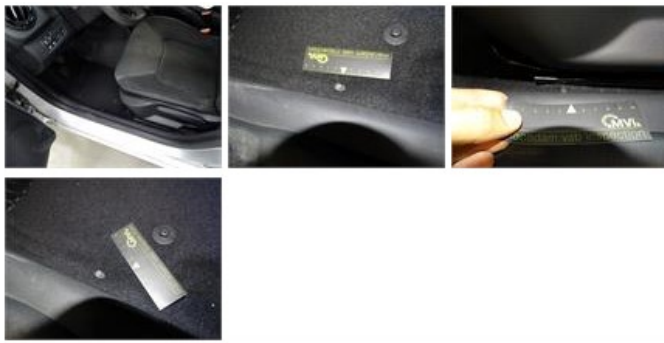
Total cost ex VAT	1405,52
Wheel cover R L, Scratch(es), Acceptable	0,00
<i>No pictures to display</i>	
Wheel cover F R, Scratch(es), Acceptable	0,00
<i>No pictures to display</i>	
Floor covering F L, Hole, Smart repair	64,32

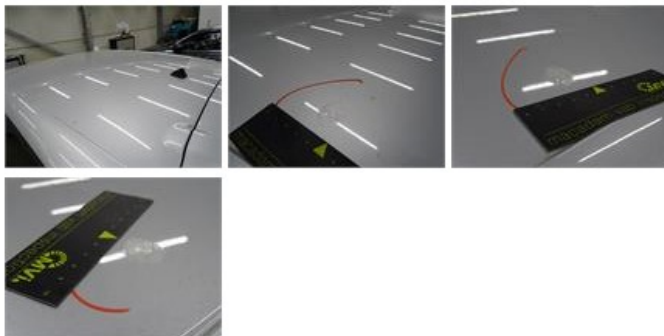
Roof, Chemical polution, LI - Repair and paint (complete)

385,20

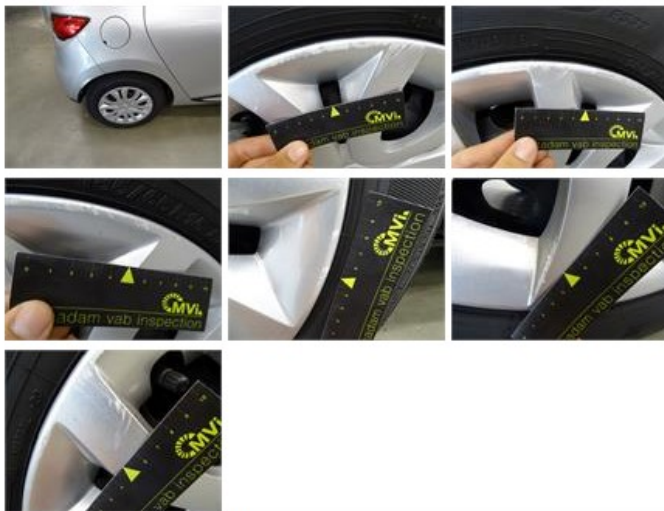
Wheel cover R R, Scratch(es), E - Replace

24,00

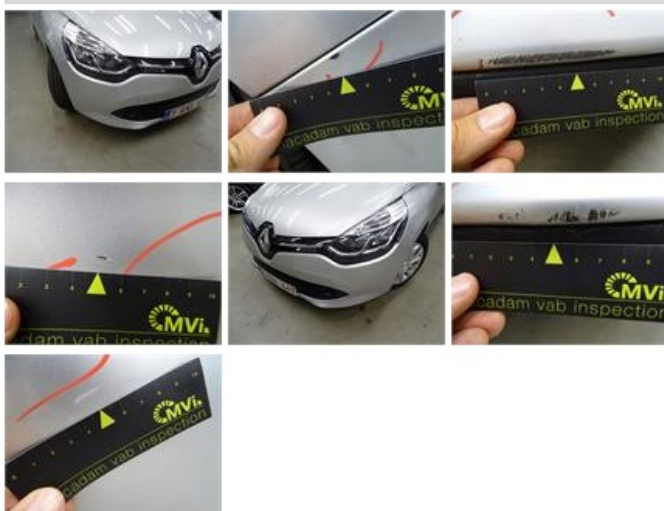
Bumper F, Scratch(es), LI - Repair and paint (complete)

169,44

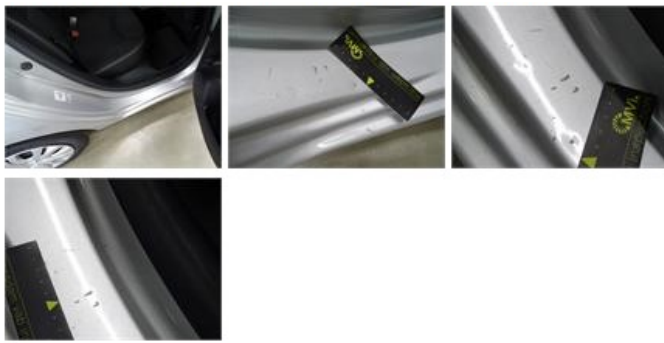
Rocker panel inner R R, Dent(s), LI - Repair and paint (complete)

115,56

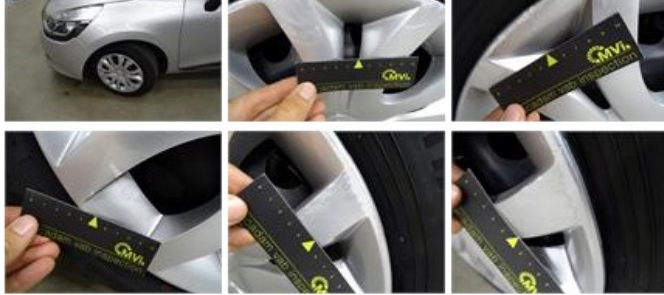
Wheel cover F L, Scratch(es), E - Replace 24,00

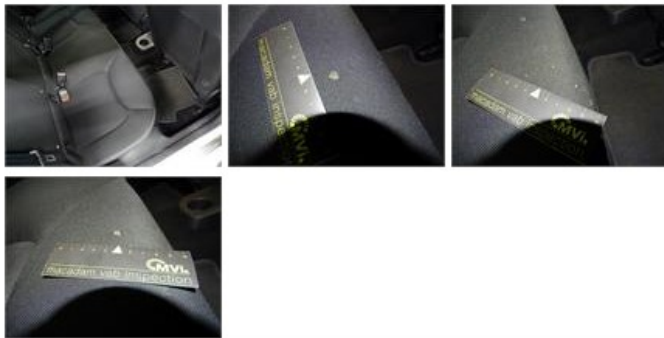
Seat cover R R, Hole, Smart repair 64,32

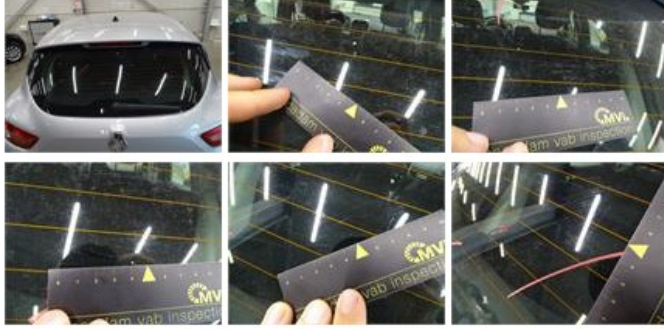
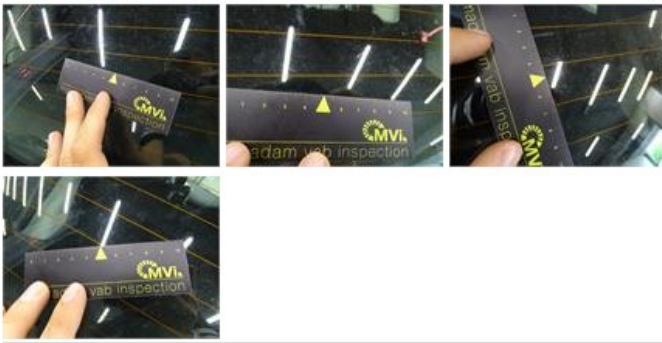
Rear window, Scratch(es), E - Replace 320,00

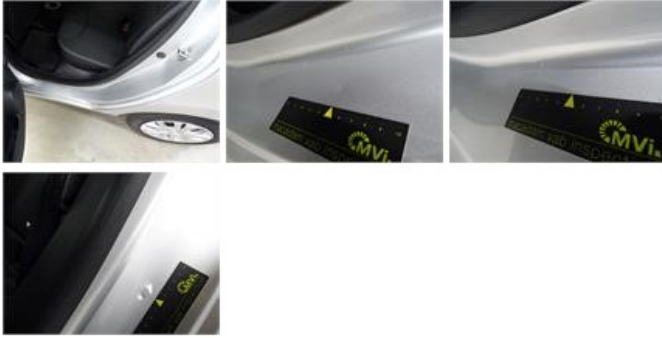
Rocker panel inner R L, Dent(s), LI - Repair and paint (complete) 115,56
