VOLVO V40: 1GBC938

Limited Technical Inspection

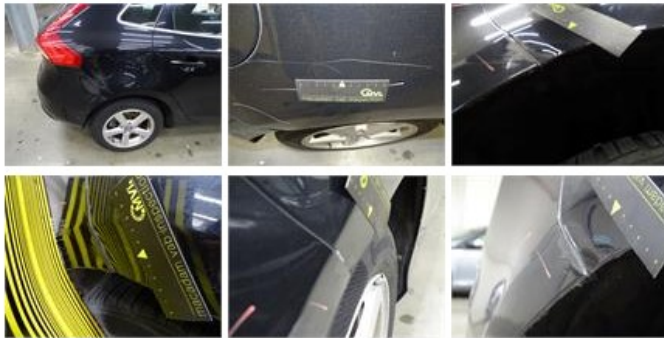
Wing R R, Dent(s) and scratch(es), LI - Repair and paint (complete)

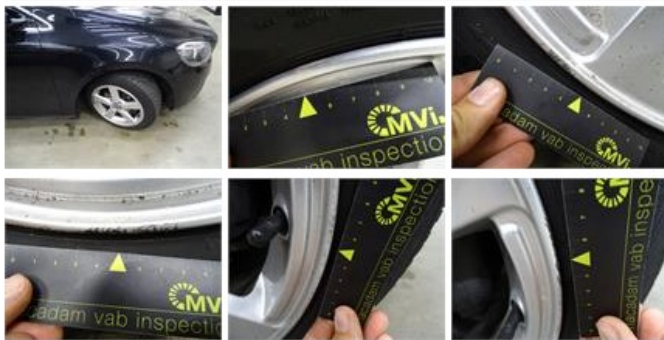
Alloy rim F R, Scratch(es), LI - Repair and paint (complete)

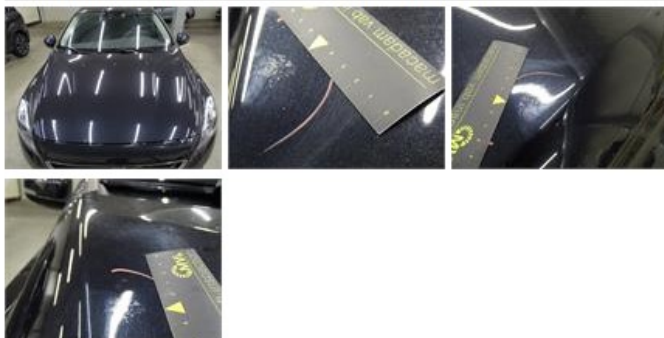
Bonnet, Chemical polution, LI - Repair and paint (complete)

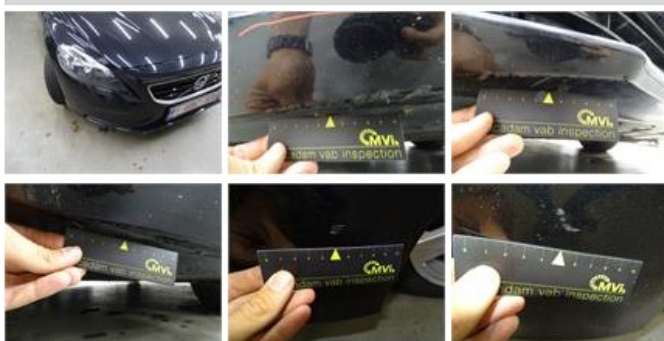
Bumper F, Scratch(es), LI - Repair and paint (complete)

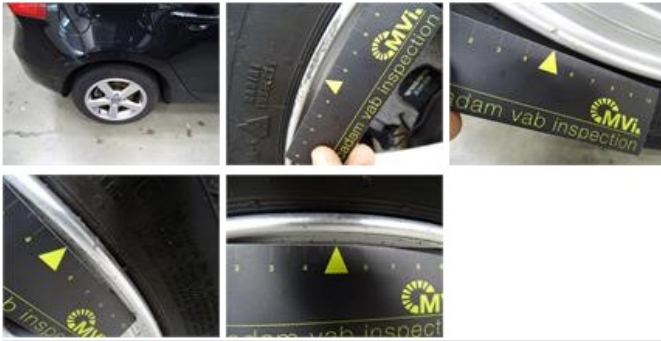
Alloy rim R R, Scratch(es), LI - Repair and paint (complete)

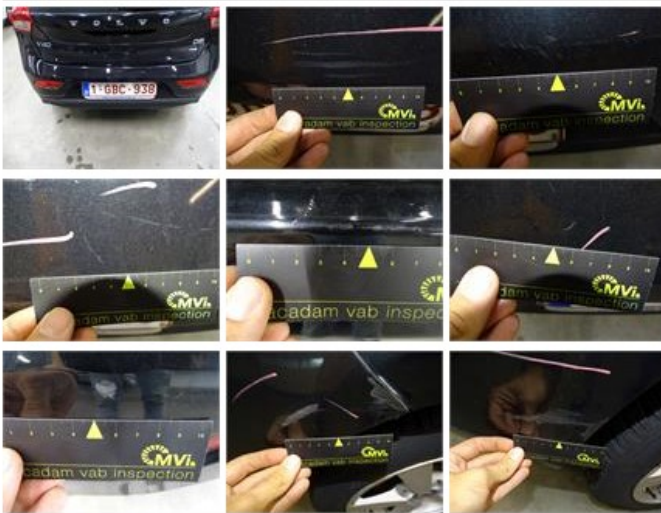
Bumper R, Scratch(es), LI - Repair and paint (complete)

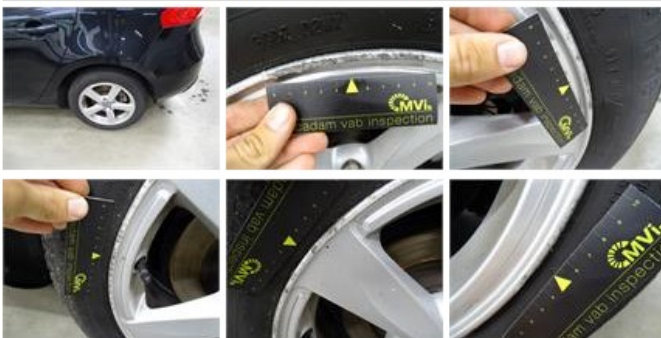
Alloy rim R L, Scratch(es), LI - Repair and paint (complete)
