VOLKSWAGEN Golf: 1GQV629

| Vinnumber: | WVWZZZAUZEW316016 | Versionname: | GOLF BER Trendline 90PK |

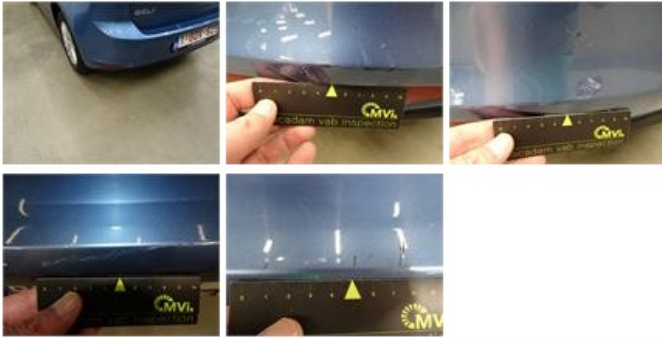
Bumper R, Scratch(es), LI - Repair and paint (complete)

211,80

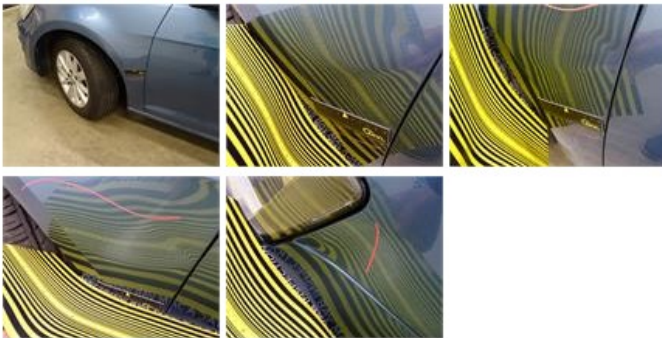
Wing F L, Dent(s), LI - Repair and paint (complete)

220,18
