**VOLKSWAGEN Golf: 1WDY238**

**Limited Technical Inspection**

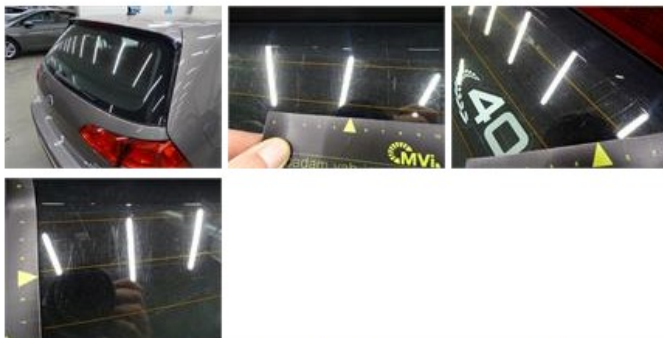
Rear window, Scratch(es), E - Replace
