BMW 2 GRAN TOURER: LK5806

Limited Technical Inspection

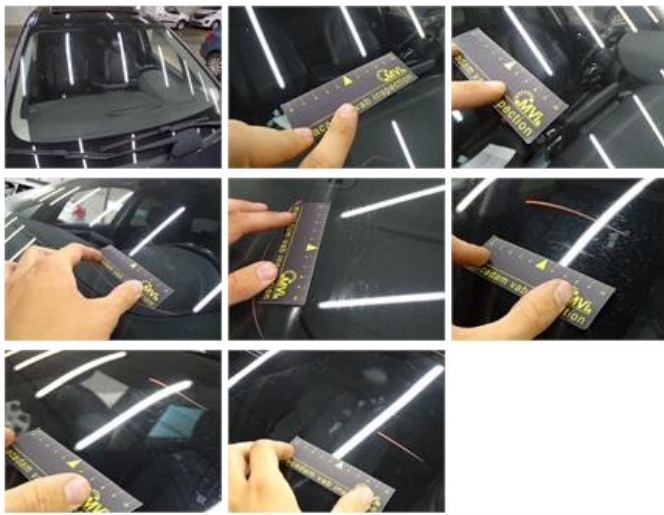
Windscreen, Scratch(es), E - Replace 487,20

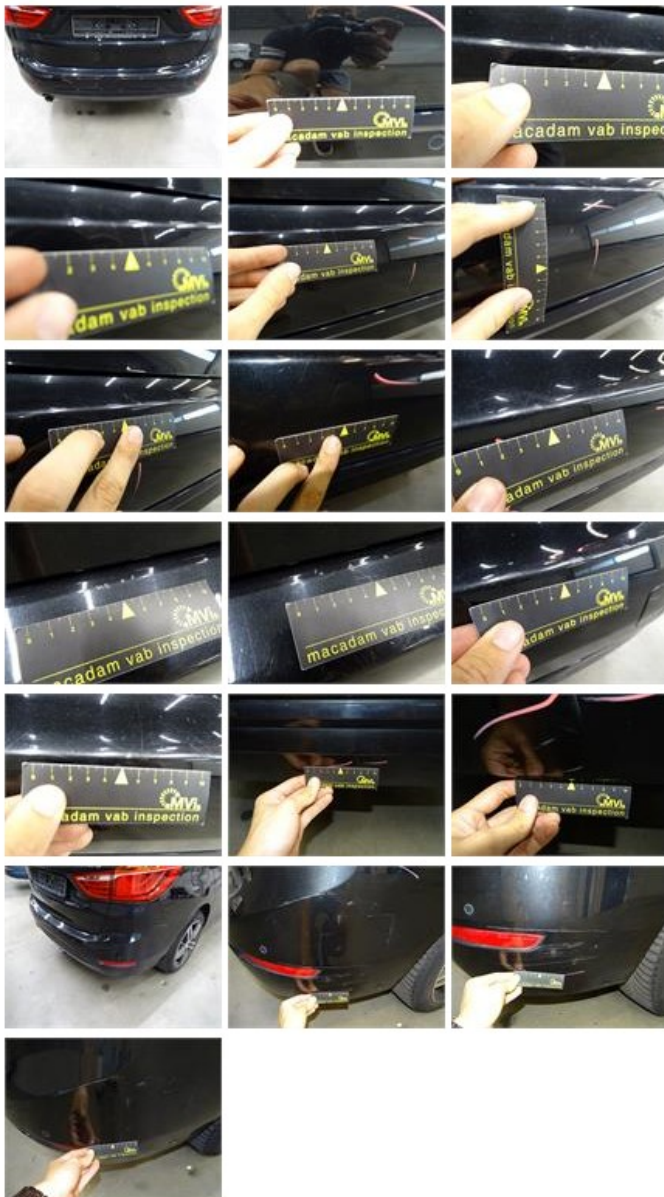
Bumper R, Scratch(es), LI - Repair and paint (complete)

211,80

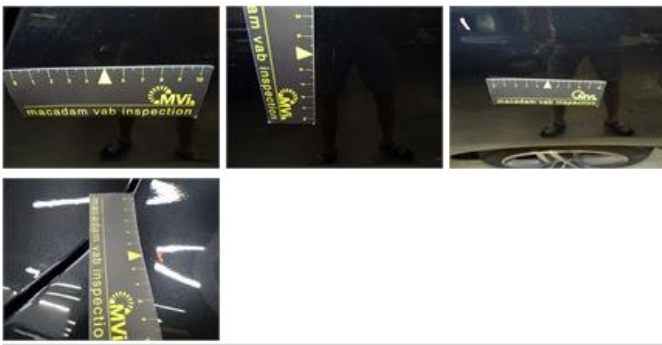
Wing R L, Scratch(es), LI - Repair and paint (complete)

308,20

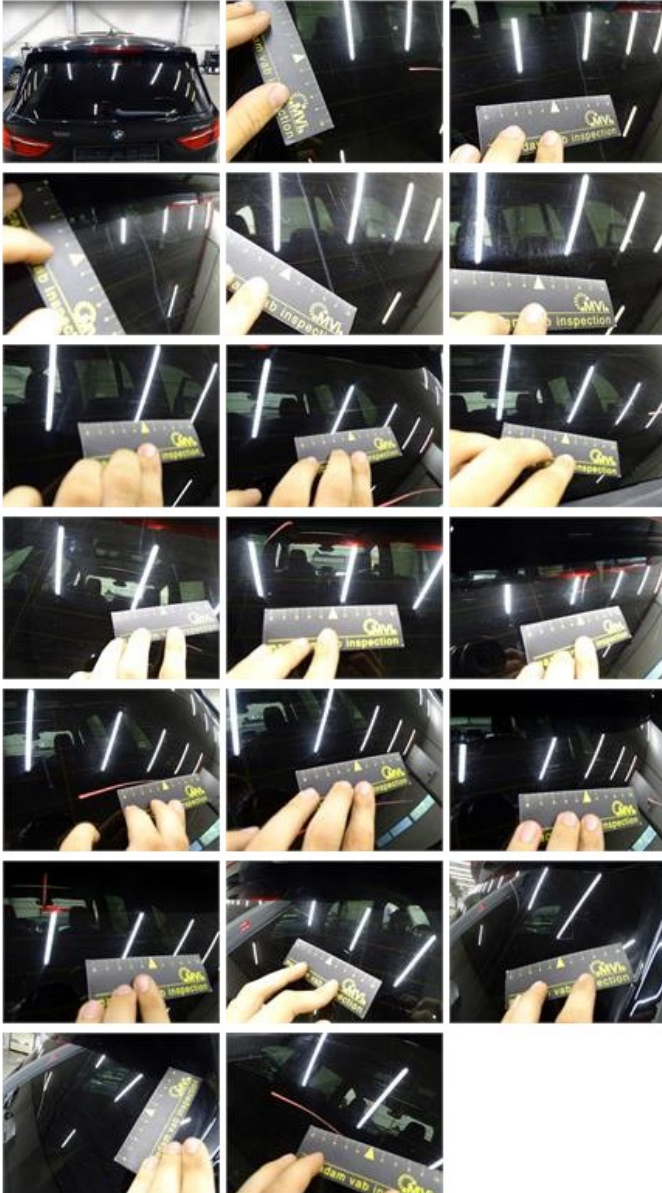
Rear window, Scratch(es), E - Replace 370,00

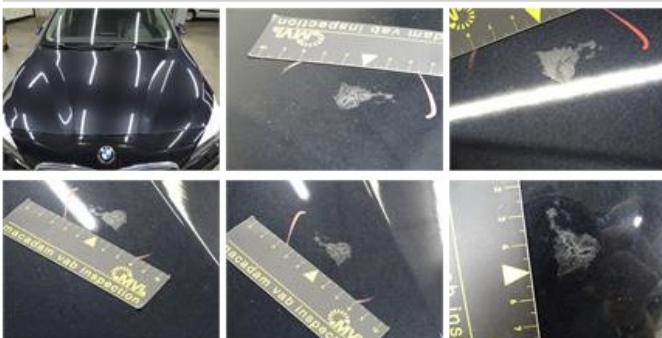
Bonnet, Chemical polution, LI - Repair and paint (complete) 290,08

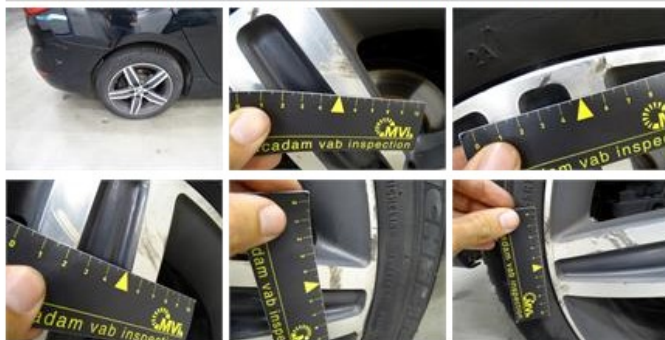
Alloy rim R R polished, Scratch(es), LI - Repair and paint (complete)

95,00
