SKODA Octavia: 1HUU491

Limited Technical Inspection

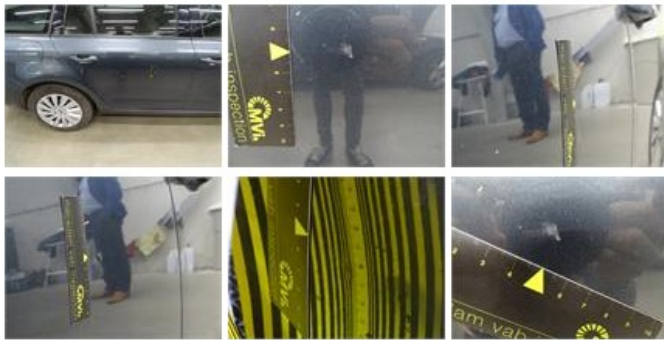
Door R R, Dent(s) and scratch(es), LI - Repair and paint (complete)

318,35

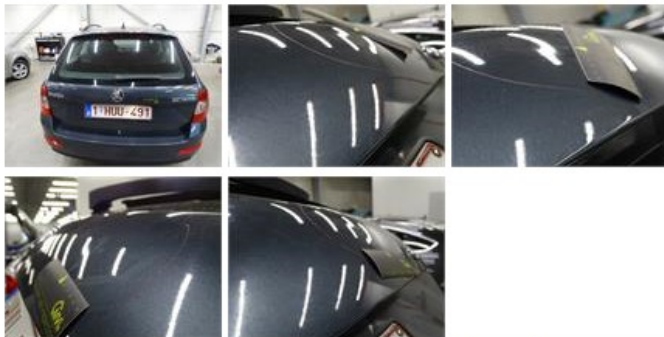
Tailgate, Dent(s), PDR - Paintless dent repair

63,00

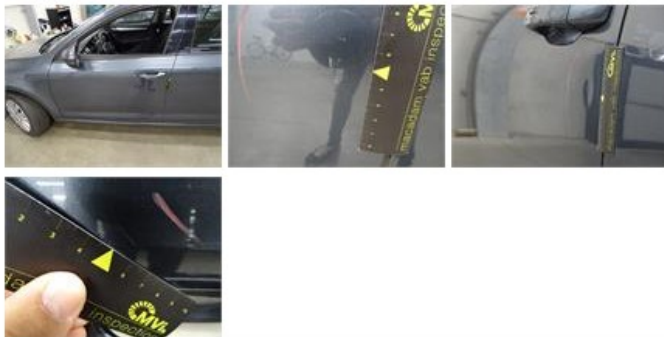
Door F L, Dent(s) and scratch(es), LI - Repair and paint (complete)

318,35

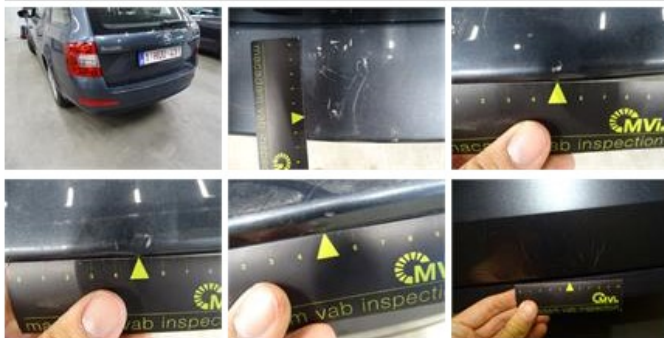
Bumper R, Scratch(es), LI - Repair and paint (complete)

211,80
