**MERCEDES B: 1KLC789**

**Limited Technical Inspection**

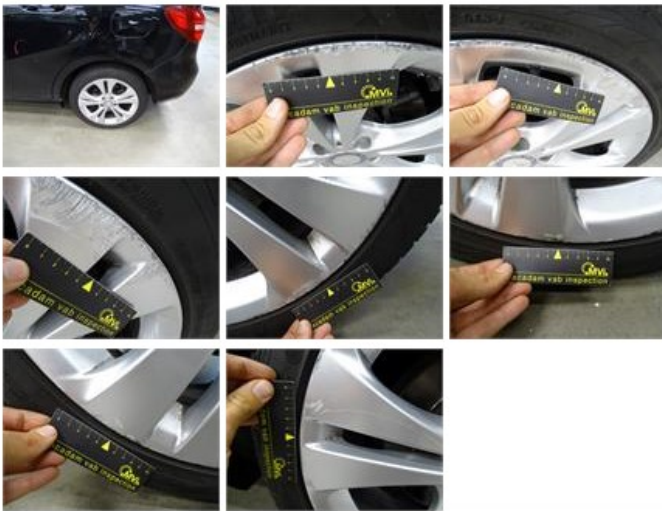
Alloy rim R L, Scratch(es), LI - Repair and paint (complete)

95,00

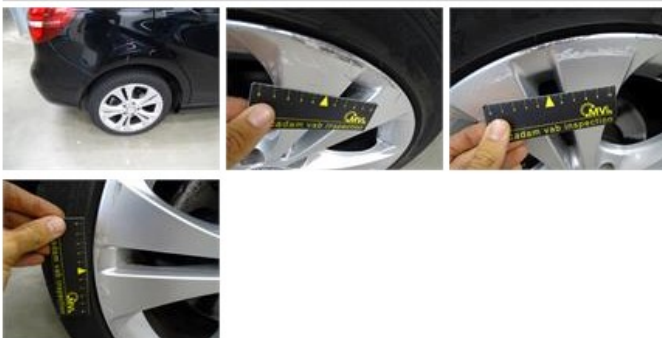
Alloy rim R R, Scratch(es), LI - Repair and paint (complete)

95,00

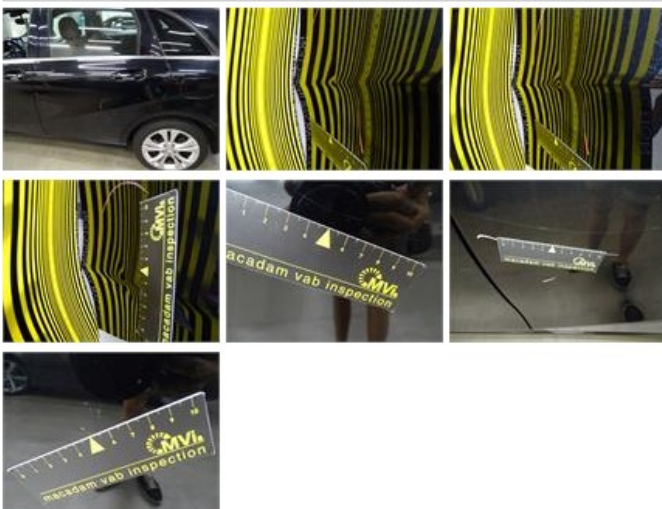
Door R L, Dent(s) and scratch(es), LI - Repair and paint (complete)

318,35

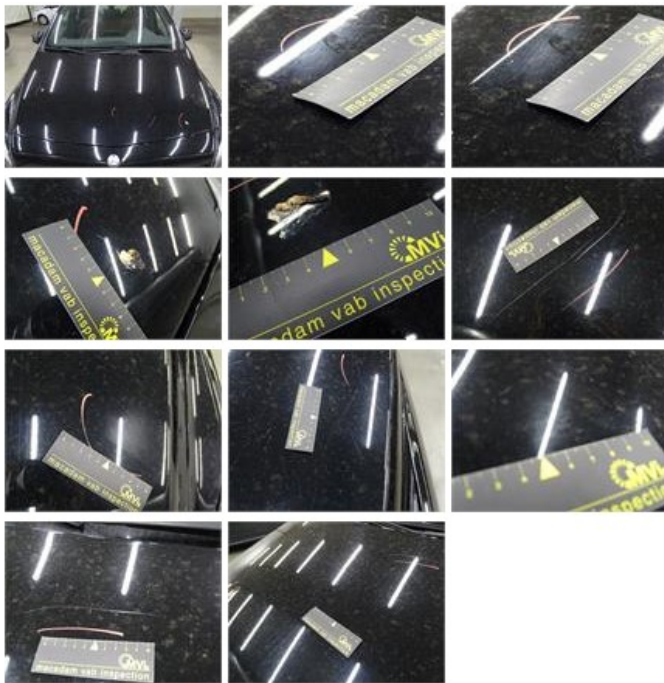
Bonnet, Chemical pollution, LI - Repair and paint (complete)

290,08

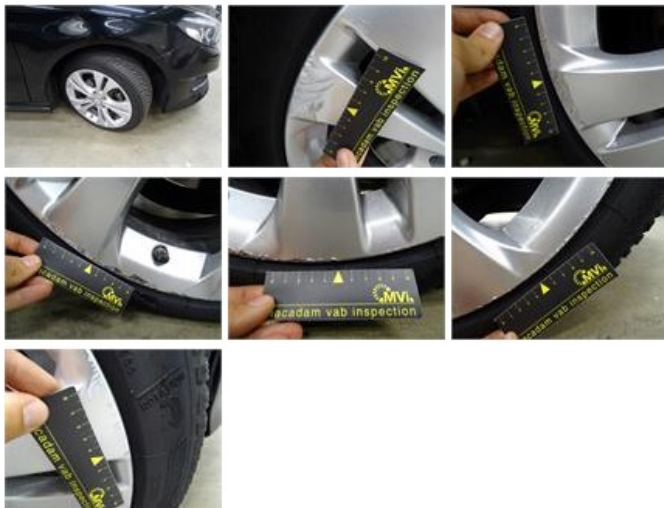
Door F R, Scratch(es), Acceptable	0,00
<i>No pictures to display</i>	
Rear spoiler, Scratch(es), Acceptable	0,00
<i>No pictures to display</i>	
Roof pillar R, Scratch(es), Acceptable	0,00
<i>No pictures to display</i>	
Alloy rim F R, Scratch(es), LI - Repair and paint (complete)	95,00

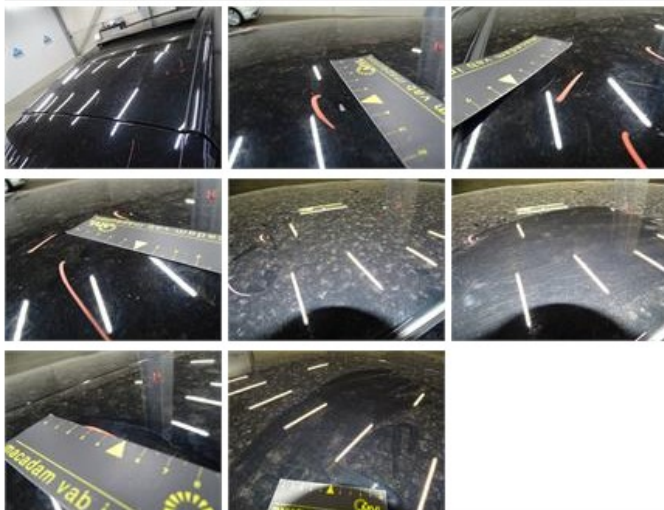
Roof pillar L, Scratch(es), Acceptable	0,00
<i>No pictures to display</i>	
Roof, Scratch(es), LI - Repair and paint (complete)	481,50

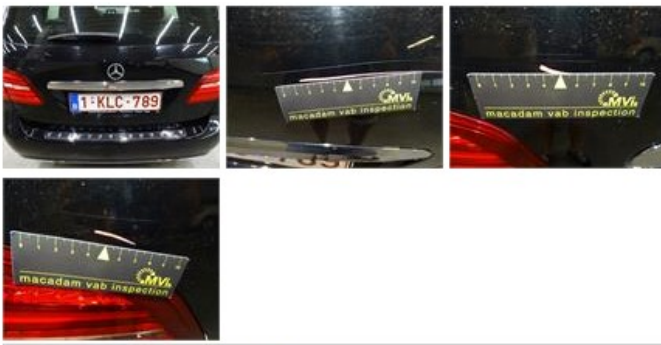
Tailgate, Scratch(es), LI - Repair and paint (complete)	301,68
---	--------

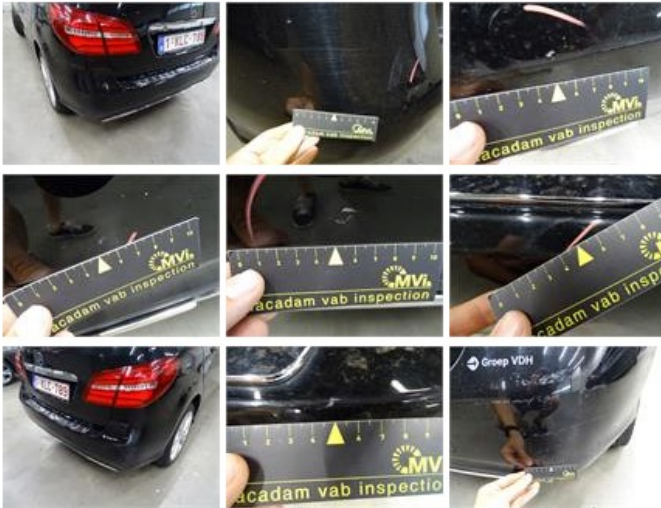
Bumper R, Scratch(es), LI - Repair and paint (complete) 211,80

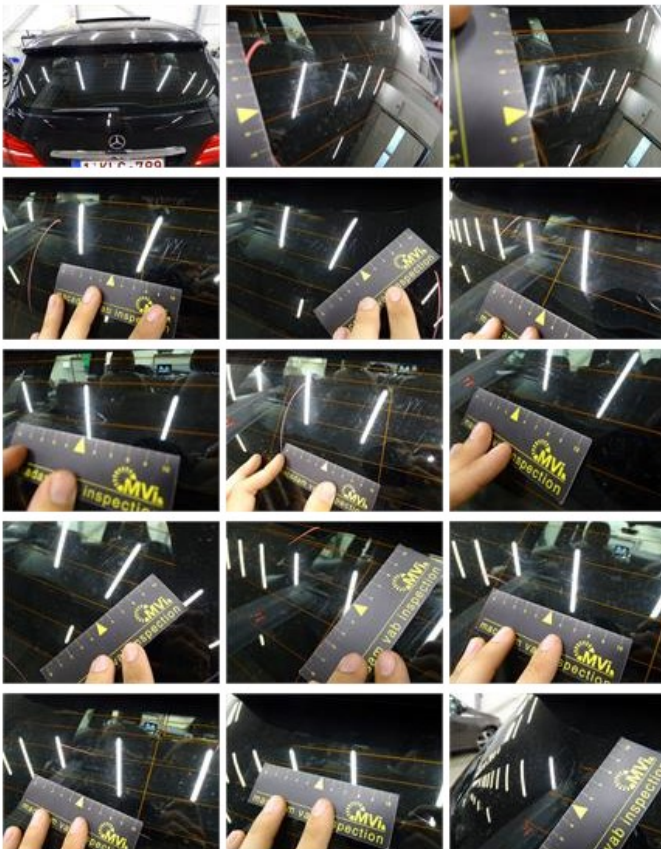
Rear window, Scratch(es), E - Replace 0,00

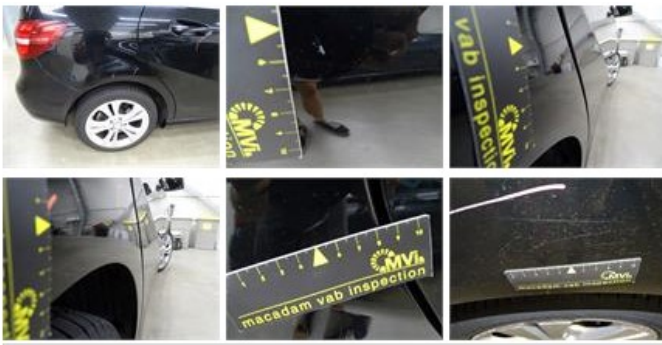
Wing R R, Dent(s) and scratch(es), LI - Repair and paint (complete) 308,20

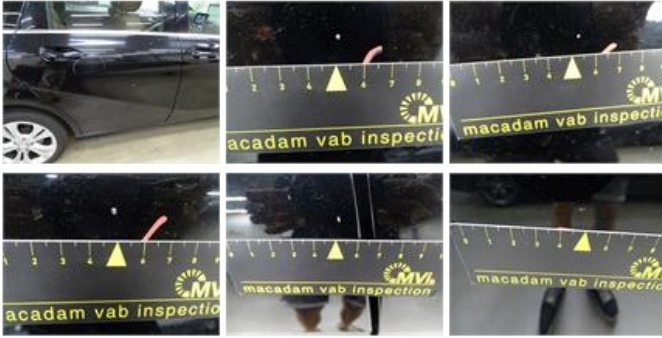
Door R R, Dent(s) and scratch(es), LI - Repair and paint (complete) 318,35

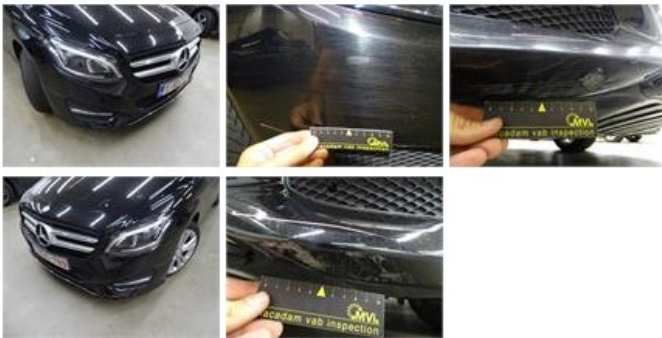
Bumper F, Scratch(es), LI - Repair and paint (complete) 211,80
