BMW 3: 1JKG313

| Vinnumber: | WBA3K91070F936475 | Versionname: | 3 TOURING 316d 116PK |

Limited Technical Inspection

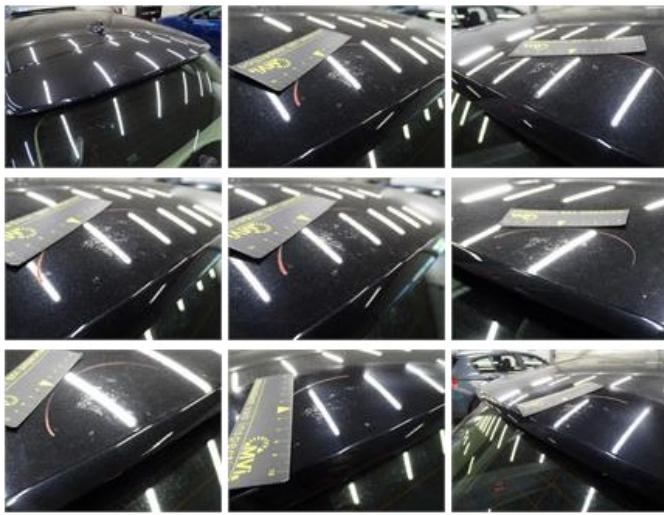
| Rear spoiler, Chemical polution, LI - Repair and paint (complete) | | 115,56 |

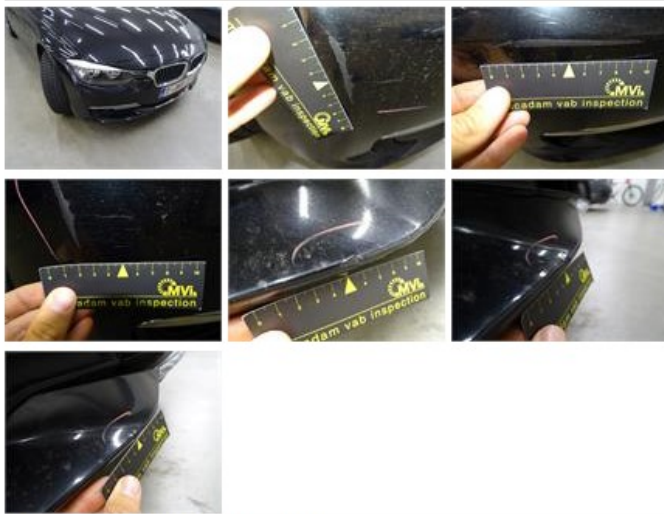
Bumper F, Scratch(es), LI - Repair and paint (complete) 211,80

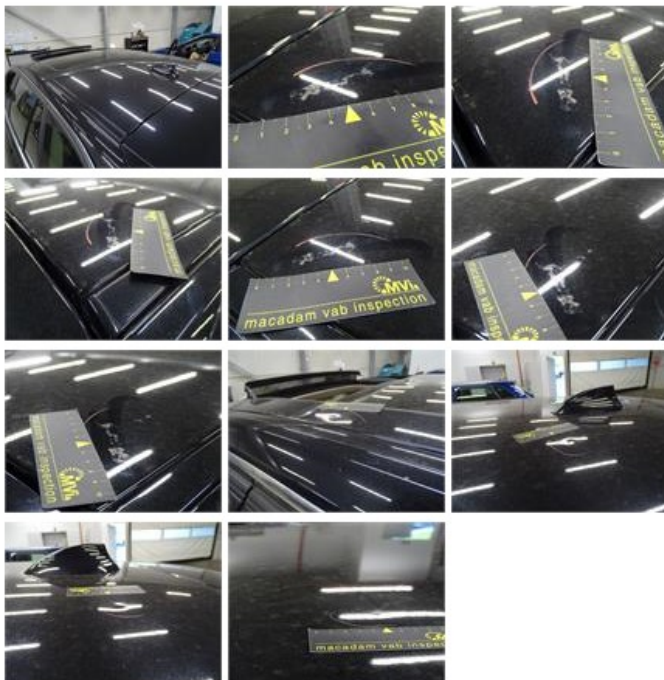
Roof, Chemical polution, LI - Repair and paint (complete) 0,00

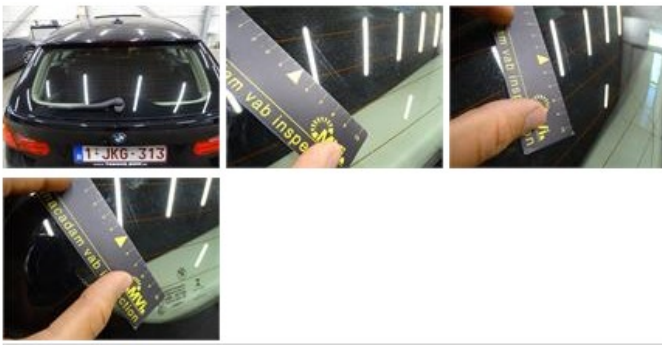
Rear window, Scratch(es), Acceptable 0,00

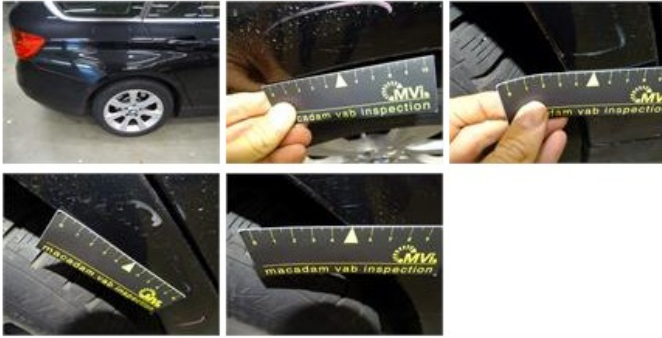
Wing R R, Scratch(es), LI - Repair and paint (complete) 308,20

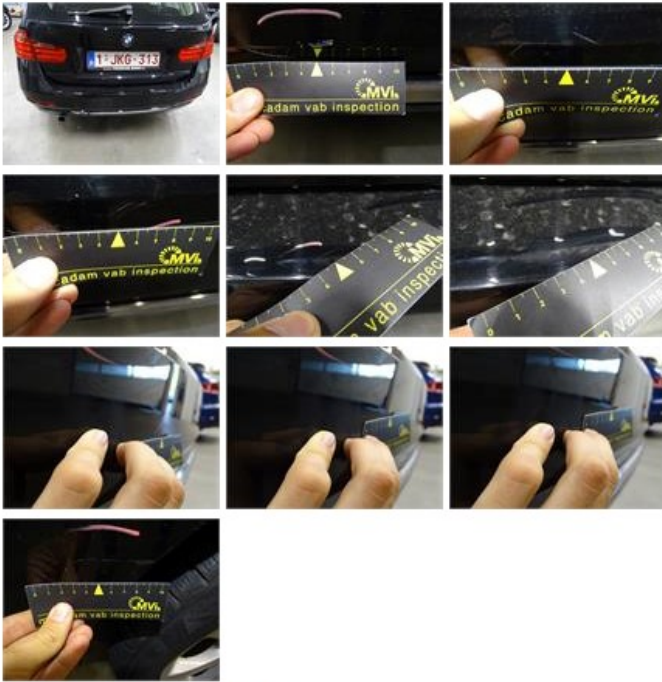
Bumper R, Dent(s) and scratch(es), LI - Repair and paint (complete) 211,80
