MINI COUNTRYMAN: 1PAG317

Limited Technical Inspection

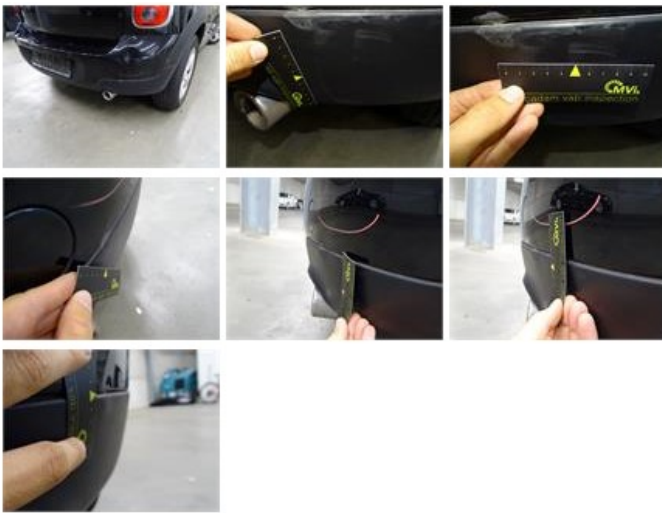
Total cost ex VAT	2543,71
Bumper cover R M, Dent(s) and scratch(es), Smart repair	110,64

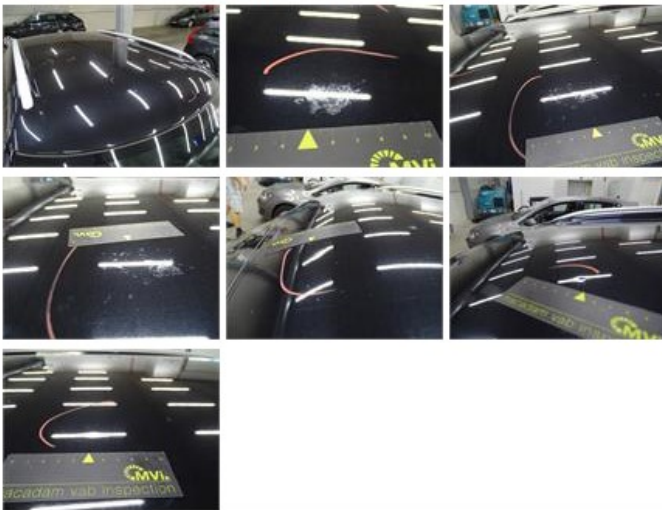
Roof, Chemical polution, LI - Repair and paint (complete) 0,00

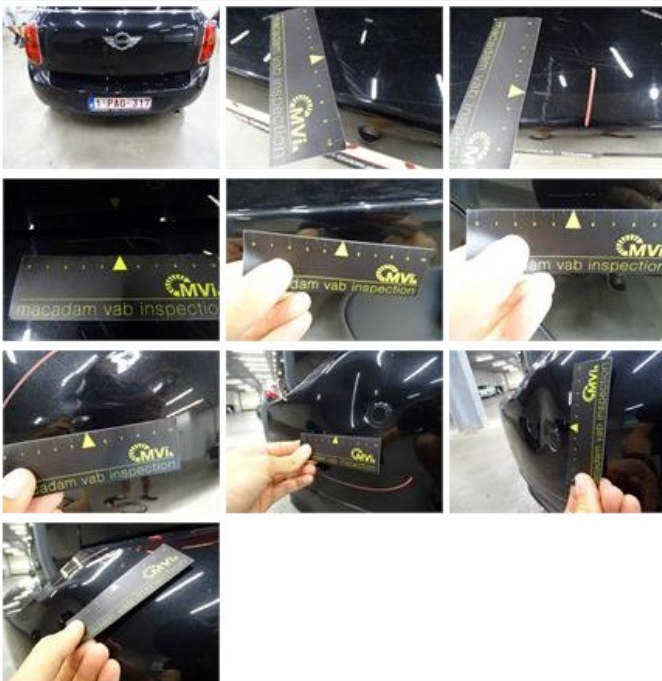
Bumper R, Dent(s) and scratch(es), LI - Repair and paint (complete) 211,80

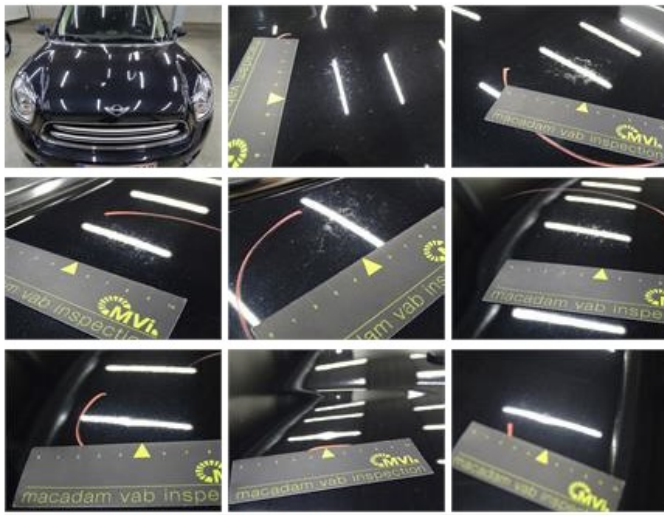
Bonnet, Chemical polution, LI - Repair and paint (complete) 314,08

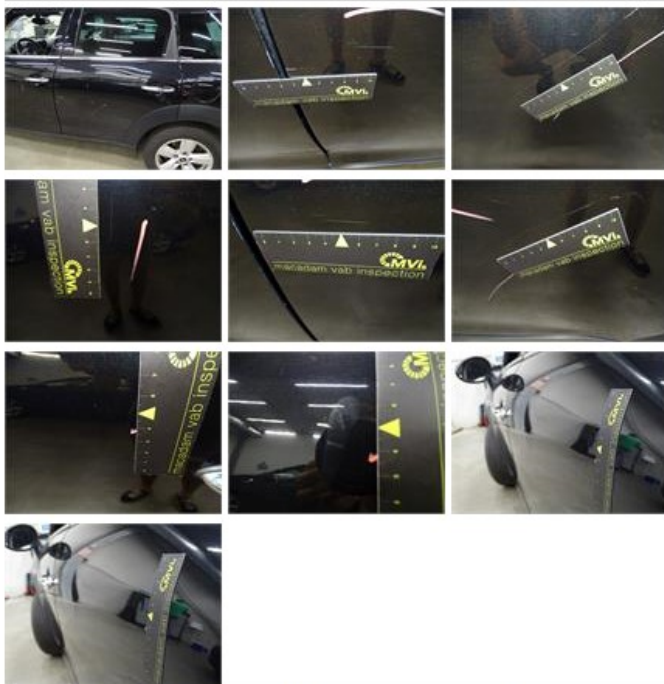
Door R L, Dent(s) and scratch(es), LI - Repair and paint (complete) 318,35

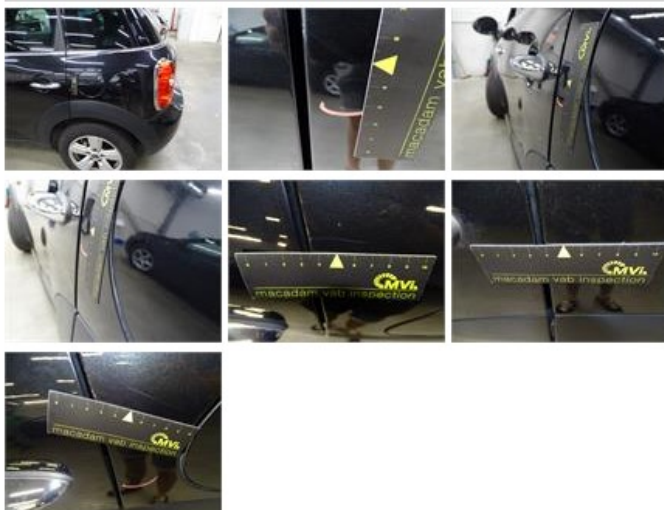
Wing R L, Dent(s) and scratch(es), LI - Repair and paint (complete) 308,20

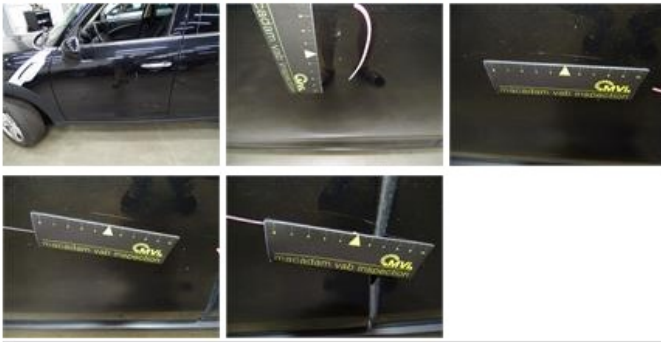
Door F L, Scratch(es), LI - Repair and paint (complete) 318,35
