**VOLVO S60: 1JRF876**

**Limited Technical Inspection**

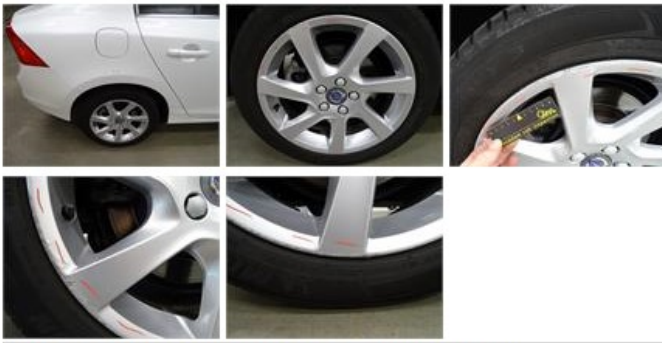
Alloy rim R R, Scratch(es), LI - Repair and paint (complete)	<b>95,00</b>
--	--------------
