VOLVO V40: 1GNU618

Limited Technical Inspection

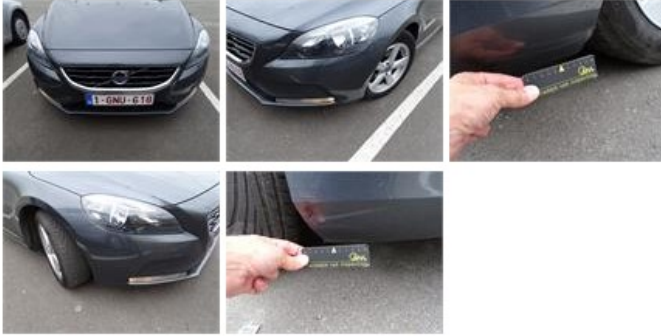
<i>No pictures to display</i>	
Bumper R, Scratch(es), Acceptable	0,00
<i>No pictures to display</i>	
Spoiler R, Scratch(es), Acceptable	0,00
<i>No pictures to display</i>	
Wing R R, Scratch(es), Acceptable	0,00
<i>No pictures to display</i>	
Rear Panel Internal Lining, Scratch(es), Acceptable	0,00
<i>No pictures to display</i>	
Alloy rim F L, Scratch(es), Acceptable	0,00
<i>No pictures to display</i>	
Trunk lid covering R, Scratch(es), Acceptable	0,00
<i>No pictures to display</i>	
Bumper F, Scratch(es), LI - Repair and paint (complete)	235,80
