VOLKSWAGEN SHARAN: 1KAN897

Limited Technical Inspection

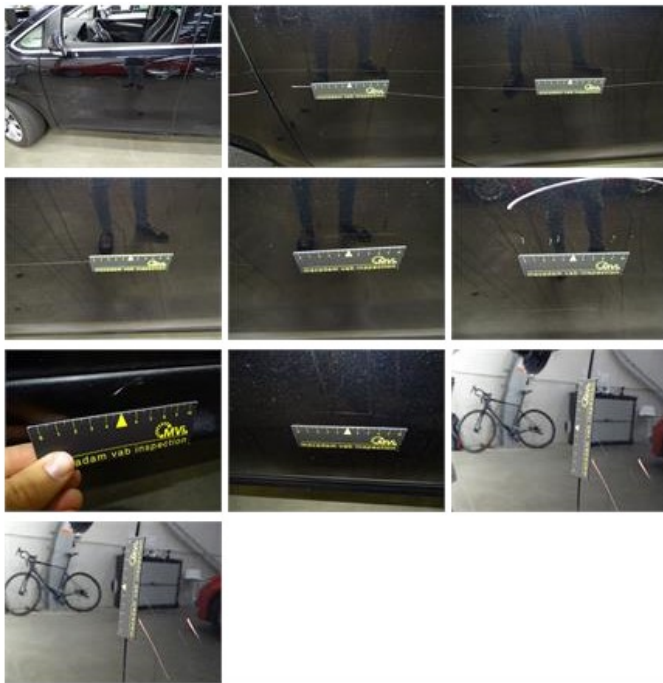
Total cost ex VAT	4473,98
Door F L, Dent(s) and scratch(es), LI - Repair and paint (complete)	382,02

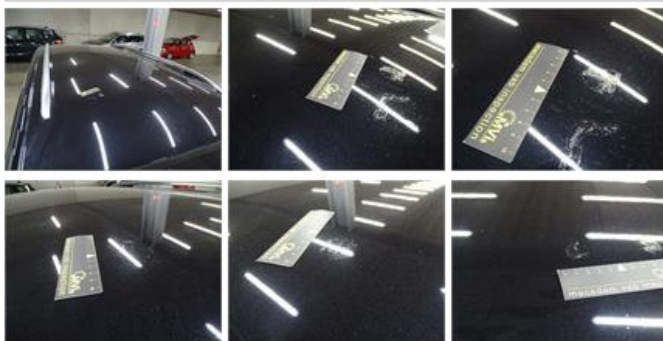
Roof, Chemical polution, LI - Repair and paint (complete)

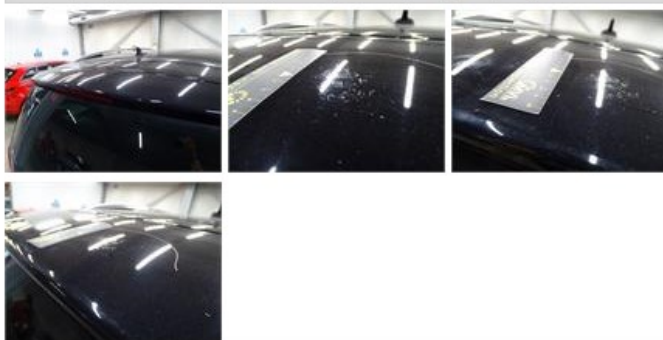
Rear spoiler, Chemical polution, LI - Repair and paint (complete)

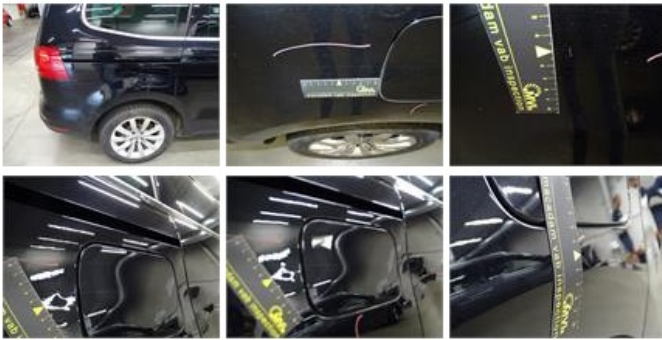
Wing R R, Dent(s) and scratch(es), LI - Repair and paint (complete) 369,84

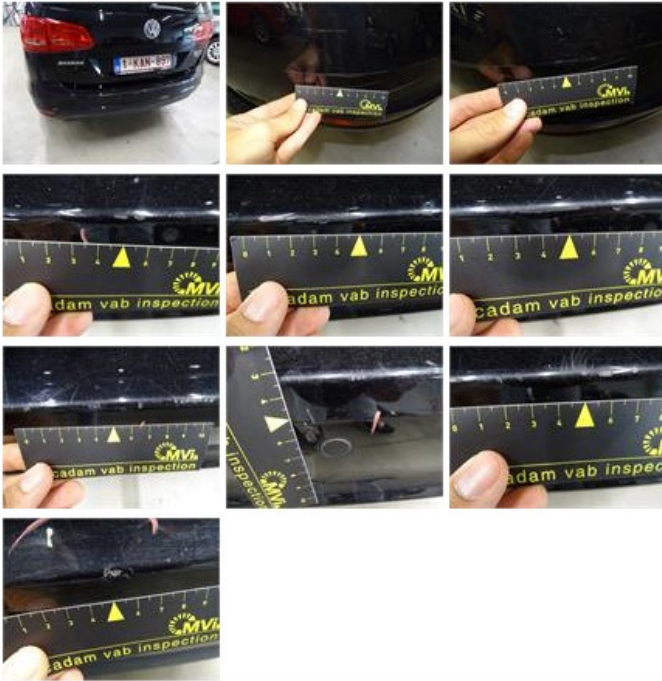
Bumper R, Scratch(es), LI - Repair and paint (complete) 254,16

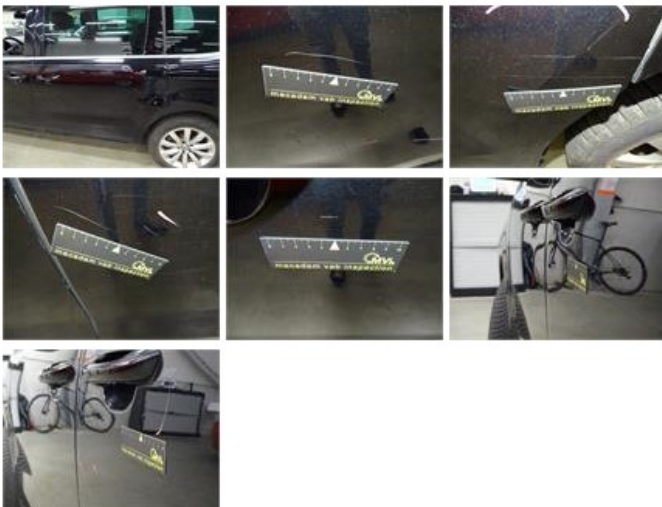
Door R L, Dent(s) and scratch(es), LI - Repair and paint (complete) 382,02

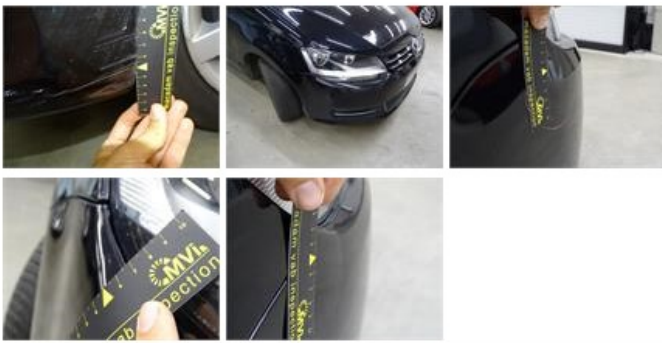
Bumper F, Dent(s) and scratch(es), LI - Repair and paint (complete) 254,16

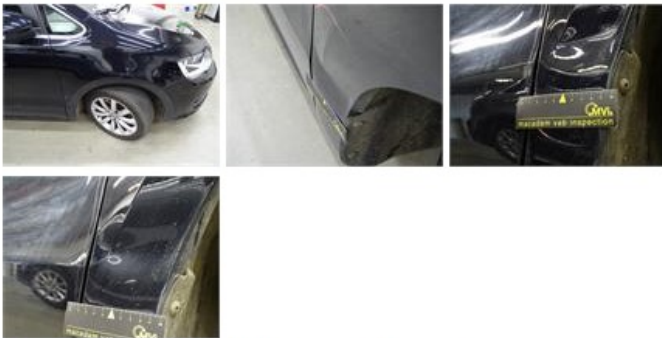
Wing F R, Dent(s), LI - Repair and paint (complete) 264,21

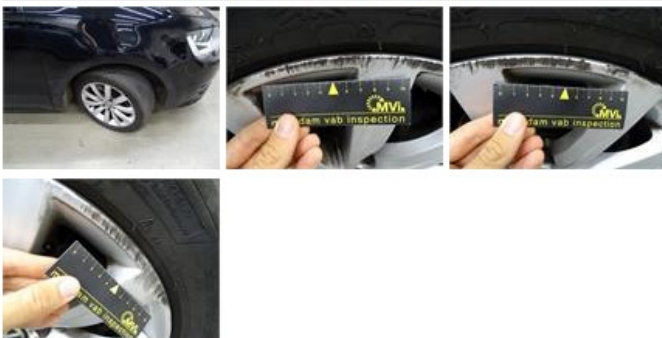
Alloy rim F R, Scratch(es), LI - Repair and paint (complete) 95,00

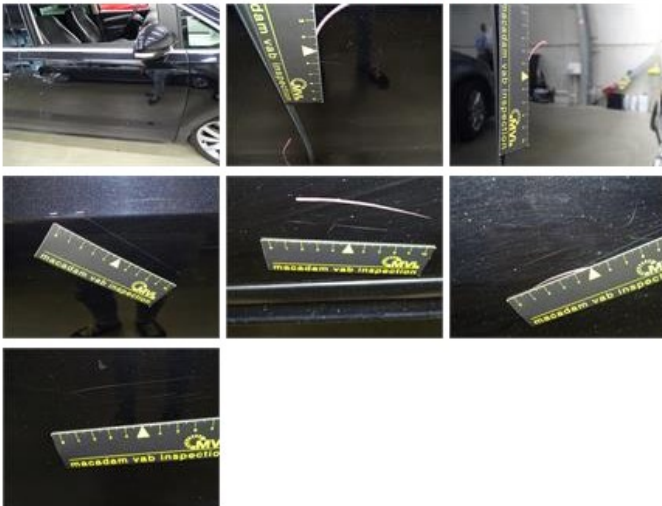
Door F R, Dent(s) and scratch(es), LI - Repair and paint (complete) 382,02

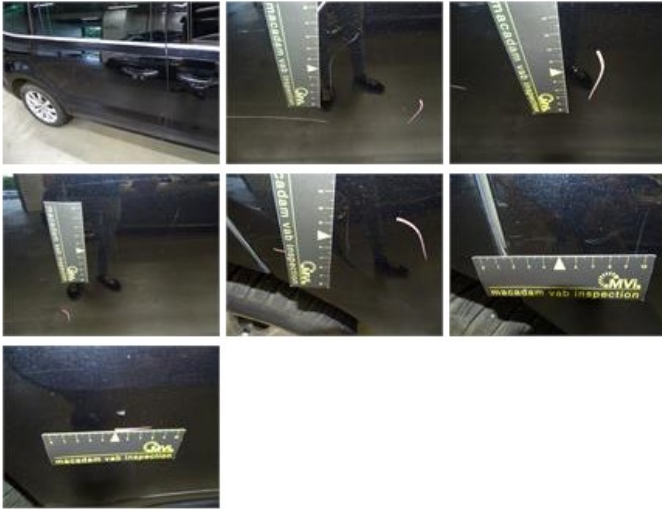
Door R R, Scratch(es), LI - Repair and paint (complete)
