VOLKSWAGEN Polo: 1JRD473

Limited Technical Inspection

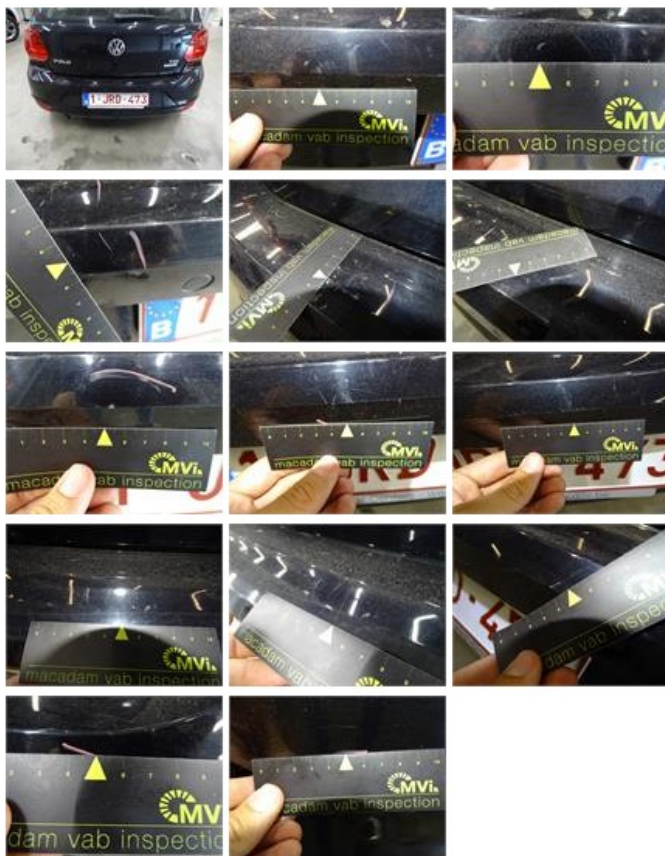
Bumper R, Scratch(es), LI - Repair and paint (complete)	169,44
---	--------

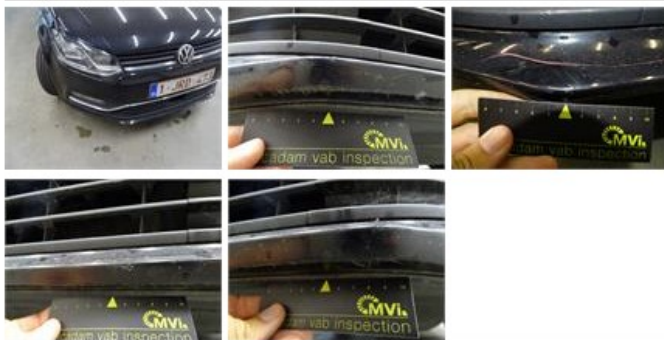
Door R L, Scratch(es), Acceptable	0,00
<i>No pictures to display</i>	
Wing R R, Scratch(es), Acceptable	0,00
<i>No pictures to display</i>	
Bumper F, Scratch(es), LI - Repair and paint (complete)	169,44
