**AUDI A3: 1FPQ751**

**Limited Technical Inspection**

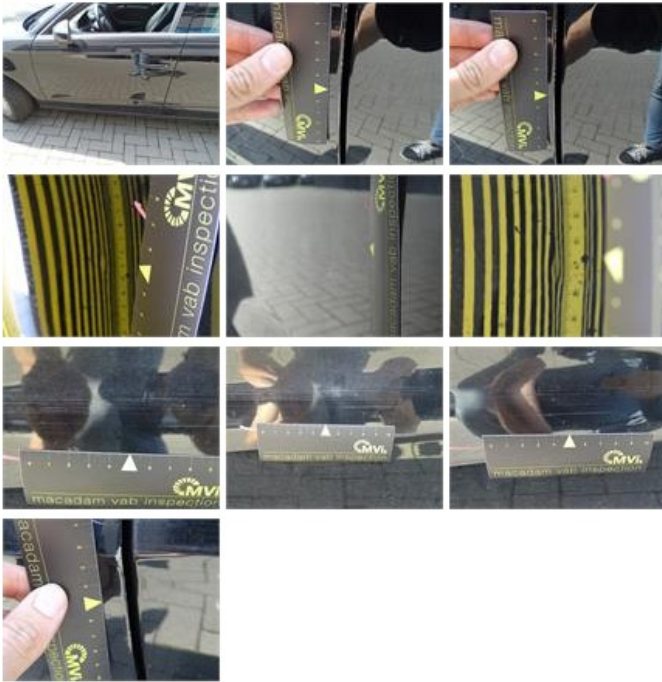
Door F L, Dent(s) and scratch(es), LI - Repair and paint (complete)

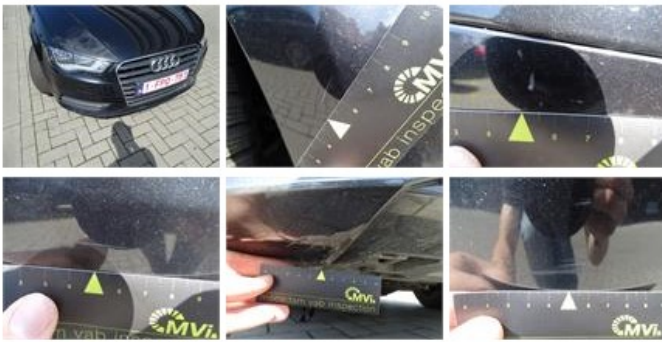
Bumper F, Scratch(es), LI - Repair and paint (complete)

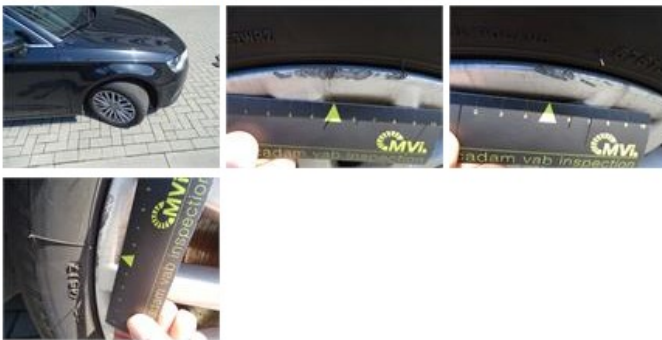
Alloy rim F R, Scratch(es), LI - Repair and paint (complete)

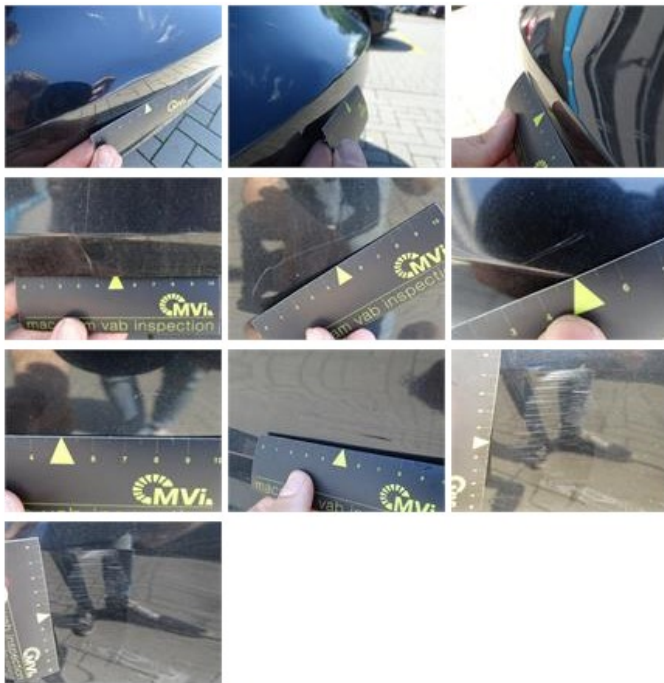
Bumper R, Dent(s) and scratch(es), LI - Repair and paint (complete)

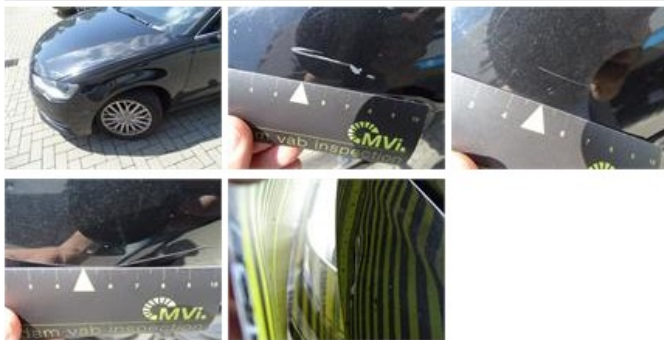
Wing F L, Dent(s) and scratch(es), LI - Repair and paint (complete) 220,18

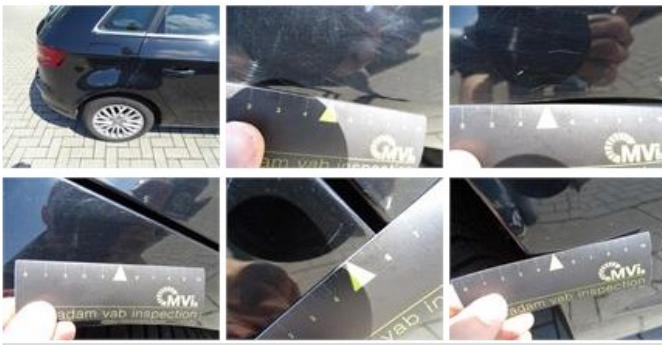
Wing R R, Scratch(es), LI - Repair and paint (complete) 308,20

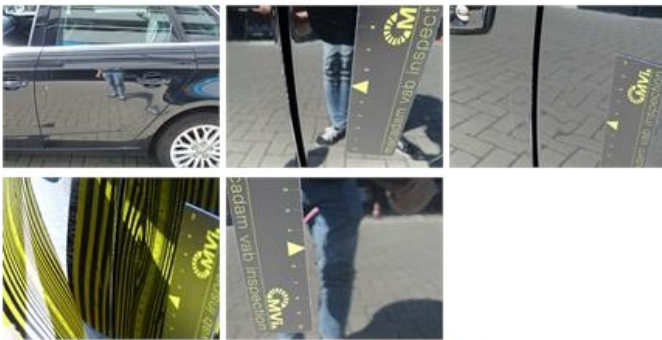
Door R L, Dent(s) and scratch(es), LI - Repair and paint (complete) 318,35

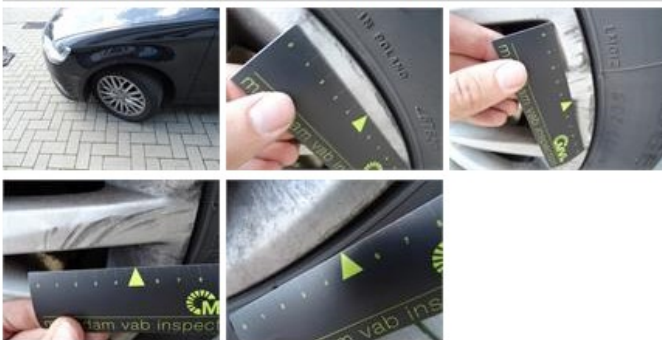
Alloy rim F L, Scratch(es), LI - Repair and paint (complete) 95,00
