VOLKSWAGEN Touran: 1HCB327

Limited Technical Inspection

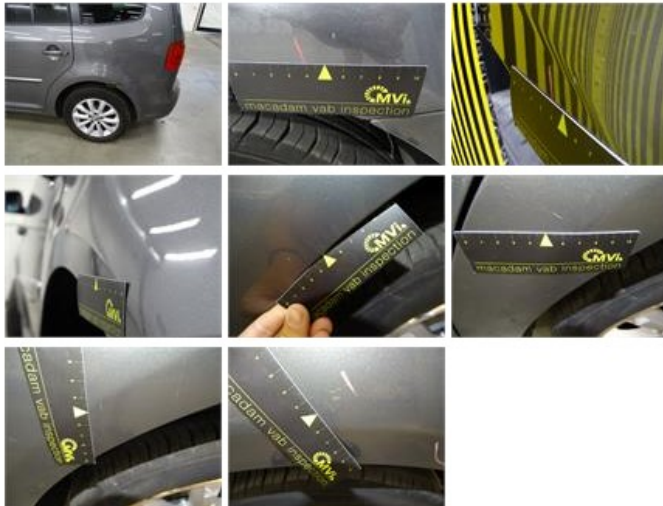
Wing R L, Dent(s) and scratch(es), LI - Repair and paint (complete)

308,20

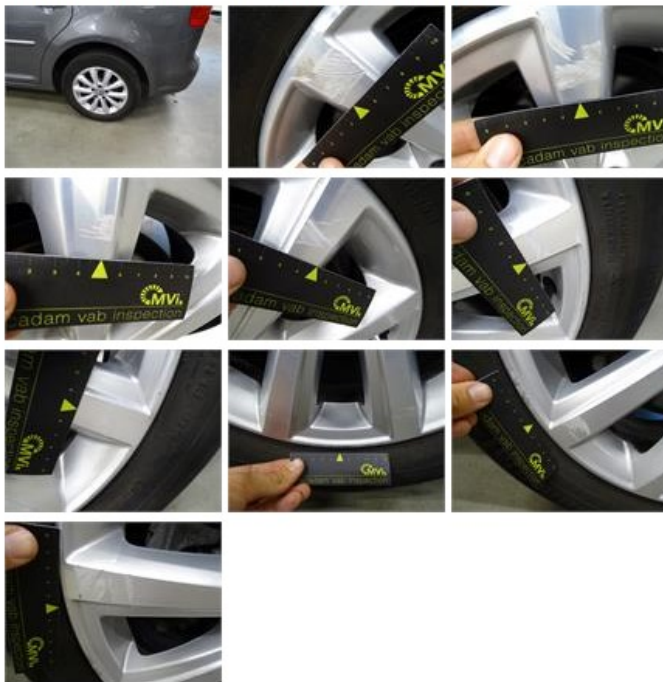
Alloy rim R L polished, Scratch(es), LI - Repair and paint (complete)

95,00

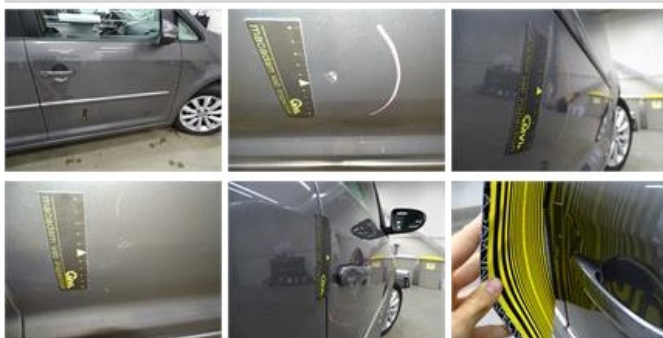
Door F R, Dent(s) and scratch(es), LI - Repair and paint (complete)

366,35

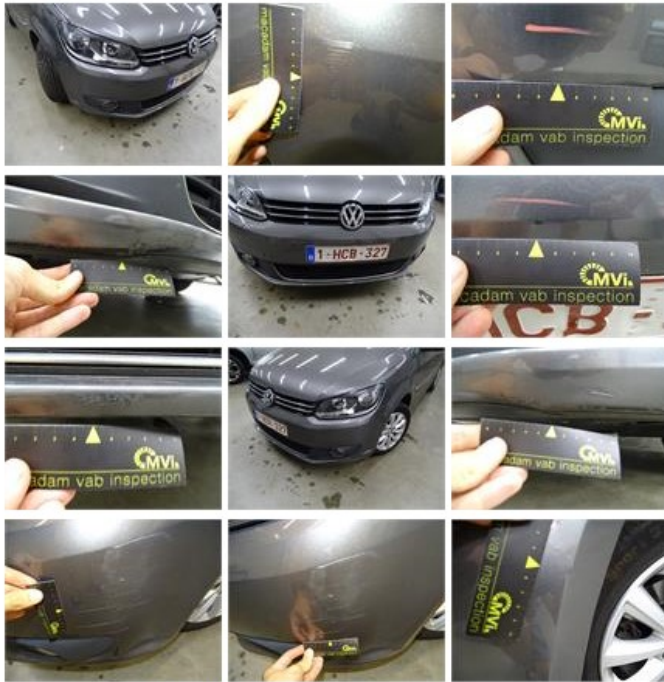
Bumper F, Scratch(es), LI - Repair and paint (complete)

211,80

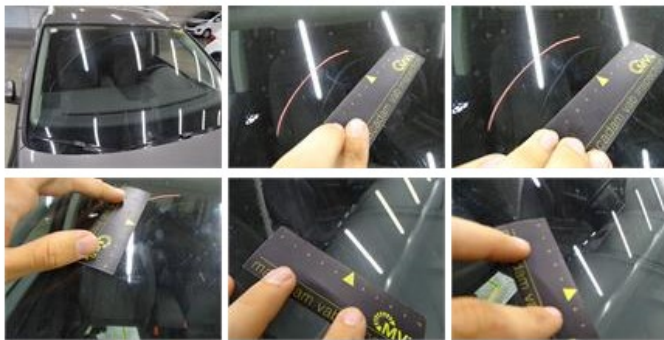
Windscreen, Scratch(es), E - Replace

0,00

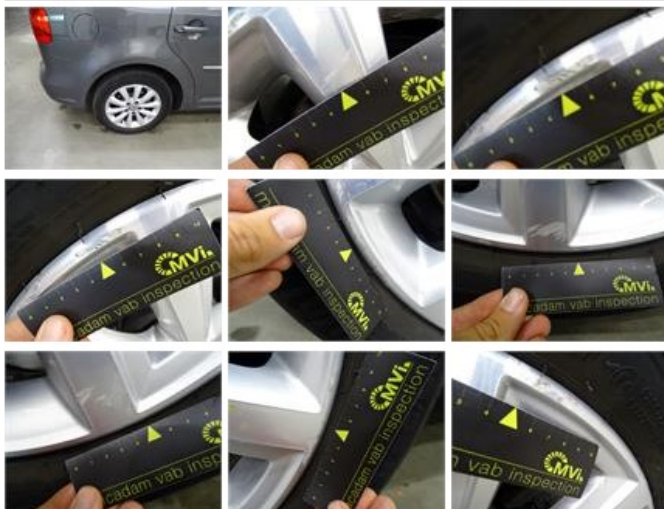
Alloy rim R R polished, Scratch(es), LI - Repair and paint (complete)

95,00

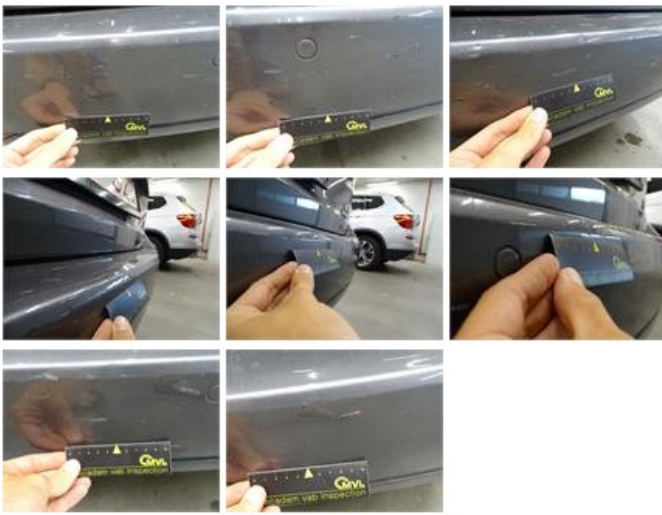
Bumper R, Dent(s) and scratch(es), LI - Repair and paint (complete)

211,80

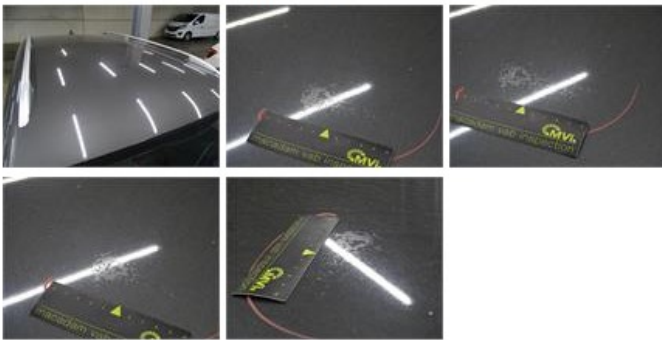
Roof, Chemical pollution, LI - Repair and paint (complete) 481,50

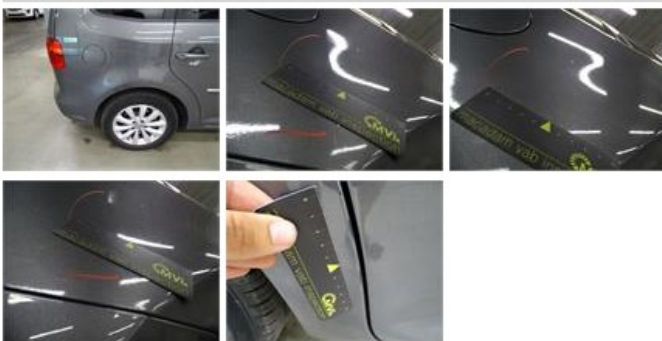
Wing R R, Bad repair, Acceptable 0,00

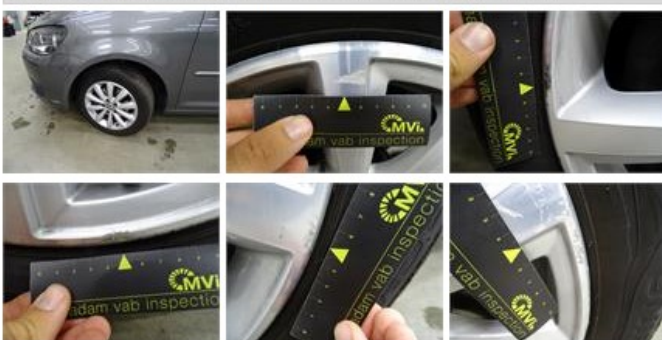
Alloy rim F L polished, Scratch(es), LI - Repair and paint (complete) 95,00

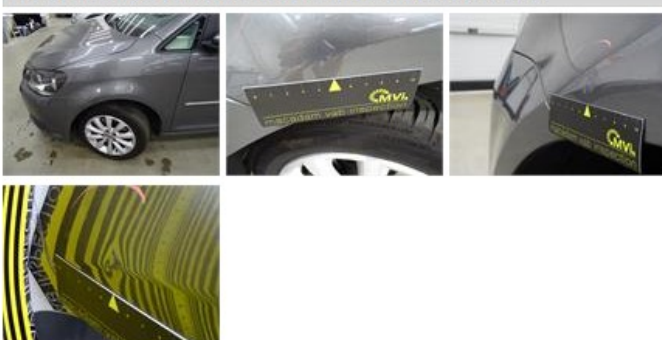
Wing F L, Dent(s) and scratch(es), LI - Repair and paint (complete) 220,18

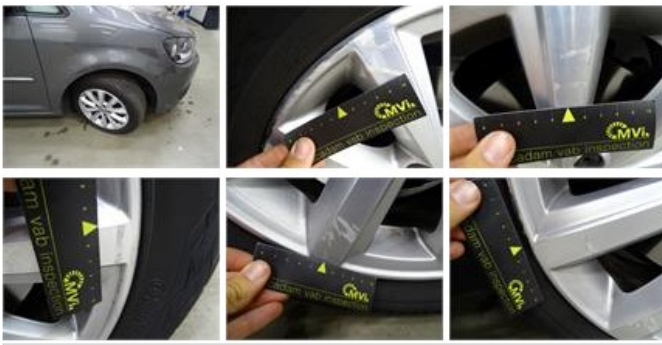
Alloy rim F R polished, Scratch(es), LI - Repair and paint (complete) 95,00

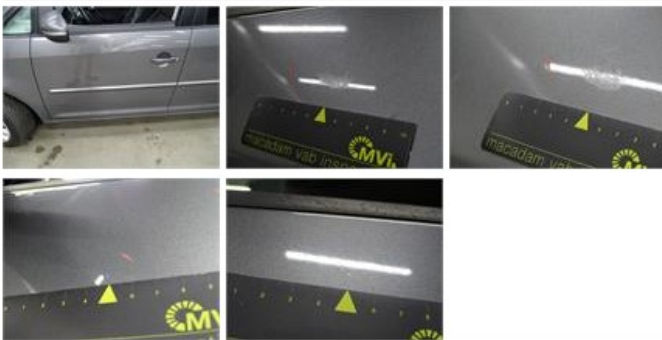
Door F L, Chemical pollution, LI - Repair and paint (complete) 318,35

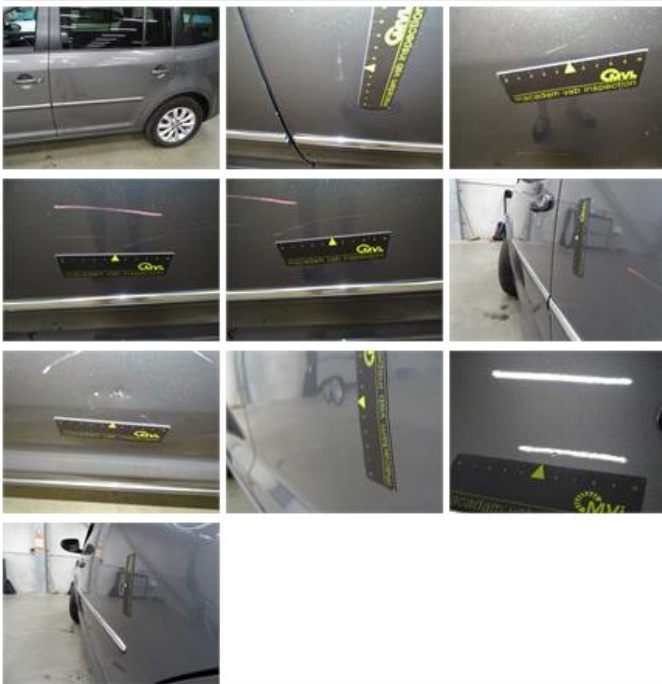
Door R L, Dent(s) and scratch(es), LI - Repair and paint (complete) 318,35
