**BMW 2 ACTIVE TOURER: 1KSJ228**

| Vinnumber: | <b>WBA2B31010V542078</b> | Versionname: | <b>1.5 216D ACTIVE TOURER</b> |

**Limited Technical Inspection**

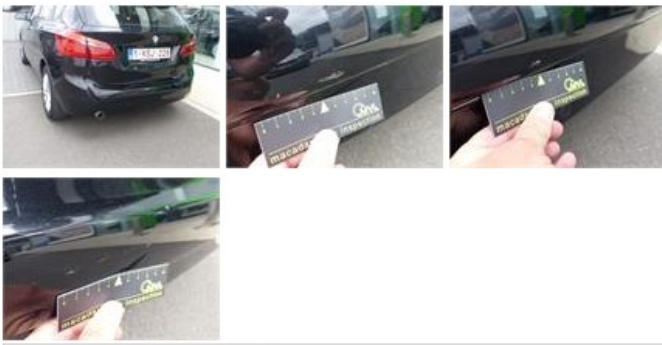
| Bumper R, Scratch(es), LI - Repair and paint (complete) | <b>211,80</b> |

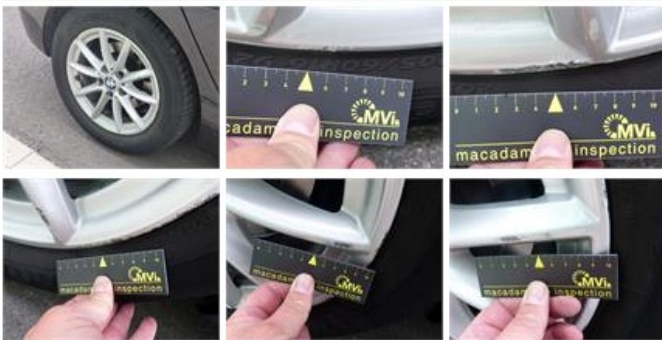
Alloy rim R R, Scratch(es), LI - Repair and paint (complete) 95,00
