BMW 3: 1HDH510			
Vinnumber:	<b>WBA3D11050F329437</b>	Versionname:	<b>3 BER 318d 136PK</b>
First Registrationdate:	<b>24/06/2014</b>	Fiscalpower:	
Expertise Mileage:	<b>117494</b>	Power Kw:	<b>100</b>
Bodytype:	<b>Berline</b>	Body color:	<b>Brown</b>
Gearbox:	<b>MAN 6 VIT</b>	Paint type:	<b>Metalic</b>
Transmission:	<b>Back</b>	Rims summer:	<b>Steel</b>
Fueltype:	<b>Diesel</b>	Oil level:	<b>OK</b>
Battery functioning:	<b>Yes</b>	Parking lot:	<b>3720</b>
Number of doors:	<b>4</b>		
Number of seats:	<b>5</b>		
Number head rests:	<b>5</b>		
Rims summer:	<b>Steel</b>		
Category:	<b>Passenger Car</b>		
Oil level:	<b>OK</b>		
Registration Certificate Car (BE):	<b>Yes</b>

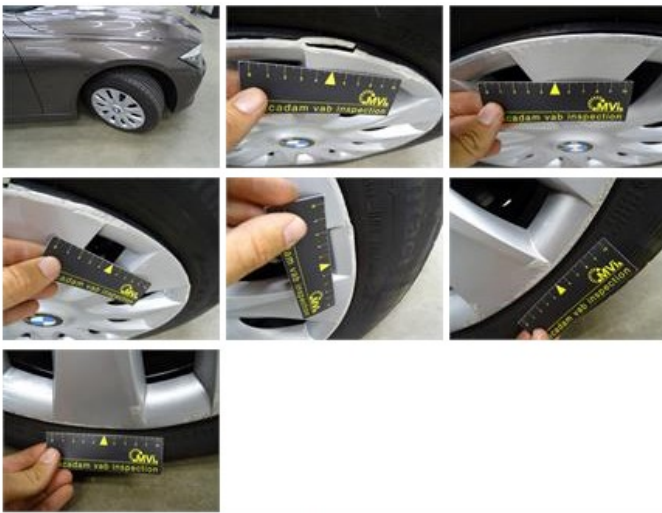
Total cost ex VAT		1636,61
Wing F R, Scratch(es), Acceptable		0,00
<i>No pictures to display</i>		
Wheel cover F R, Deformed / Strained, E - Replace		30,00

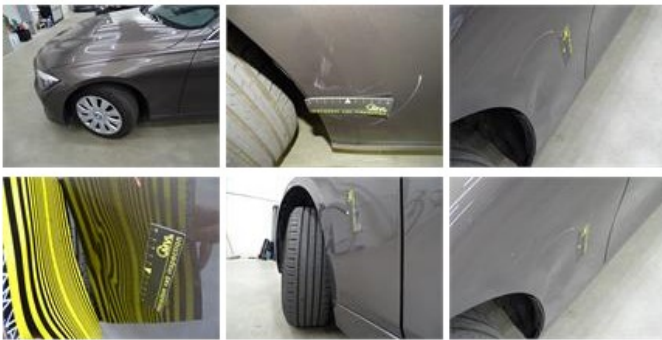
Wing F L, Dent(s) and scratch(es), LI - Repair and paint (complete) 268,18

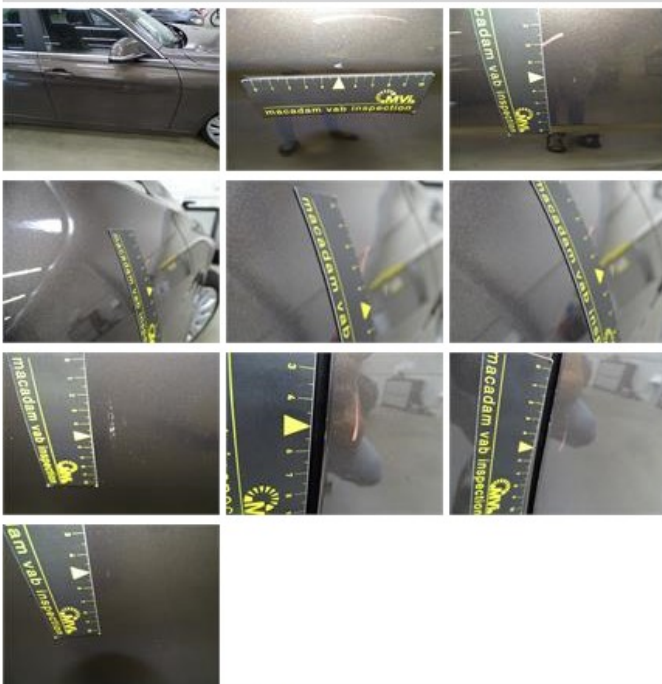
Door F R, Dent(s) and scratch(es), LI - Repair and paint (complete) 318,35

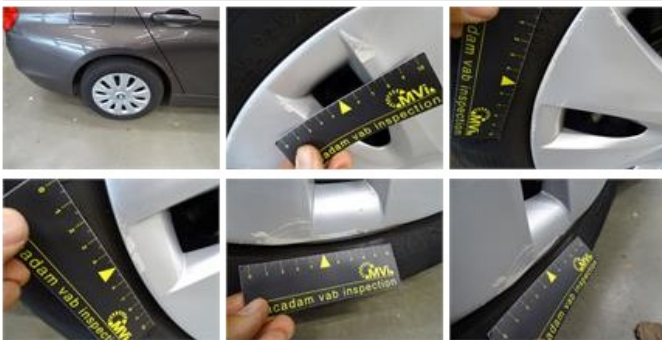
Wheel cover R R, Scratch(es), E - Replace 30,00

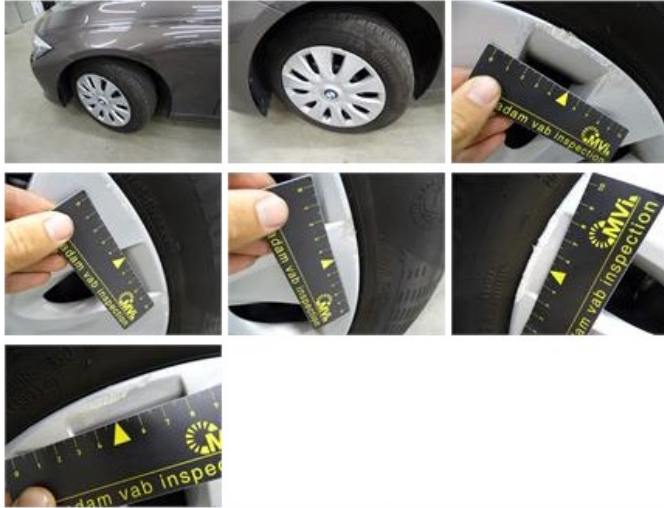
Wheel cover F L, Scratch(es), E - Replace 30,00

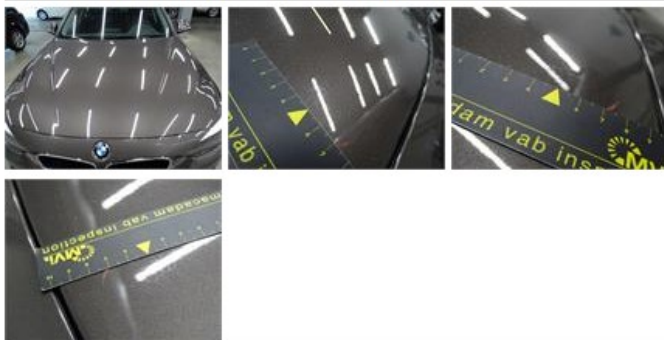
Bonnet, Chemical polution, LI - Repair and paint (complete) 290,08

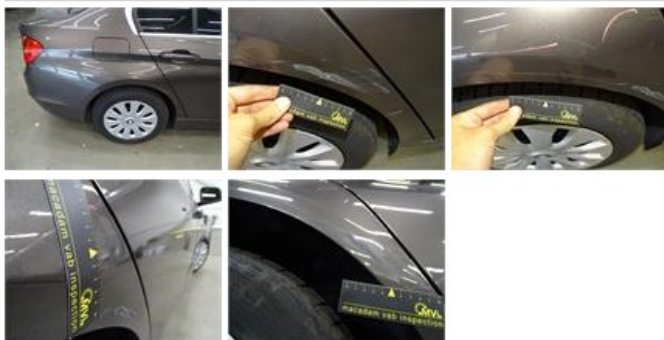
Wing R R, Dent(s) and scratch(es), LI - Repair and paint (complete) 308,20
