**BMW 2 ACTIVE TOURER: 1KRH186**

**Limited Technical Inspection**

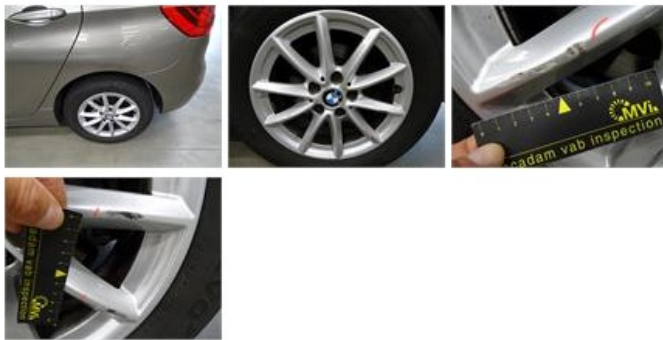
Alloy rim R L, Scratch(es), I - Repair

100,00

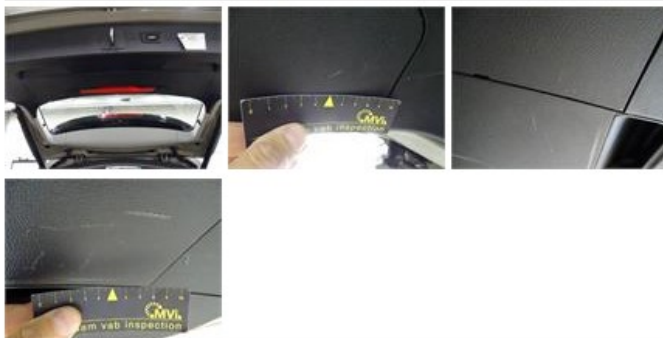
Trunk lid covering R, Scratch(es), Smart repair

110,64

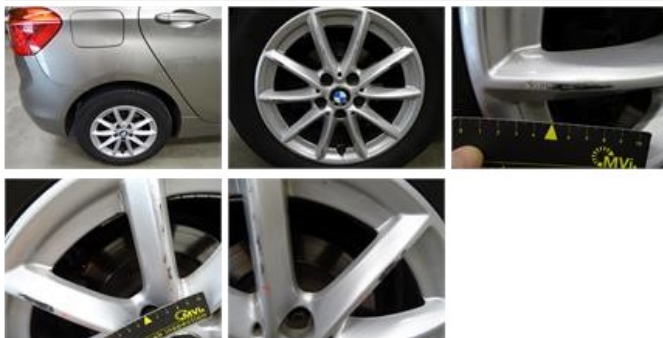
Alloy rim R R, Scratch(es), I - Repair

100,00
