BMW 1 SPORTSHATCH: 1NTY336

Limited Technical Inspection

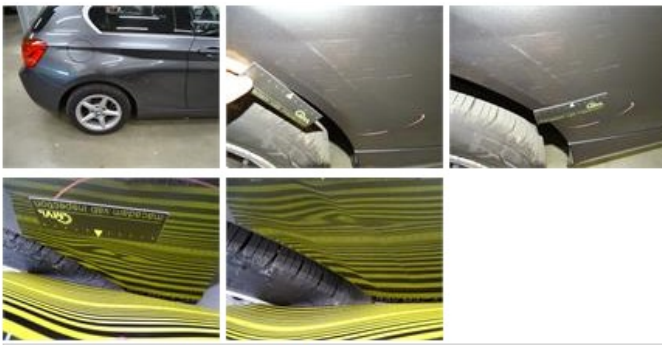
Wing R R, Dent(s) and scratch(es), LI - Repair and paint (complete) 308,20

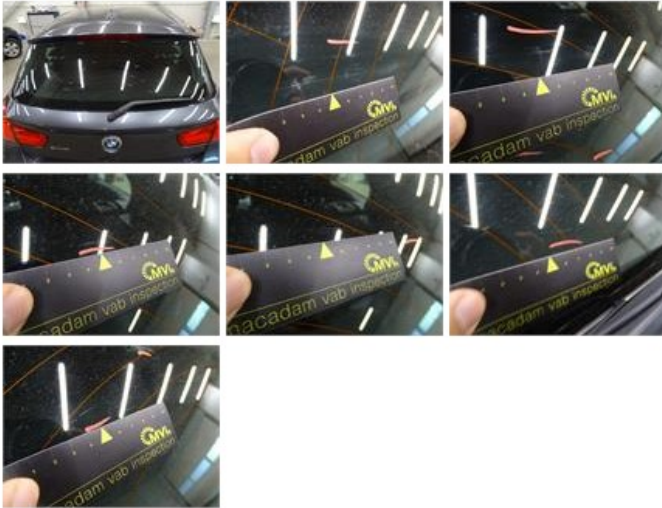
Rear window, Scratch(es), Acceptable 0,00

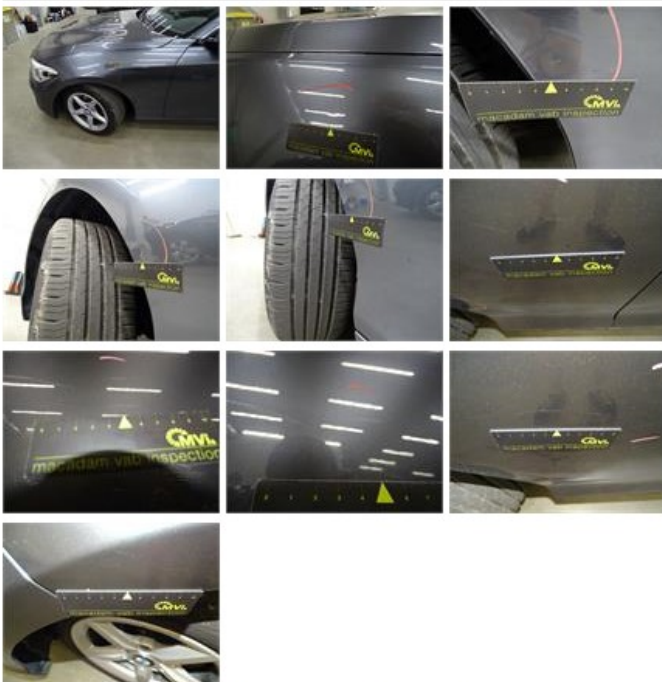
Wing F L, Dent(s) and scratch(es), LI - Repair and paint (complete) 220,18

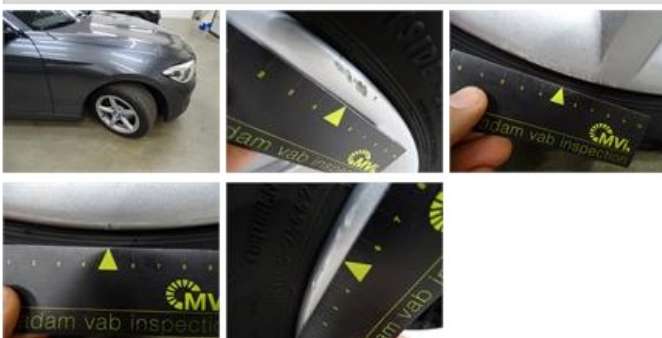
Alloy rim F R, Scratch(es), LI - Repair and paint (complete) 95,00

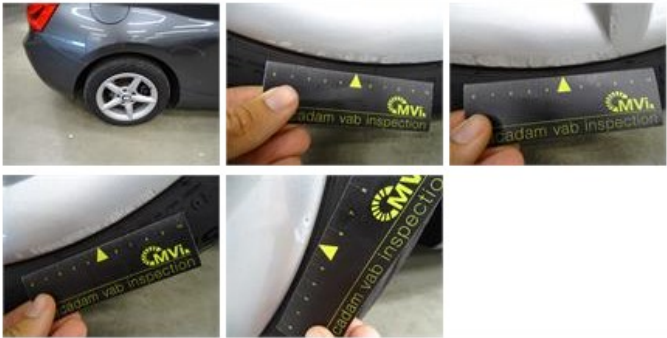
Door F L, Dent(s) and scratch(es), Acceptable	0,00
<i>No pictures to display</i>	
Alloy rim R R, Scratch(es), LI - Repair and paint (complete)	95,00

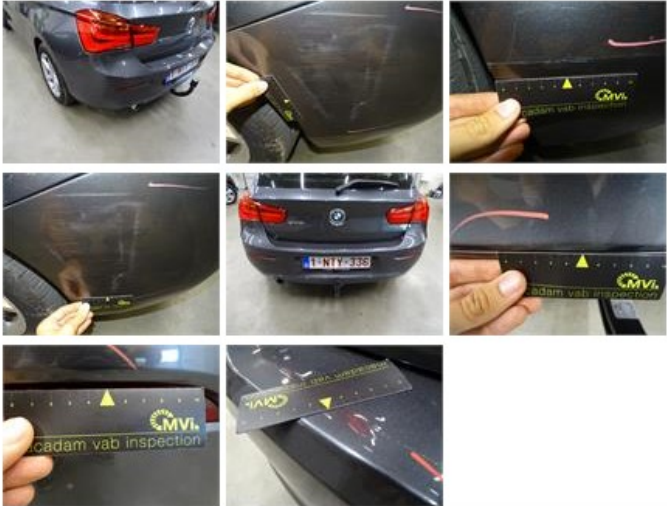
Wing R L, Scratch(es), Acceptable	0,00
<i>No pictures to display</i>	
Bumper R, Scratch(es), LI - Repair and paint (complete)	211,80
