BMW 2 ACTIVE TOURER: 1LLJ306

Limited Technical Inspection

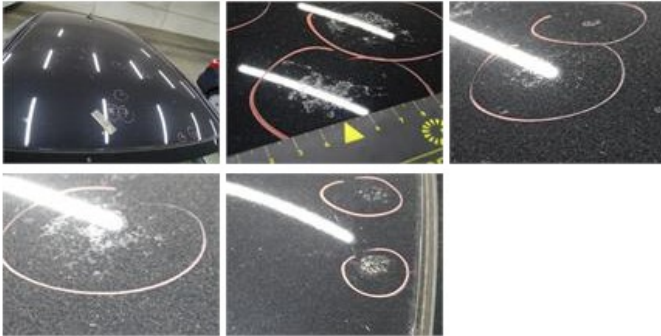
Roof, Chemical polution, LI - Repair and paint (complete)

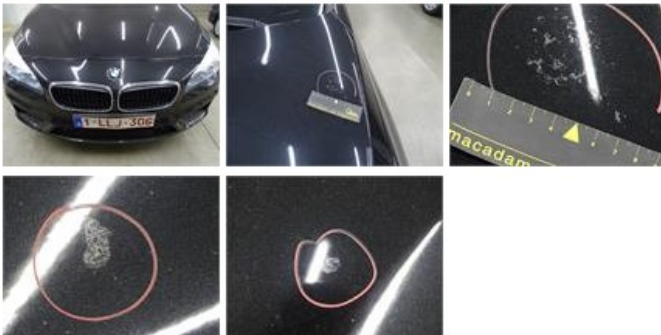
Bonnet, Chemical polution, LI - Repair and paint (complete)

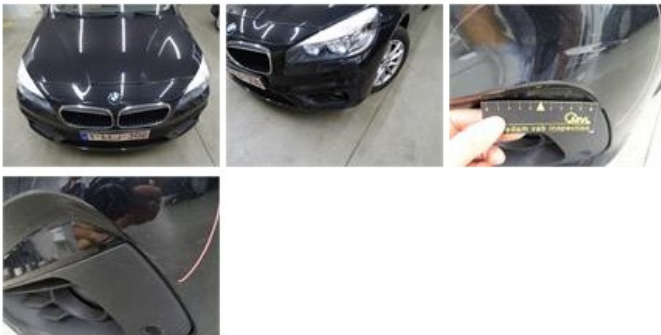
Bumper F, Scratch(es), LI - Repair and paint (complete)

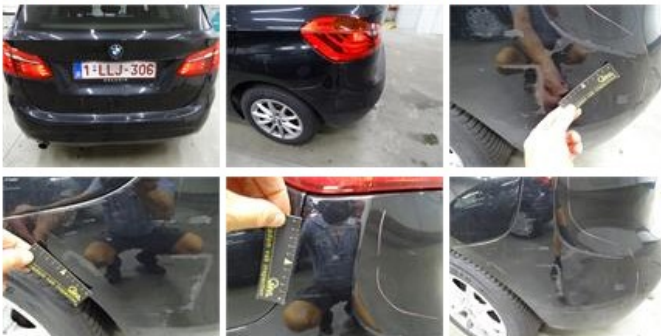
Bumper R, Scratch(es), LI - Repair and paint (complete)
