MERCEDES C: 1FOP074

Limited Technical Inspection

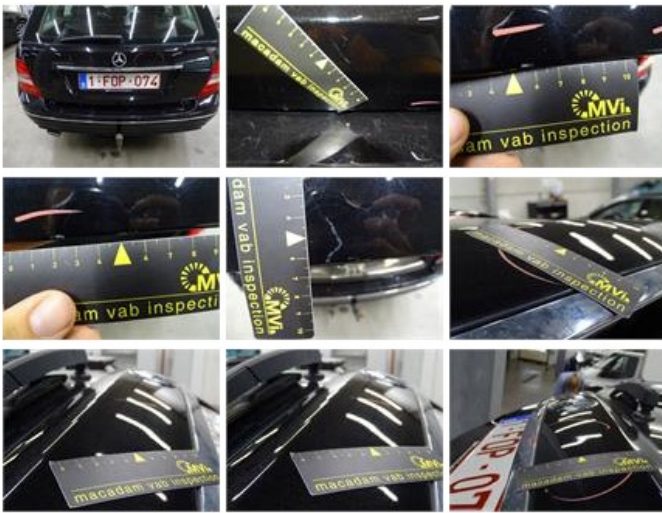
Total cost ex VAT	2701,56
Tailgate, Dent(s) and scratch(es), LI - Repair and paint (complete)	301,68

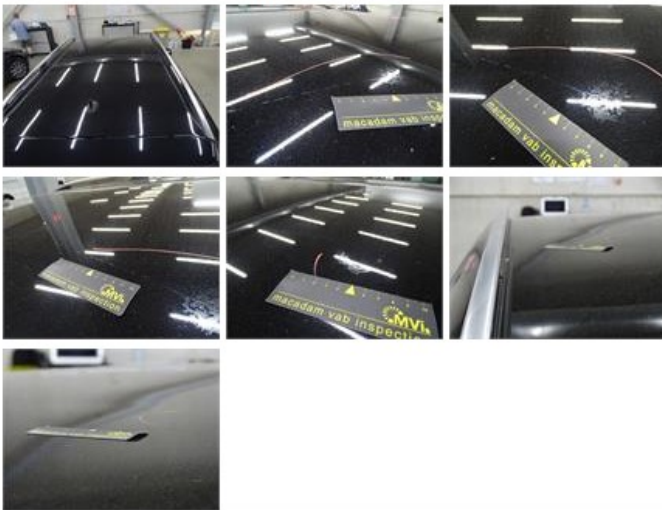
Roof, Chemical polution, LI - Repair and paint (complete)

481,50

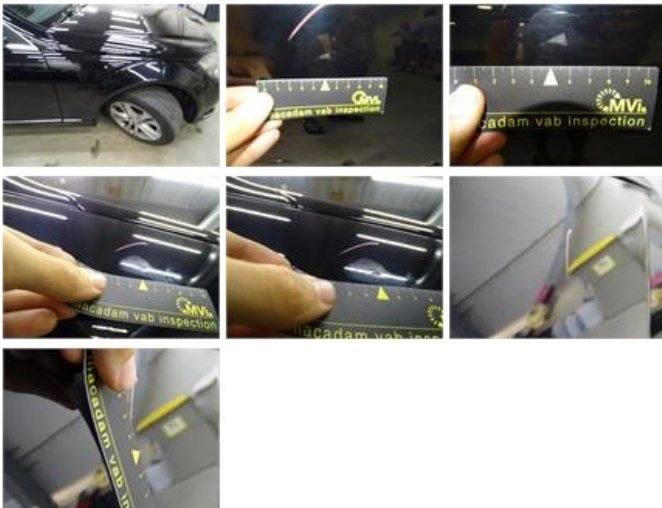
Wing F R, Dent(s) and scratch(es), LI - Repair and paint (complete)

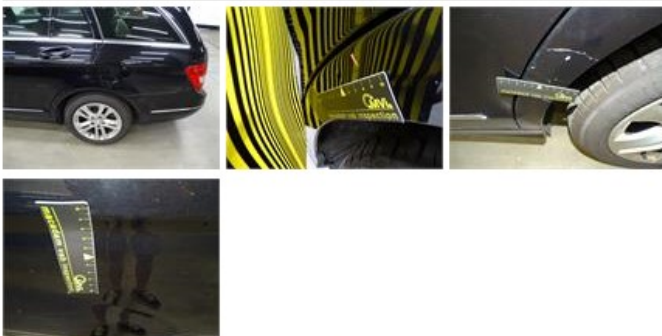
Wing R L, Dent(s) and scratch(es), LI - Repair and paint (complete)

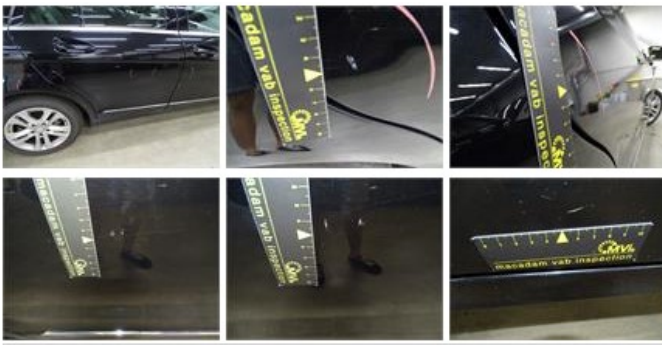
Door R R, Dent(s) and scratch(es), LI - Repair and paint (complete)

318,35

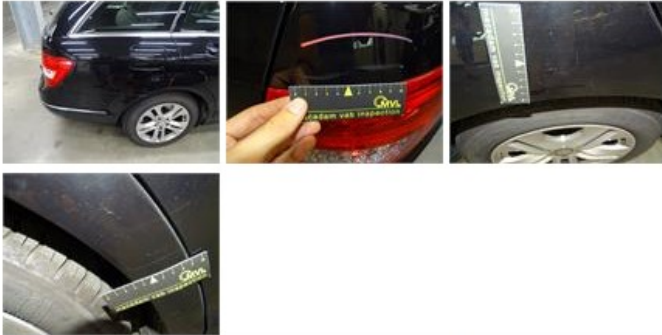
Wing R R, Scratch(es), LI - Repair and paint (complete) 0,00

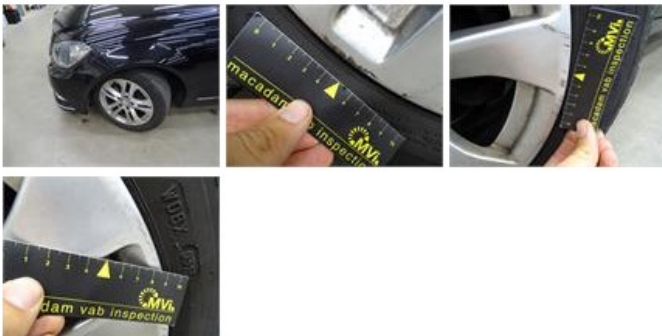
Alloy rim F L, Scratch(es), LI - Repair and paint (complete) 95,00

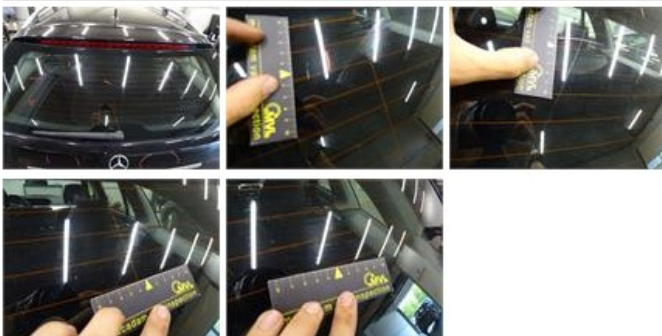
Rear window, Scratch(es), Acceptable 0,00

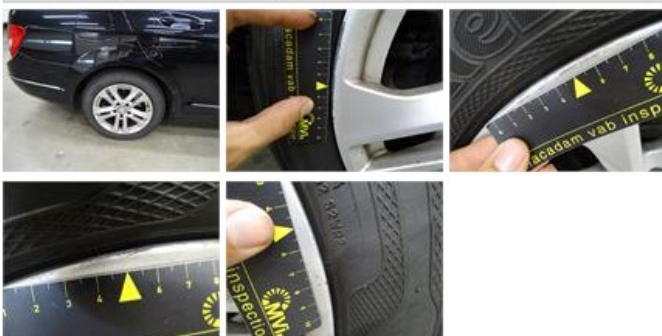
Alloy rim R R, Scratch(es), LI - Repair and paint (complete) 95,00

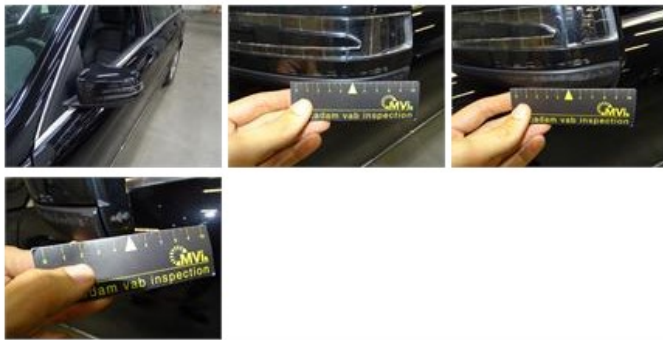
Rearview mirror L complete, Scratch(es), Le - Replace and paint

283,00

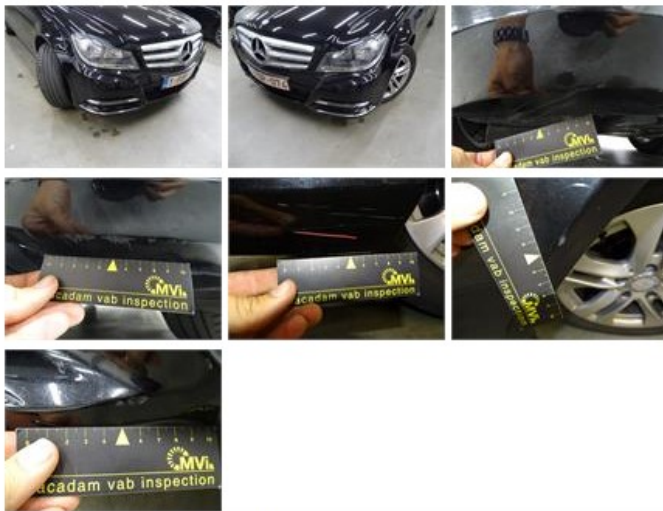
Bumper F, Scratch(es), LI - Repair and paint (complete)

211,80

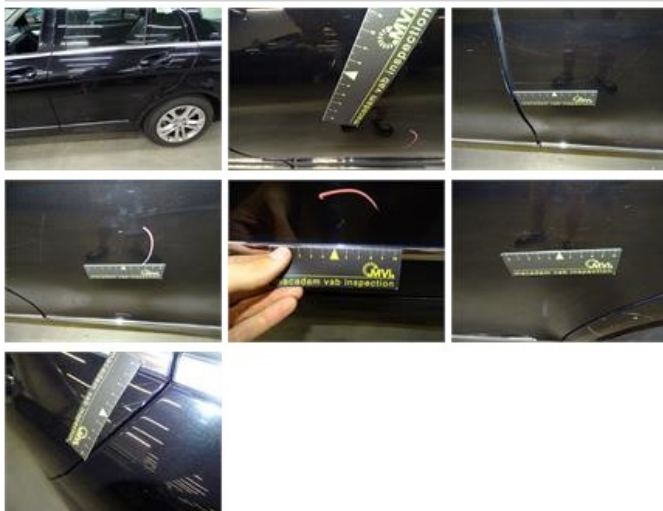
Door R L, Scratch(es), LI - Repair and paint (complete)

318,35

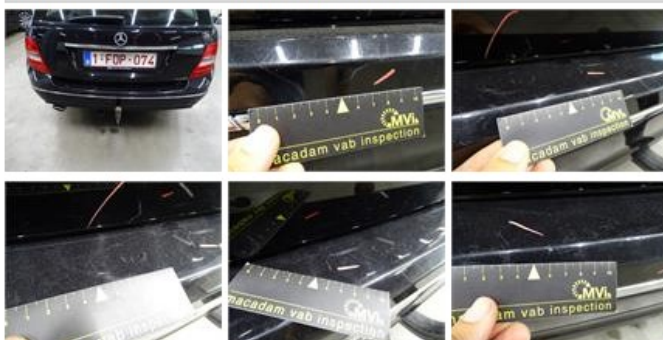
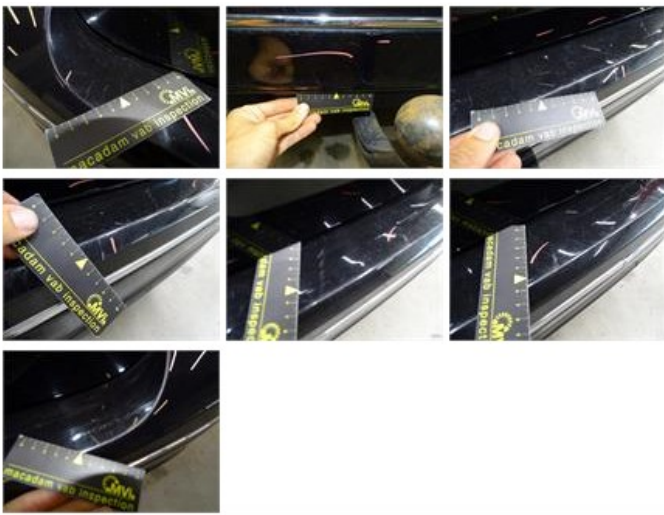
Bumper R, Scratch(es), LI - Repair and paint (complete)

211,80

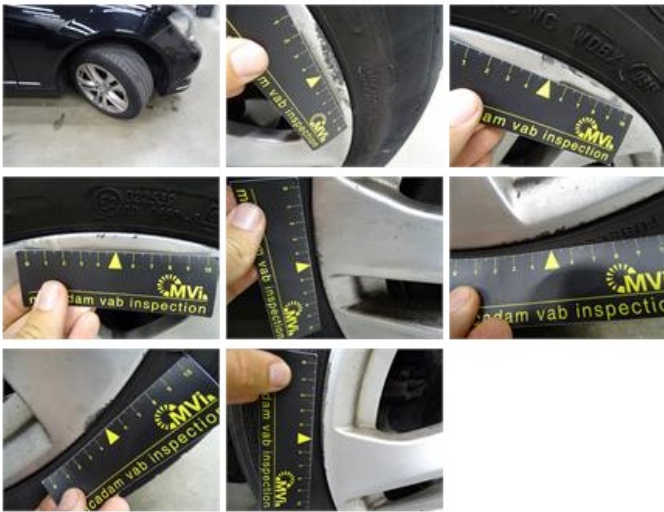
Alloy rim F R, Scratch(es), LI - Repair and paint (complete) 95,00
