**BMW 2 ACTIVE TOURER: 1KUY667**

**Limited Technical Inspection**

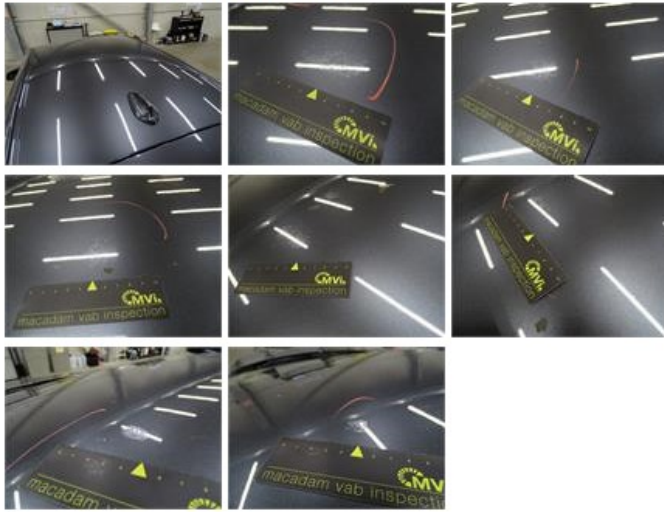
Roof, Chemical polution, LI - Repair and paint (complete)

481,50

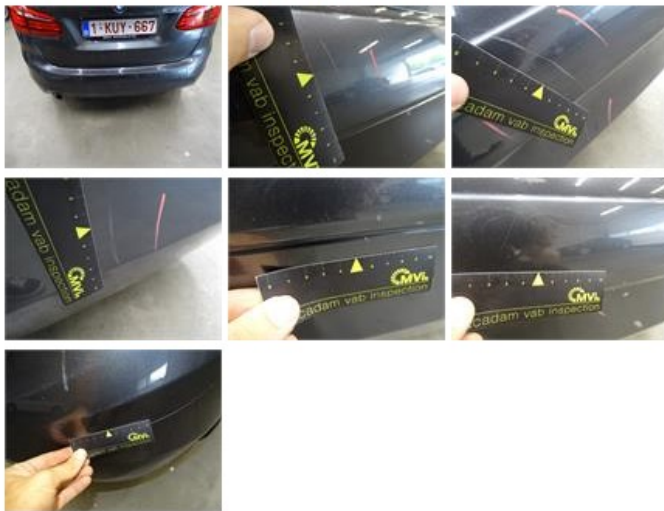
Bumper R, Scratch(es), LI - Repair and paint (complete)

211,80

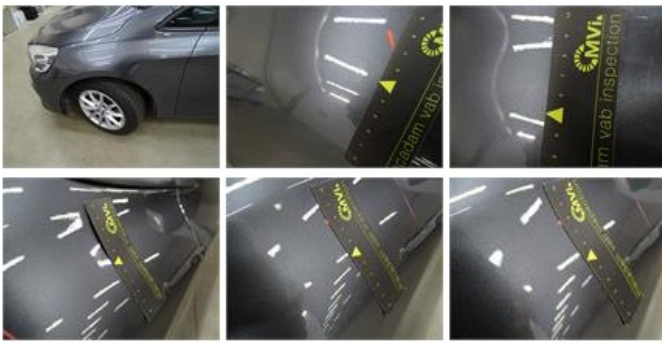
Wing F L, Chemical polution, LI - Repair and paint (complete)

220,18

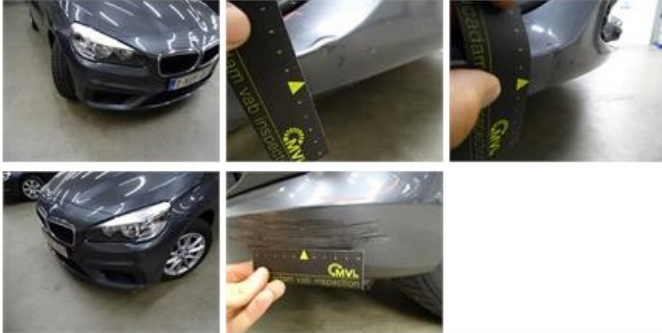
Bumper F, Dent(s) and scratch(es), LI - Repair and paint (complete) 211,80

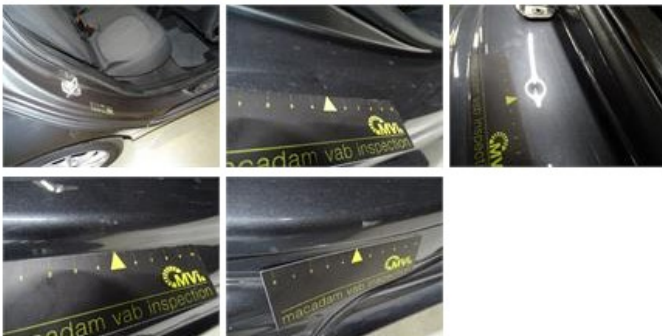
Rocker panel inner R R, Dent(s), LI - Repair and paint (complete) 115,56

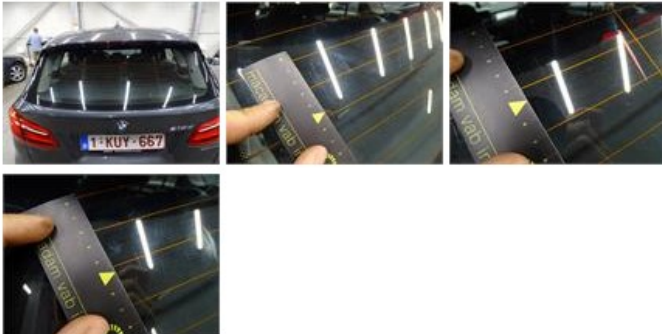
Rear window, Scratch(es), Acceptable 0,00

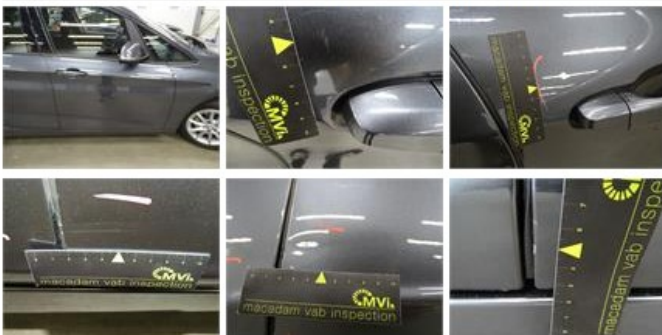
Door F R, Dent(s) and scratch(es), LI - Repair and paint (complete) 318,35
