**MERCEDES A: 1RXS725**

**Limited Technical Inspection**

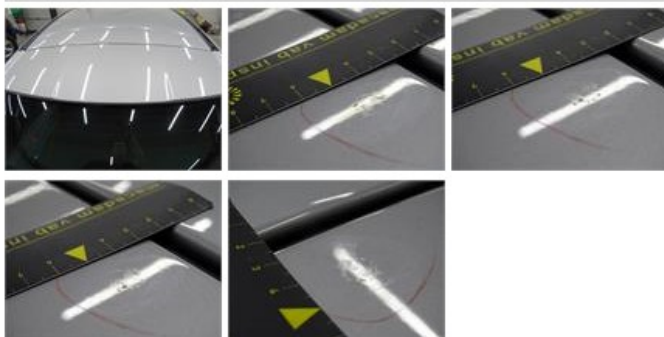
Rear spoiler, Chemical polution, LI - Repair and paint (complete)

115,56

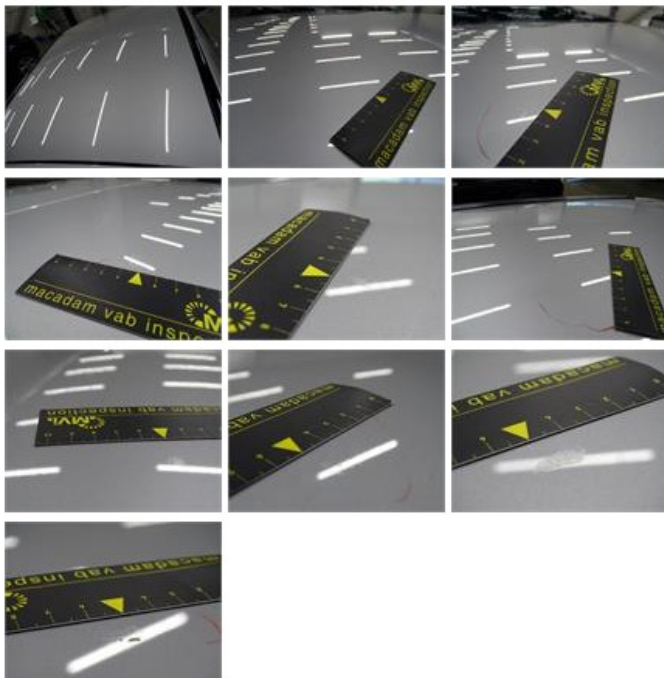
Roof, Chemical polution, LI - Repair and paint (complete)

481,50
