**MINI Mini: 1GUL227**

**Limited Technical Inspection**

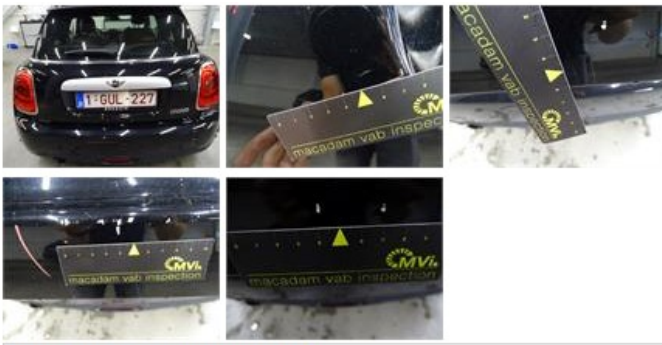
Total cost ex VAT	<b>3890,25</b>
Tailgate, Scratch(es), LI - Repair and paint (complete)	<b>301,68</b>

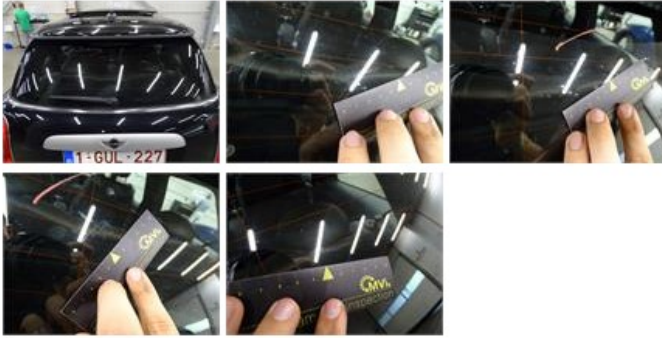
Rear window, Scratch(es), Acceptable 0,00

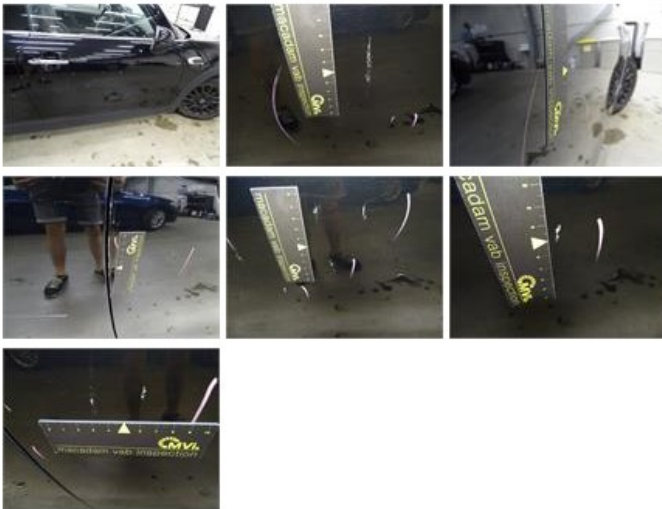
Door F R, Dent(s) and scratch(es), LI - Repair and paint (complete) 318,35

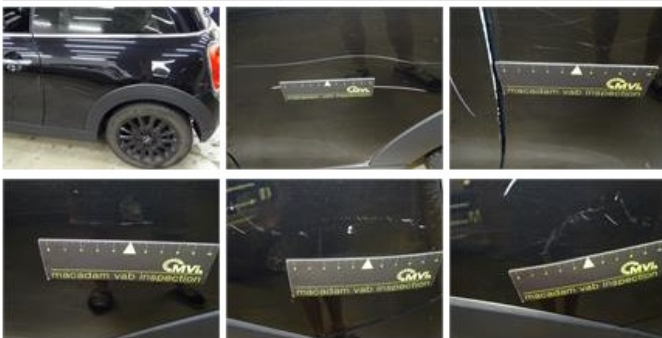
Wing R L, Scratch(es), LI - Repair and paint (complete) 308,20

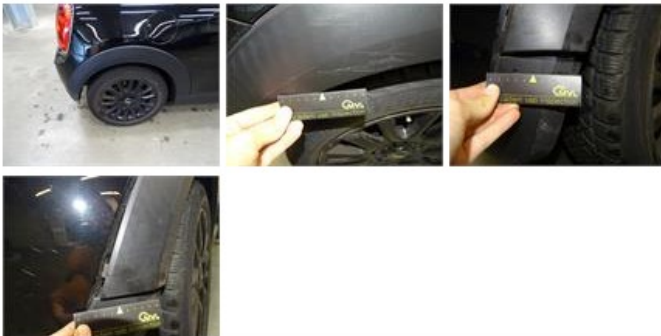
Wing trim R R, Deformed / Strained, E - Replace 84,00

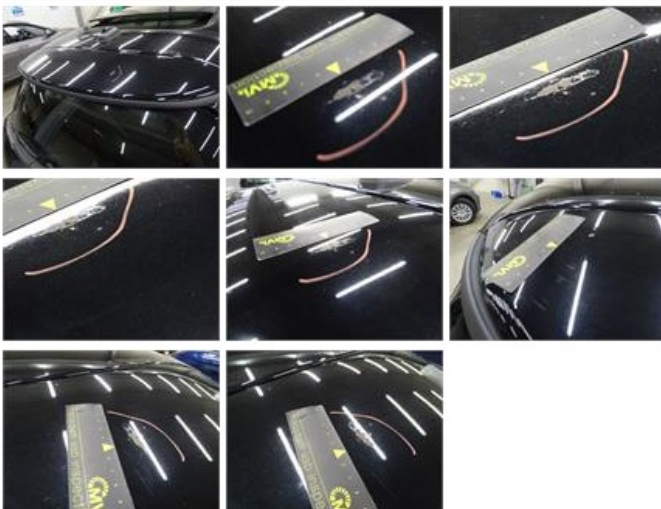
Rear spoiler, Chemical polution, LI - Repair and paint (complete) 115,56

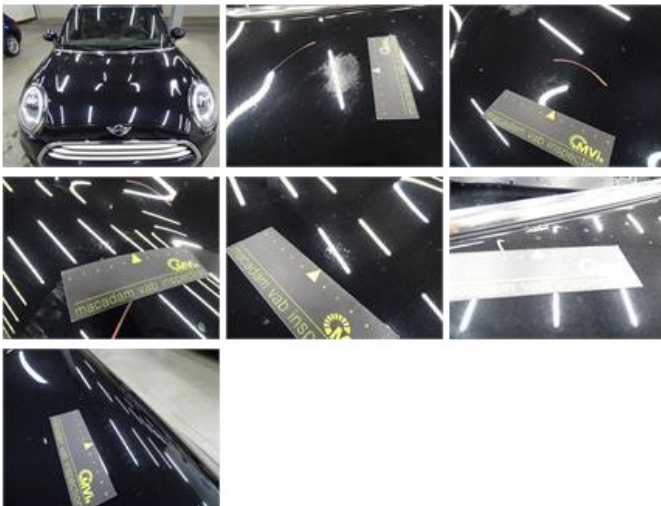
Bonnet, Chemical polution, LI - Repair and paint (complete) 290,08

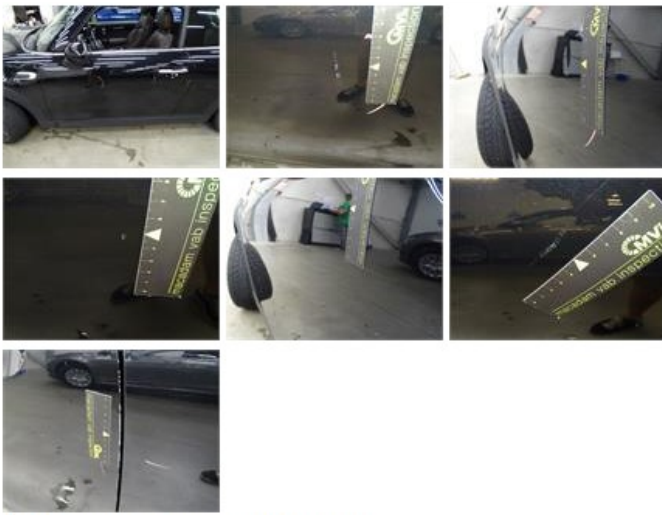
Door F L, Dent(s) and scratch(es), LI - Repair and paint (complete) 318,35

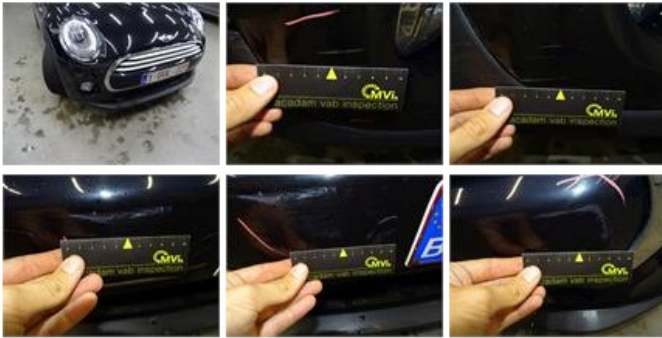
Bumper F, Scratch(es), LI - Repair and paint (complete) 211,80

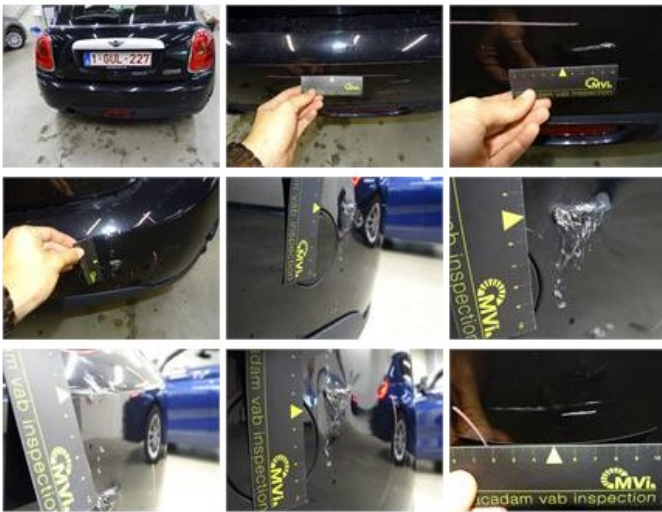
Bumper R, Deformed / Strained, LI - Repair and paint (complete) 211,80

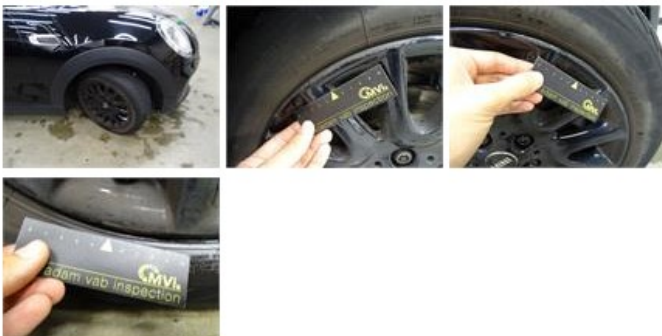
Alloy rim F R, Scratch(es), LI - Repair and paint (complete) 95,00

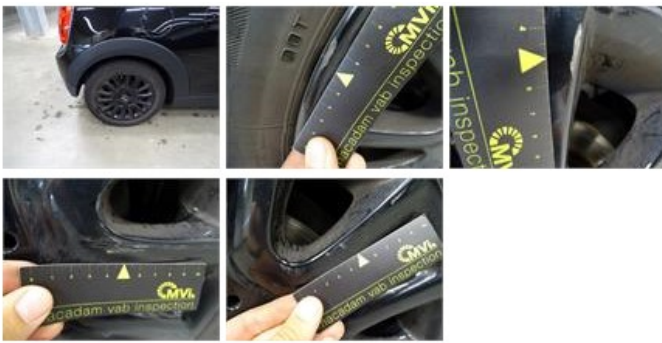
Alloy rim R R, Scratch(es), LI - Repair and paint (complete) 95,00

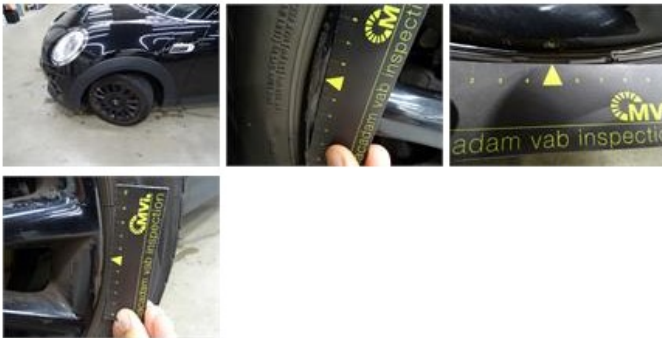
Alloy rim F L, Scratch(es), LI - Repair and paint (complete) 95,00

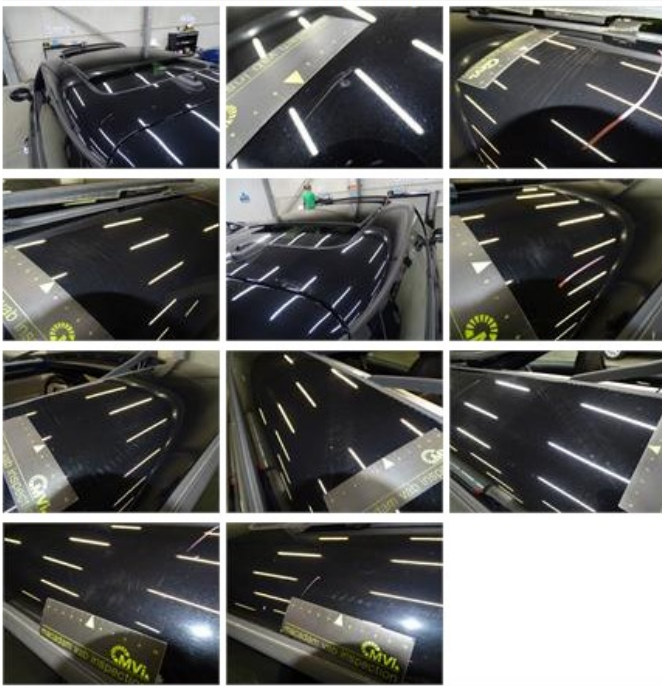
Roof, Scratch(es), LI - Repair and paint (complete) 481,50

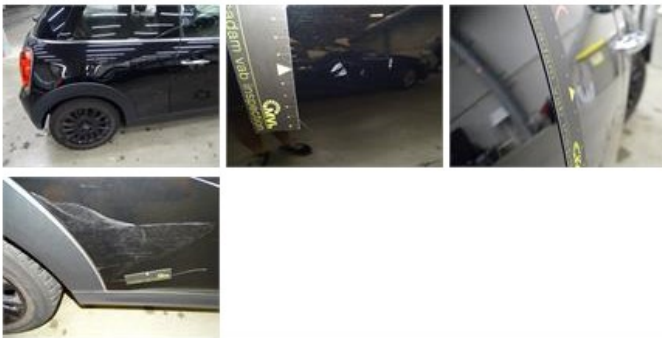
Wing R R, Dent(s) and scratch(es), LI - Repair and paint (complete) 308,20
