**VOLKSWAGEN TOURAN: 1LEN701**

**Limited Technical Inspection**

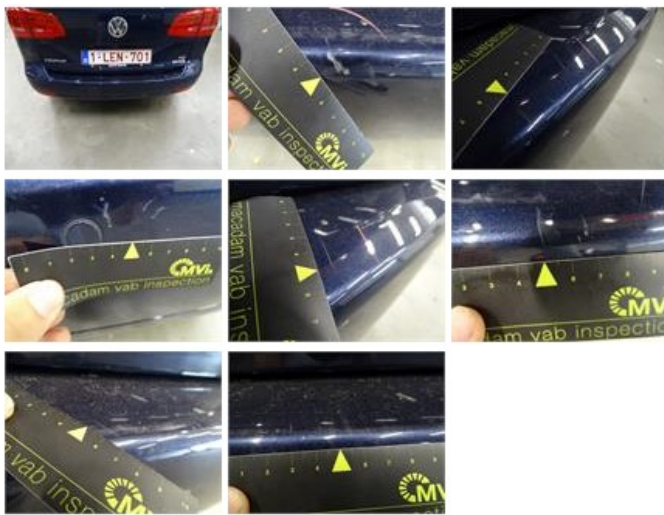
<b>Total cost ex VAT</b>	<b>915,28</b>
<b>Bumper R, Scratch(es), LI - Repair and paint (complete)</b>	<b>211,80</b>

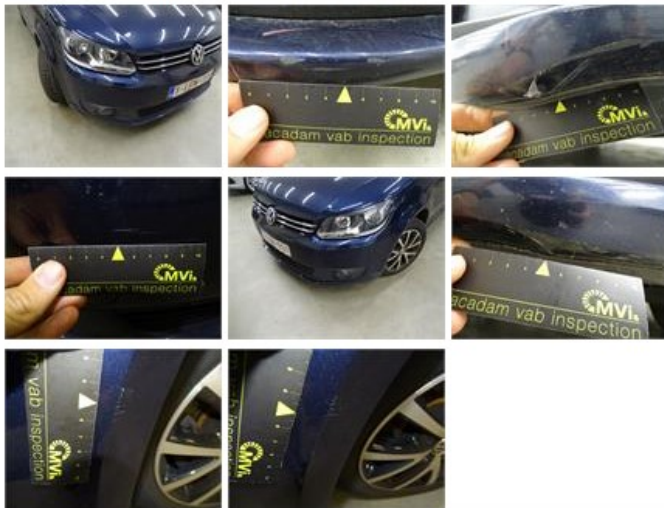
Bumper F, Scratch(es), LI - Repair and paint (complete)

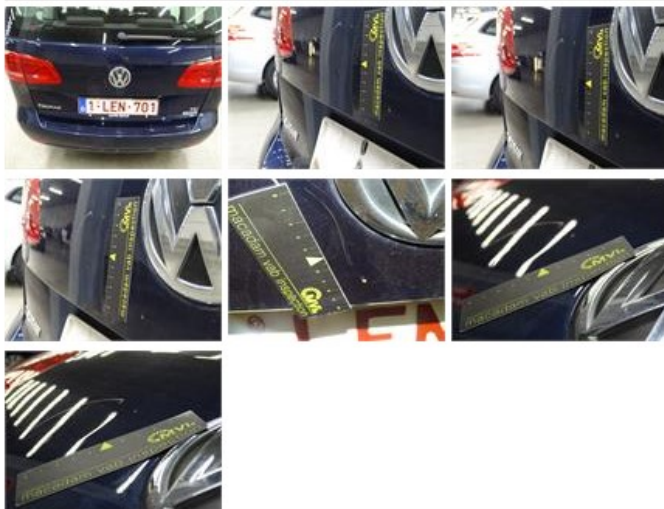
Tailgate, Scratch(es), Acceptable

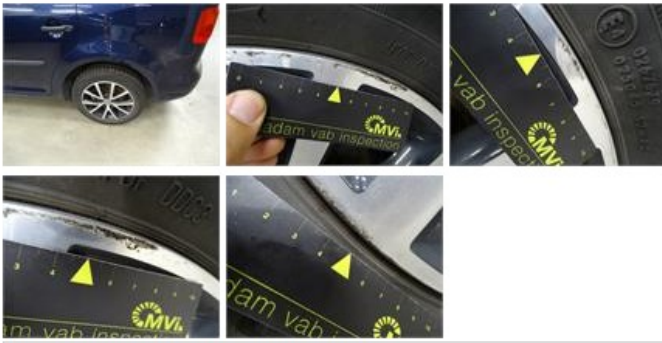
Alloy rim R L polished, Scratch(es), LI - Repair and paint (complete)

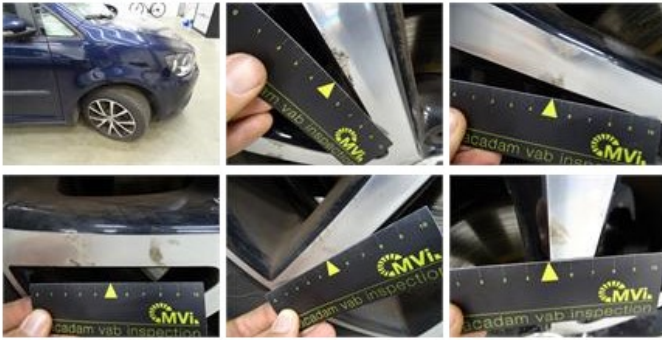
Alloy rim F R polished, Scratch(es), LI - Repair and paint (complete) 95,00
