BMW 3: 1HYB004

Limited Technical Inspection

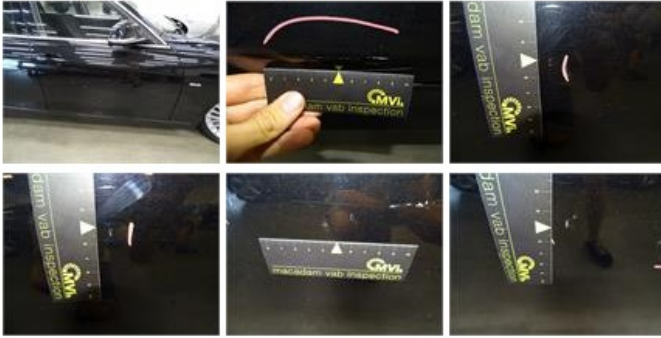
Door F R, Scratch(es), LI - Repair and paint (complete) 318,35

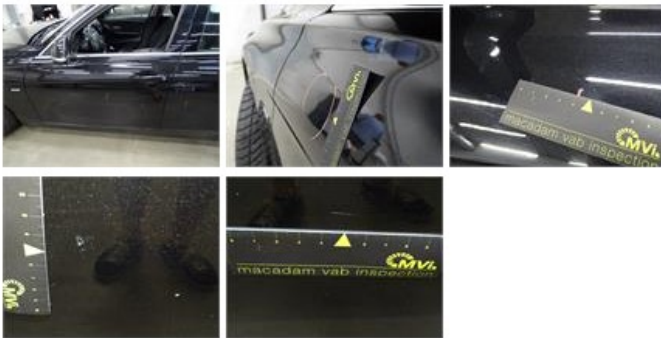
Door F L, Bad repair, Acceptable 0,00

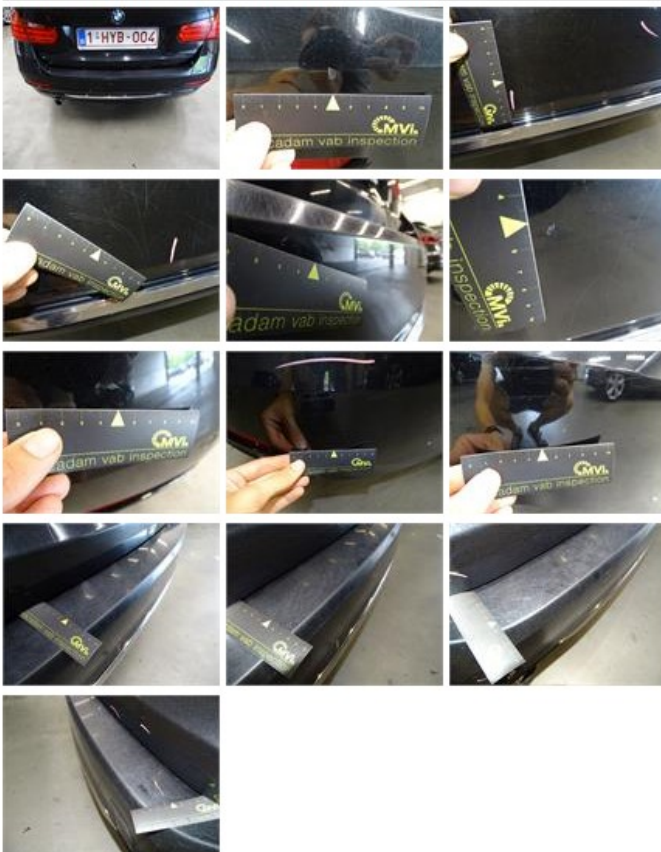
Bumper R, Scratch(es), LI - Repair and paint (complete) 211,80

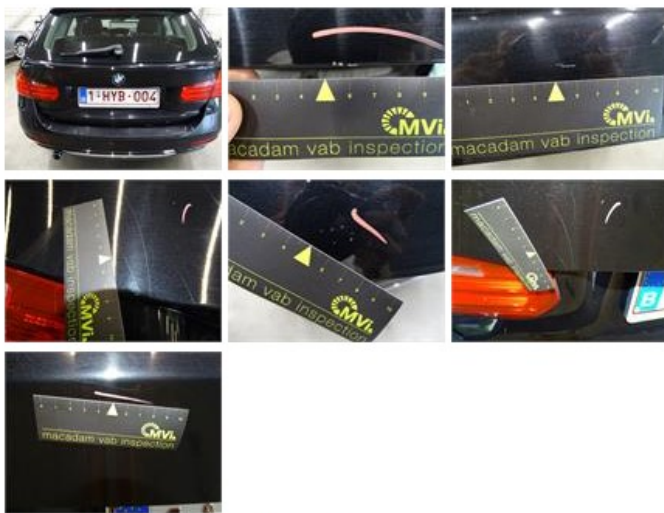
Tailgate, Scratch(es), LI - Repair and paint (complete) 301,68

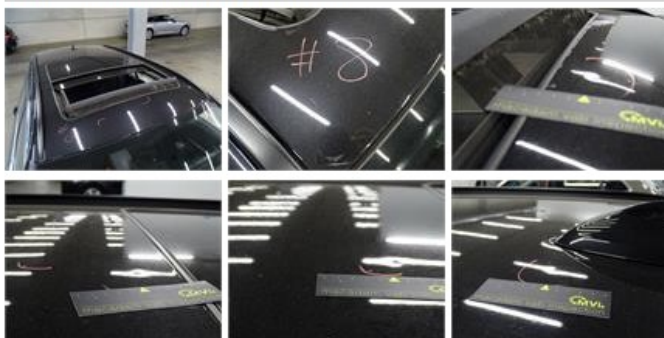
Roof, Dent(s), PDR - Paintless dent repair

201,60

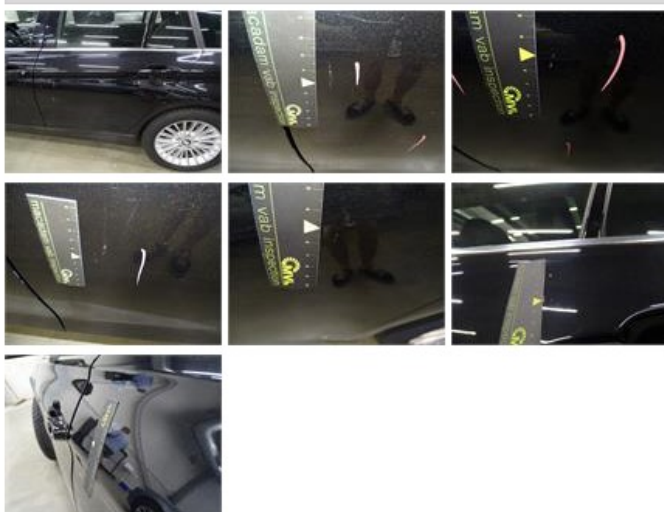
Door R L, Bad repair, Acceptable

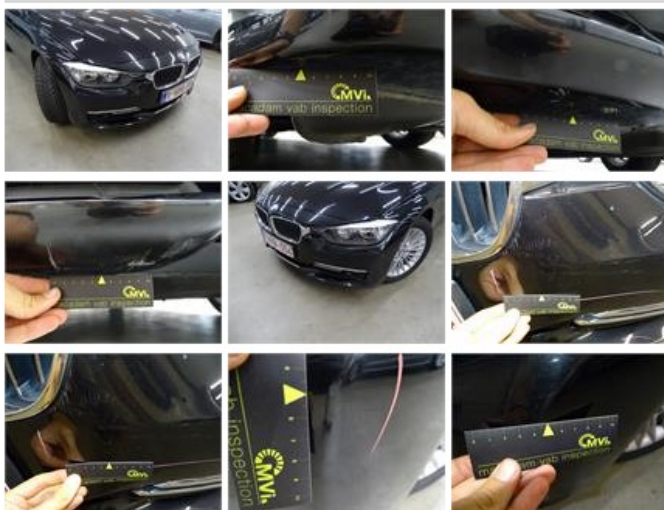
Bumper F, Scratch(es), LI - Repair and paint (complete)

211,80
