**FORD GRAND C-MAX: 1KFJ958**

**Limited Technical Inspection**

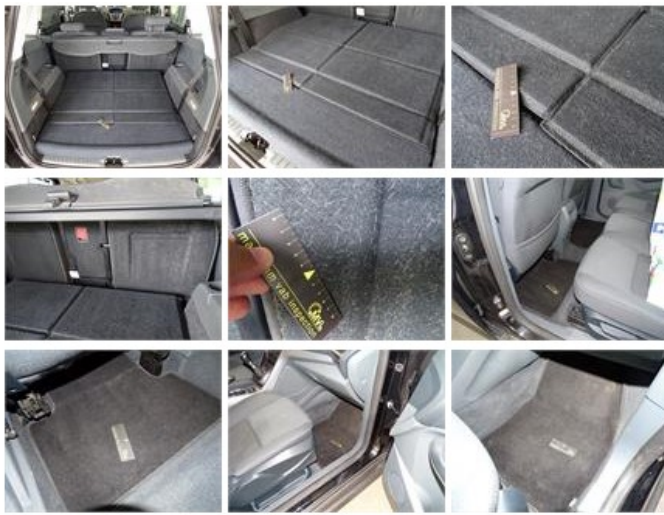
Total cost ex VAT	<b>1556,10</b>
Alloy rim R L, Scratch(es), Acceptable	<b>0,00</b>
<i>No pictures to display</i>	
Interior, Dirty, Chemical cleaning	<b>150,00</b>

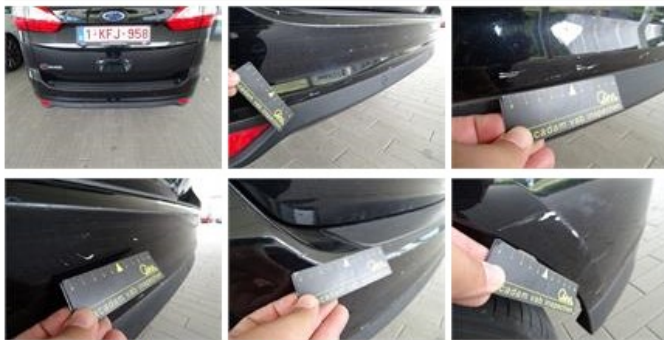
Bumper R, Dent(s) and scratch(es), LI - Repair and paint (complete) 307,80

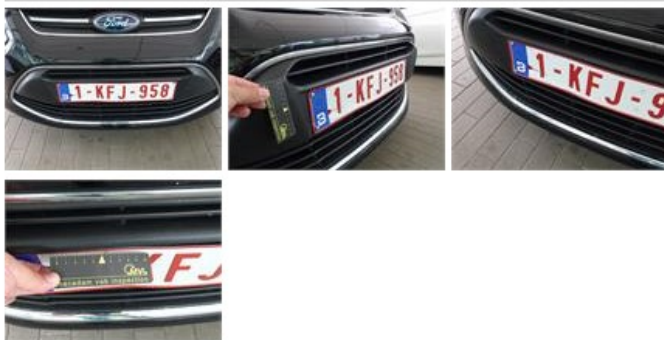
Bumper grille, Deformed / Strained, E - Replace 32,40

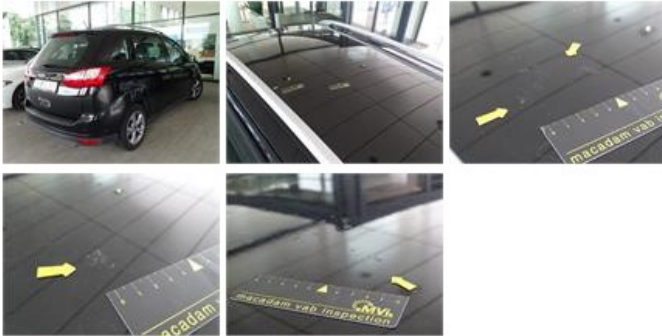
Roof, Chemical polution, LI - Repair and paint (complete) 481,50
