AUDI A3: 1GIL216

Limited Technical Inspection

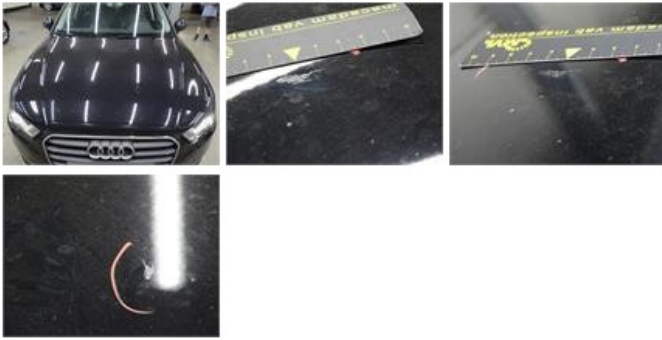
<i>No pictures to display</i>	
Door R L, Scratch(es), Acceptable	0,00
<i>No pictures to display</i>	
Alloy rim F L, Scratch(es), Acceptable	0,00
<i>No pictures to display</i>	
Bonnet, Chemical polution, LI - Repair and paint (complete)	290,08

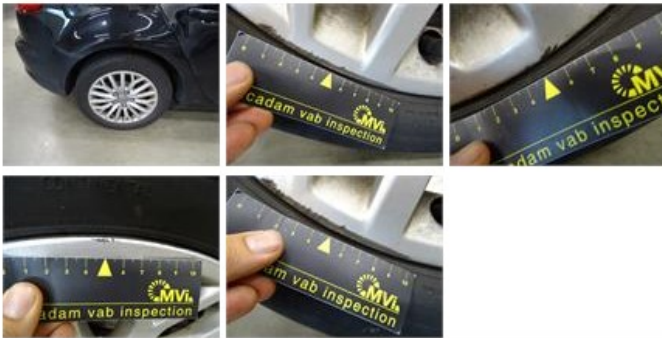
Rocker panel inner R L, Dent(s), Acceptable	0,00
<i>No pictures to display</i>	
Wing R L, Scratch(es), Acceptable	0,00
<i>No pictures to display</i>	
Alloy rim R R, Scratch(es), LI - Repair and paint (complete)	95,00

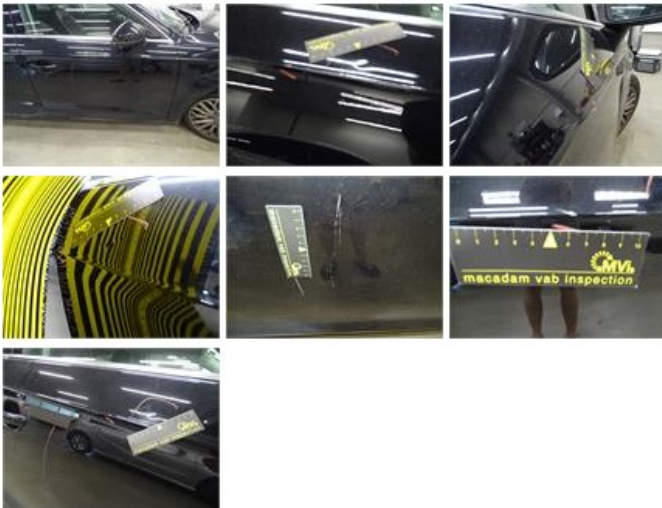
Alloy rim F R, Scratch(es), Acceptable	0,00
<i>No pictures to display</i>	
Door F R, Scratch(es), LI - Repair and paint (complete)	318,35

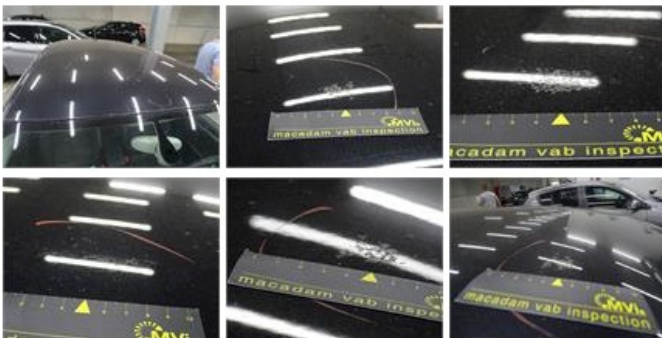
Roof, Chemical polution, LI - Repair and paint (complete)	481,50
---	--------

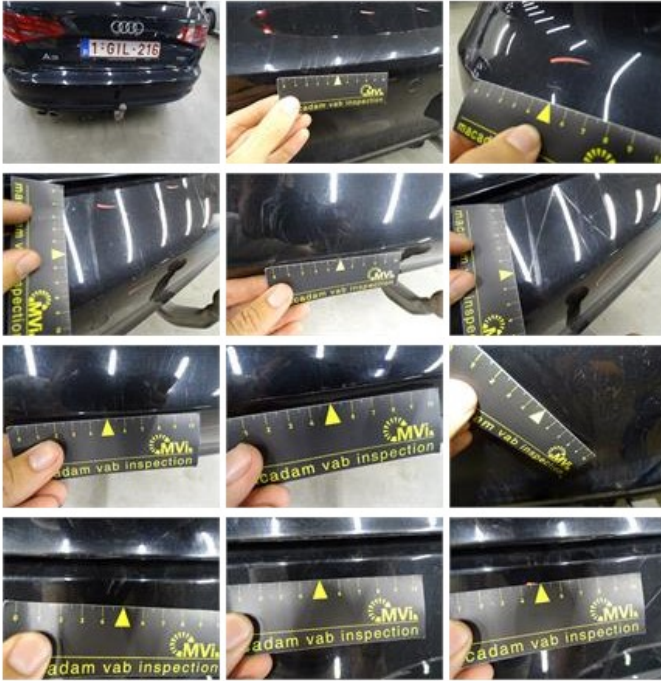
Bumper R, Scratch(es), LI - Repair and paint (complete)

211,80
