VOLVO V60: 1PED904

Limited Technical Inspection

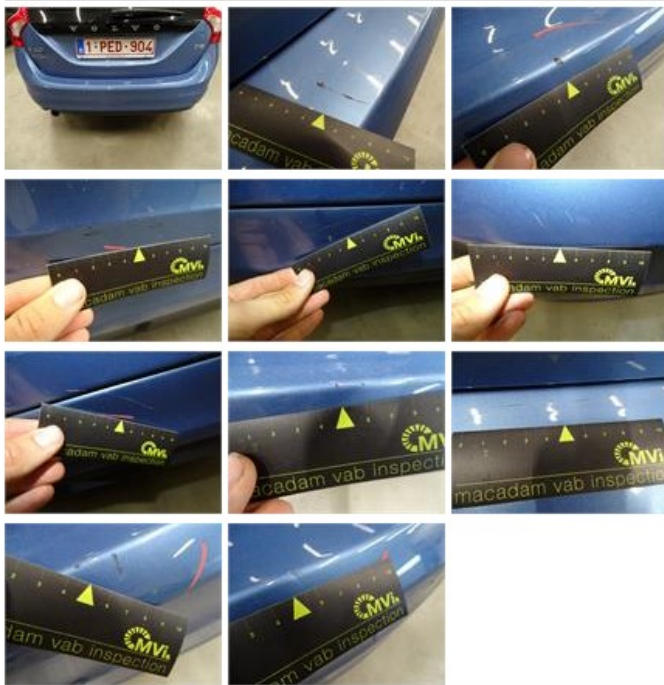
Bumper R, Scratch(es), LI - Repair and paint (complete) 211,80

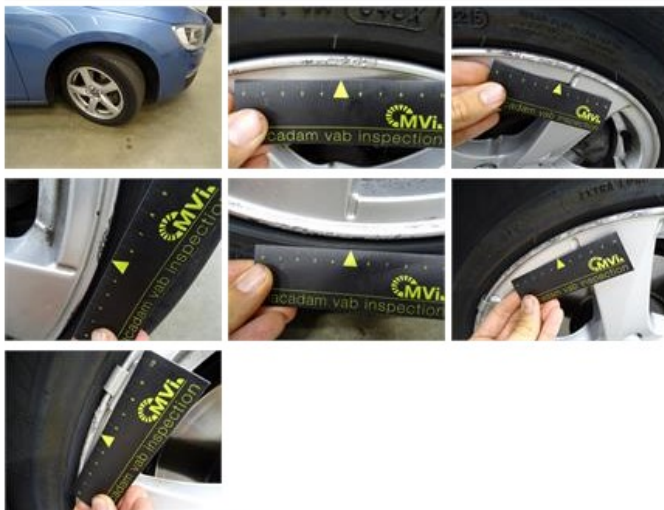
Alloy rim F R, Scratch(es), LI - Repair and paint (complete) 95,00

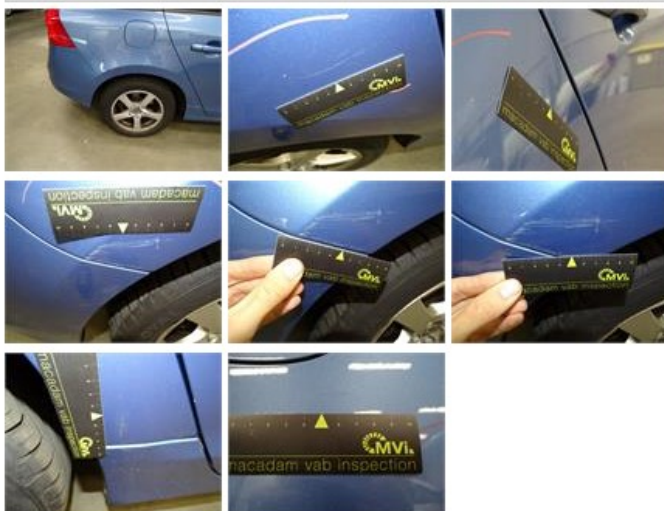
Wing R R, Dent(s) and scratch(es), LI - Repair and paint (complete) 308,20

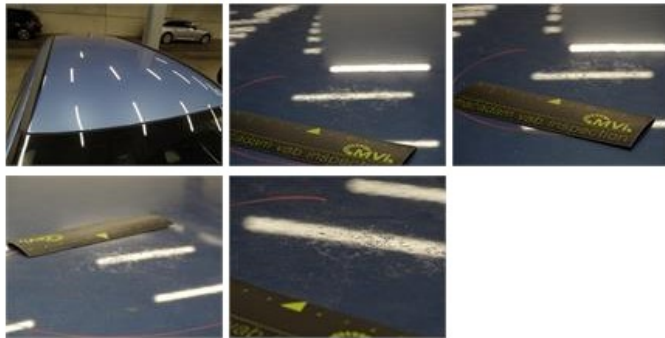
Roof, Chemical polution, LI - Repair and paint (complete) 481,50

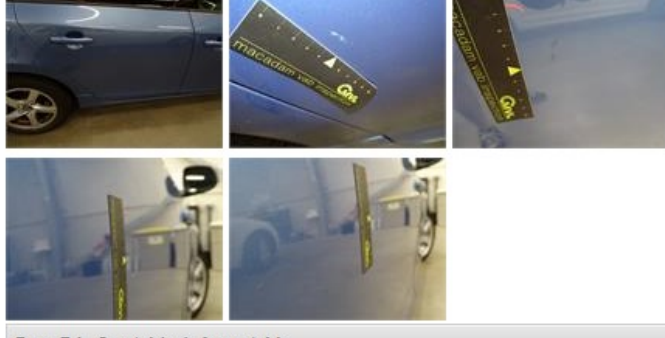
Door R R, Dent(s) and scratch(es), LI - Repair and paint (complete) 318,35

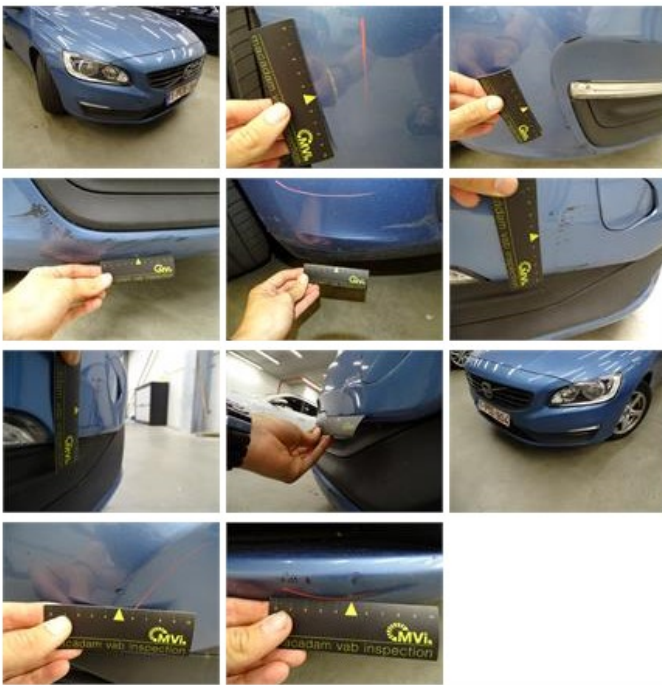
Bumper F, Dent(s) and scratch(es), LI - Repair and paint (complete) 211,80

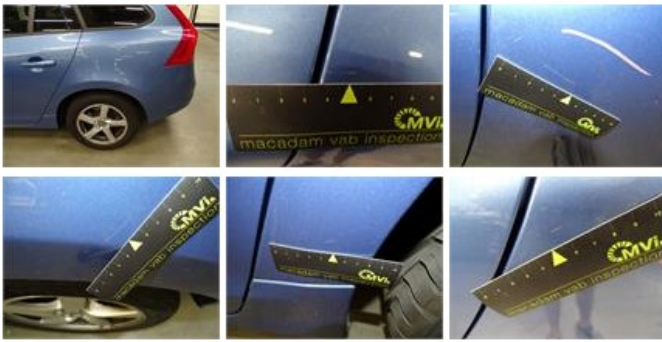
Wing R L, Scratch(es), LI - Repair and paint (complete)

308,20
