BMW 1: 1HAN428

Limited Technical Inspection

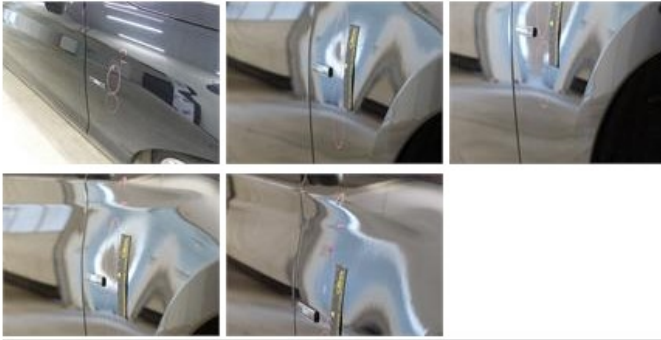
Wing F R, Dent(s), PDR - Paintless dent repair

63,00
