VOLVO XC60: 1KSE018

Limited Technical Inspection

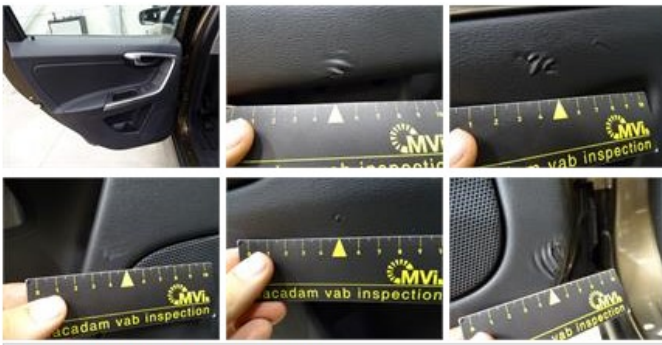
Total cost ex VAT	4028,17
Door panel R L, Hole, E - Replace	132,00

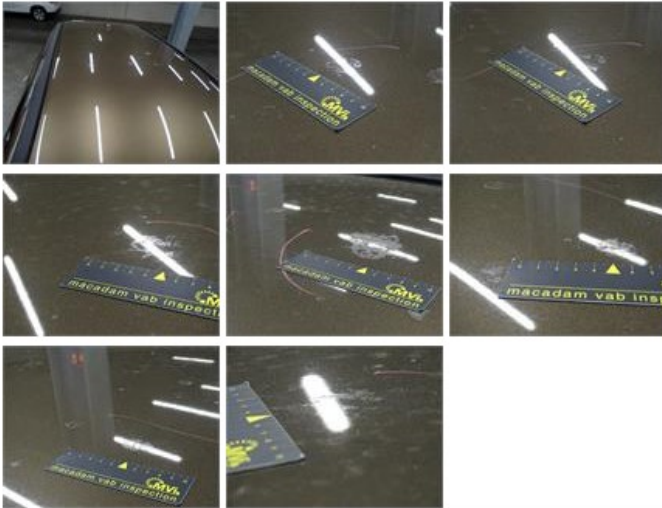
Roof, Chemical polution, LI - Repair and paint (complete) 577,80

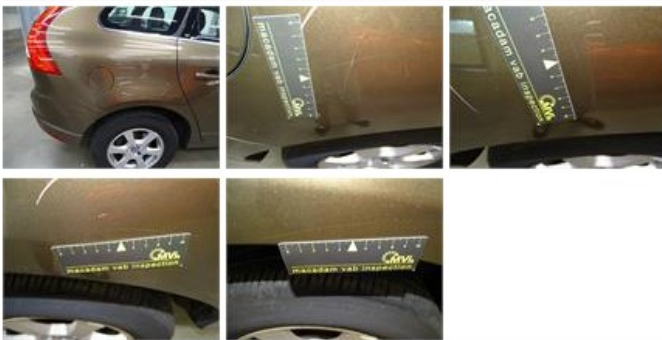
Wing R R, Scratch(es), LI - Repair and paint (complete) 369,84

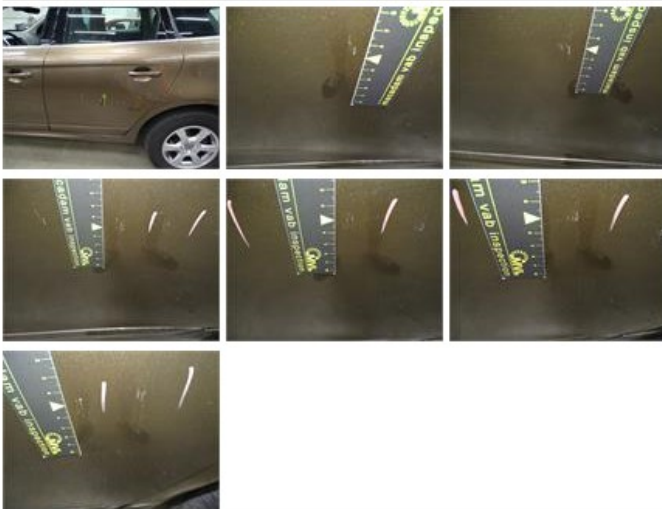
Door R L, Scratch(es), LI - Repair and paint (complete) 382,02

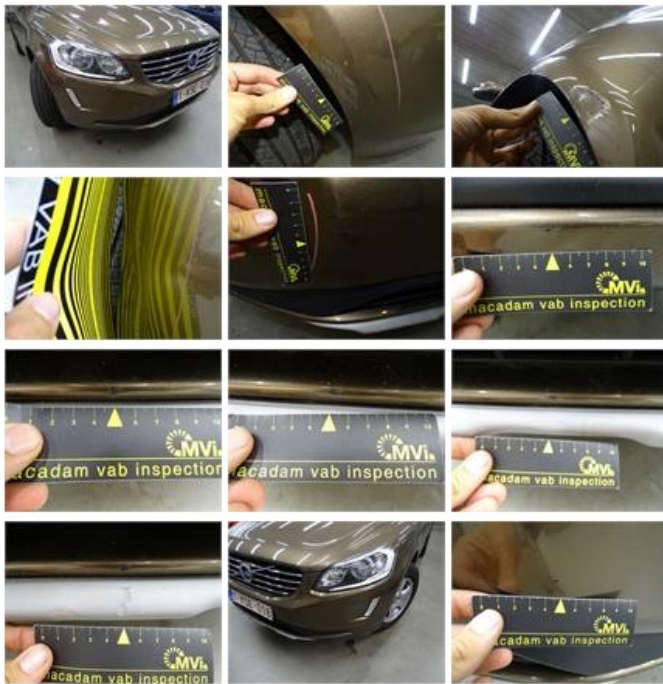
Bumper F, Dent(s) and scratch(es), LI - Repair and paint (complete)

254,16

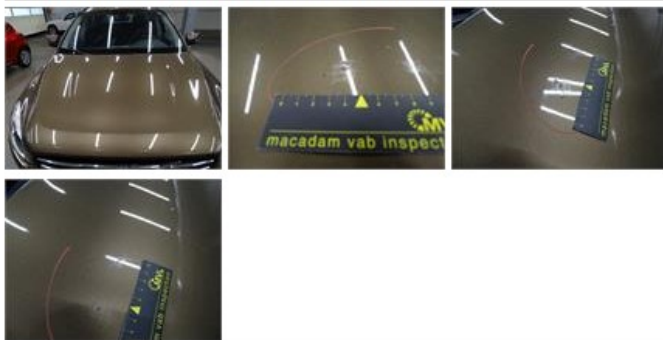
Bonnet, Chemical polution, LI - Repair and paint (complete)

348,09

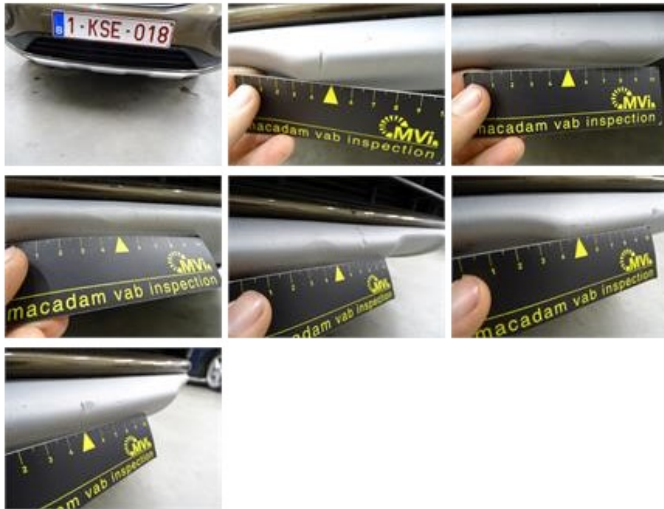
Bumper spoiler F, Scratch(es), E - Replace

48,00

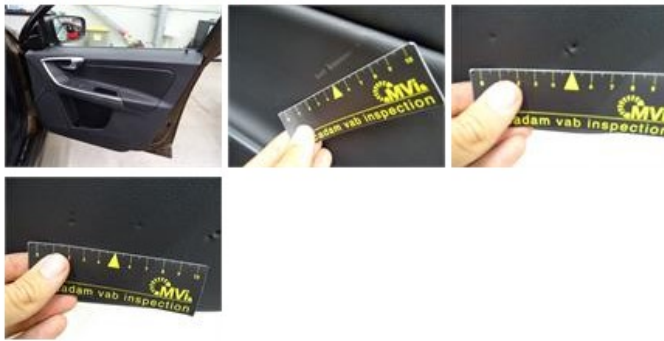
Door panel F R, Hole, E - Replace

132,00

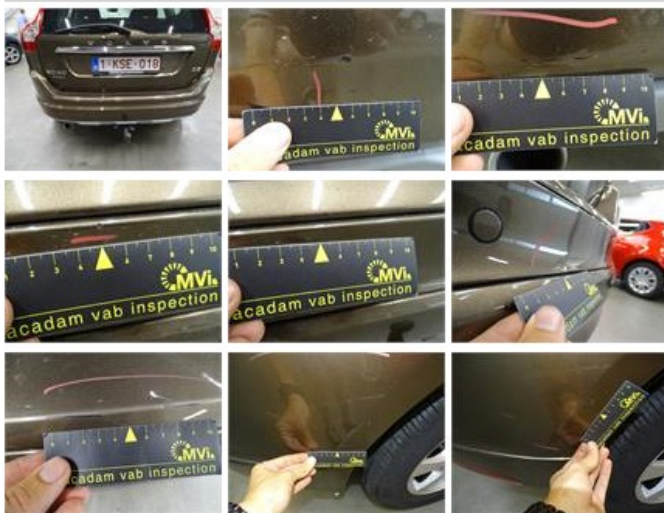
Bumper R, Dent(s) and scratch(es), LI - Repair and paint (complete)

254,16

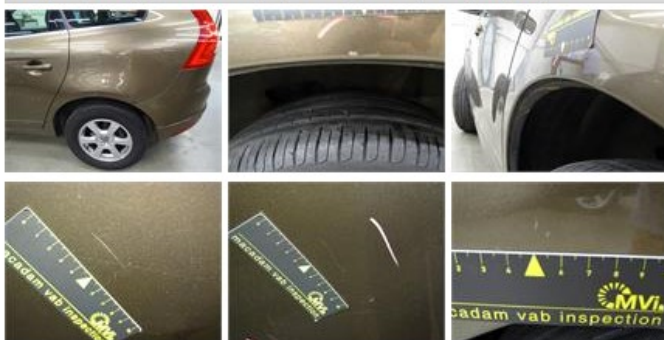
Wing R L, Dent(s) and scratch(es), LI - Repair and paint (complete)

369,84
